City of Indianapolis Park, Recreation and Open Space Plan
Park Inventory & Assessment

PIKE TOWNSHIP ASSESSED PARKS

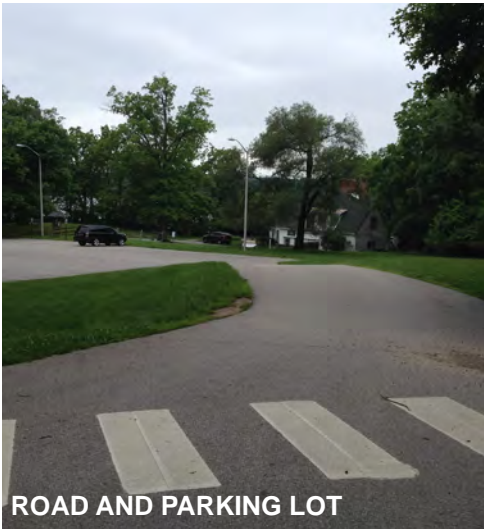
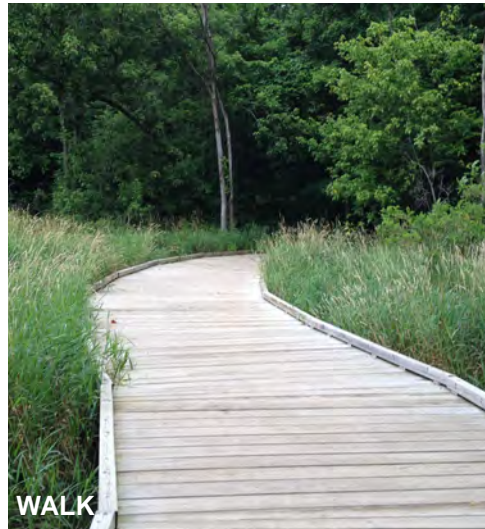
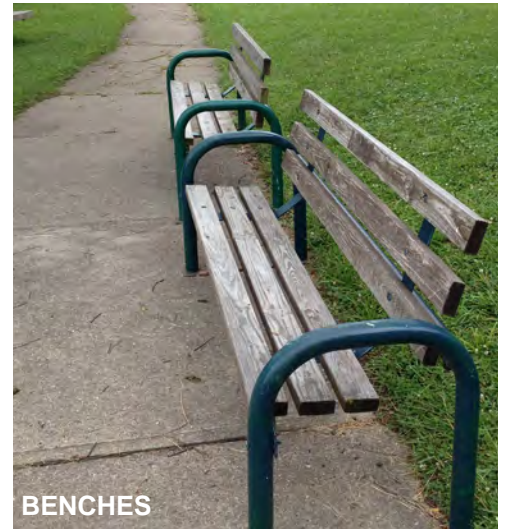
Description	Scale of Conditions	Notes
Roads	3	Main park road recently resurfaced. Some curves could use additional safety guards at sharp turns.
Walks	2.5	Walks focused at major attractions only. Condition of walk varies greatly depending on location in park.
Trails	3	Mainly dirt trails but some crushed stone in high traffic areas. Some erosion visible on some trails.
Parking	2.5	Mix of paved asphalt and crushed stone. Parking at south entrance is in particularly bad shape.
Benches	2.5	Mainly wooden seating with metal frame. Condition and style varies throughout site.
Trash Receptacles	2	Mix of metal and plastic's barrels. More trash receptacles could mitigate some litter issues.
Site Lighting	2	Minimal lighting present.
Bike Racks	2	Small amount present throughout park. Excluding Discovery Center. Additional bike racks would be helpful.
Park Signage	2.5	Main Park signs in fair condition. Park could use updated wayfinding throughout entire site.

Park Infrastructure General Notes: Park infrastructure condition varies a great deal throughout park. Main park drive and a few parking lots appear in good condition while other parking areas and roads need to be resurfaced.

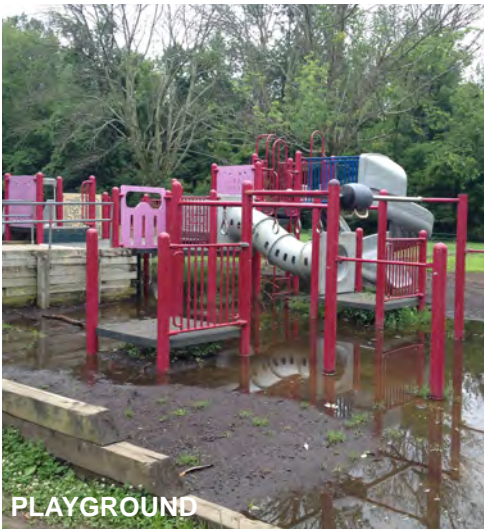
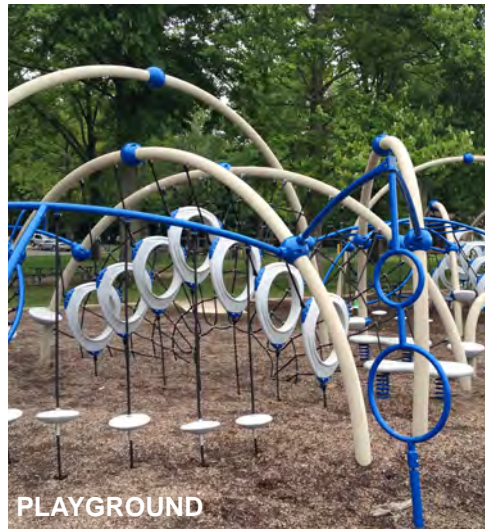
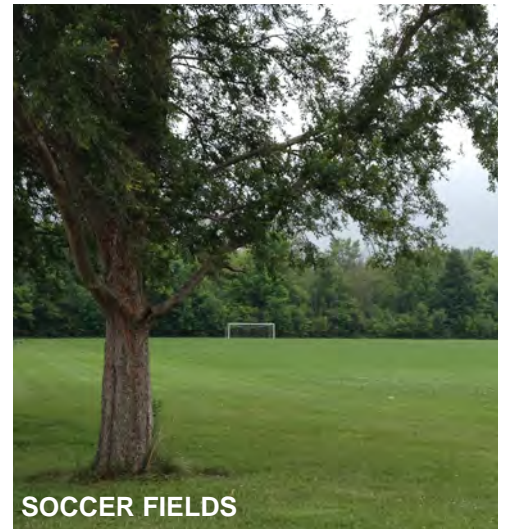
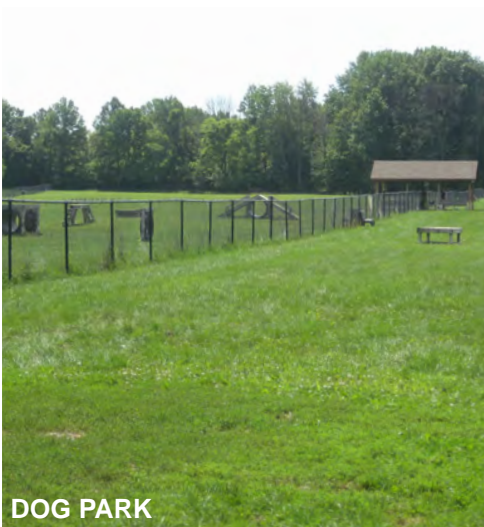
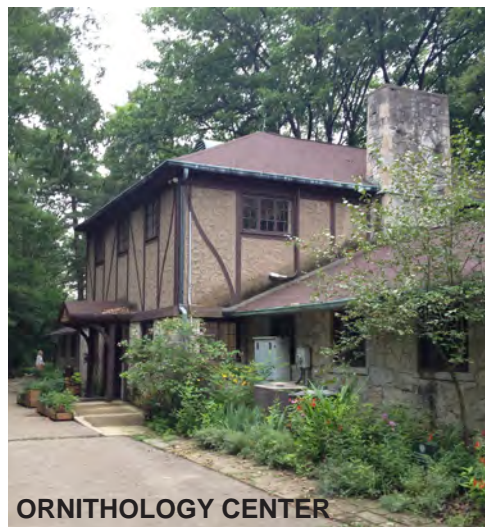
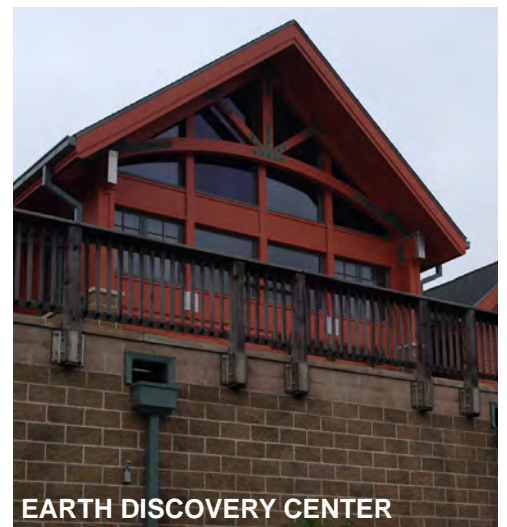
Programmed Park Amenities

Description	Scale of Conditions	QTY	Notes
Playground	2.5	4	All need fresh layer of mulch. Newer play structure located at Beach.
Basketball Court	0	-	N/A
Tennis Court	0	-	N/A
Volleyball Court	0	-	N/A
Softball Field	0	-	N/A
Soccer Field	3	8	Located near Group Picnic Area and next to Colts Complex.
Football Field	0	-	N/A
Baseball Field	0	-	N/A
Canine Zone	3	1	Large space but with limited shaded play and seating areas. Adjacent to I-465, road noise.
Spray Area	0	-	N/A
Pool-Outside	0	-	N/A
Water Slide	0	-	N/A
Sledding Hill	4	1	Located at overlook off of 56th Street.
Horseshoes	0	-	N/A
Disc Golf Holes	0	-	N/A
Nature Center	4	1	Called the Discovery Center. New facility that appears to be in great shape.

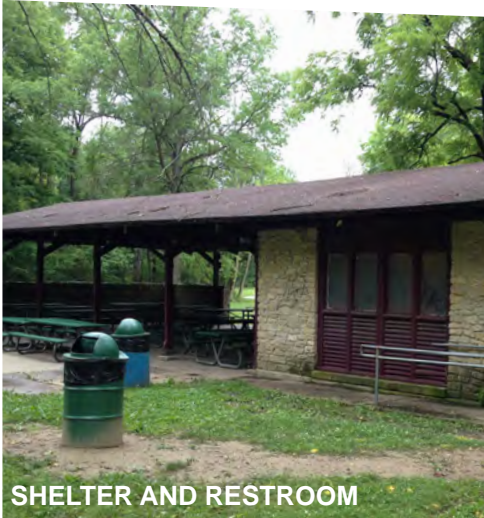
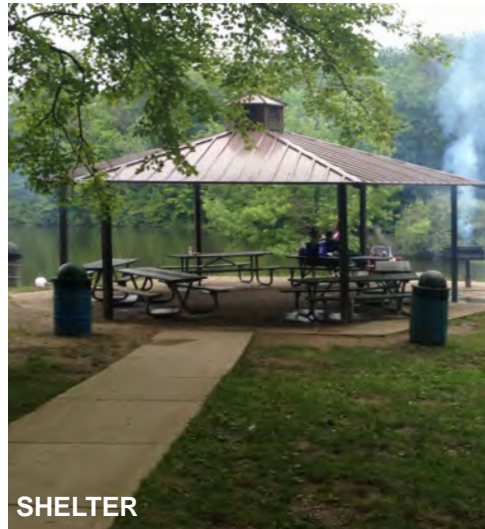
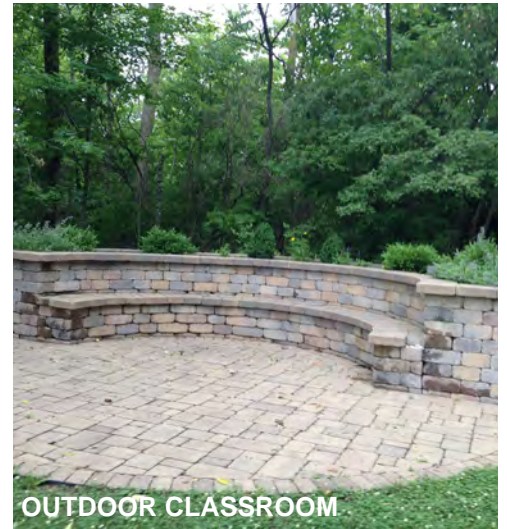
Programmed Park Amenities - Continued

Ornithology Center	3	1	Older facility with exhibits. Banks eroding. New migratory education trail/exhibit to open soon.
Restroom Facility	1.5	20+	Restroom facilities and shelters vary a great deal on site. Plans for renovations in 2016.
Picnic Shelter	1.5	17	Many shelters are in poor condition and need immediate attention. Few new shelters installed.
Water Sports Center	2	1	Older facility that could use updates. Lacks true "beach" area.
Marina	3	1	Marina is the park's rental shop. Rentals include bikes, canoes, paddle boards / boats, kayak.
Ropes Course	4	1	Go Ape Ropes Course is a new facility that appears to be in great shape.
Fishing Pier	3	2+	Small Fishing Pier at Lilly Pond. Limited fishing piers on Eagle Creek Reservoir.
Programed Park Amenities General Notes: Park amenities are geared towards nature activities and hiking. The 35+ restroom facilities and shelters need immediate attention - plans for renovations in 2016.

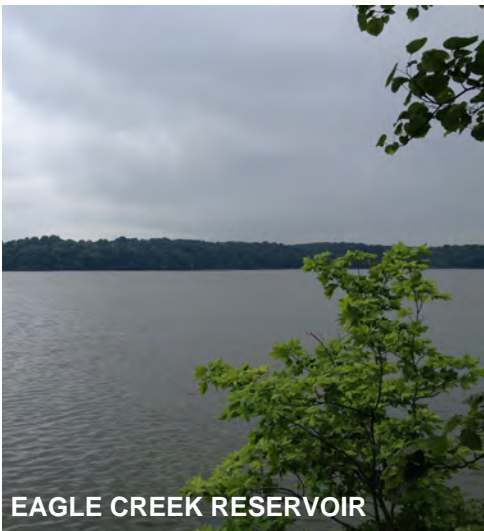
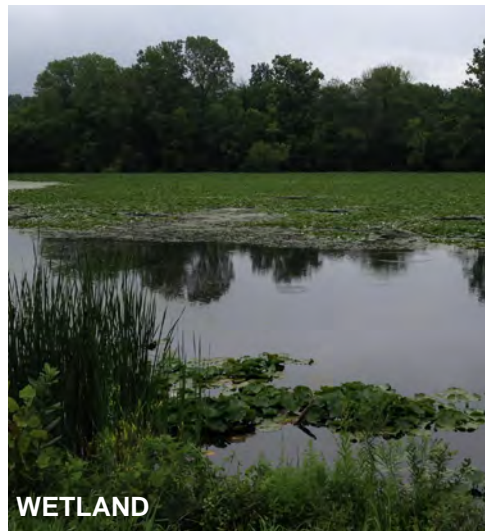
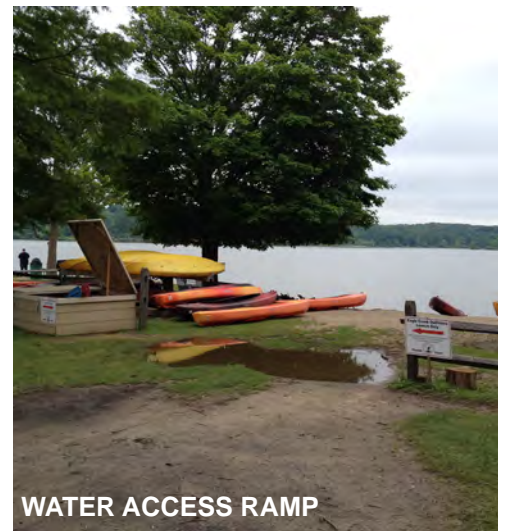
Park Open Space

Description	Scale of Conditions	Notes
Mowing	2	The park is primarily wooded but has a fair amount of large unprogrammed open space.
General Tree Conditions	2	Park is primarily forest but many of the large shade trees in lawn areas need pruning or removed.
Planting Areas	0	N/A
Water Feature	4	Good water access with boat rental available.

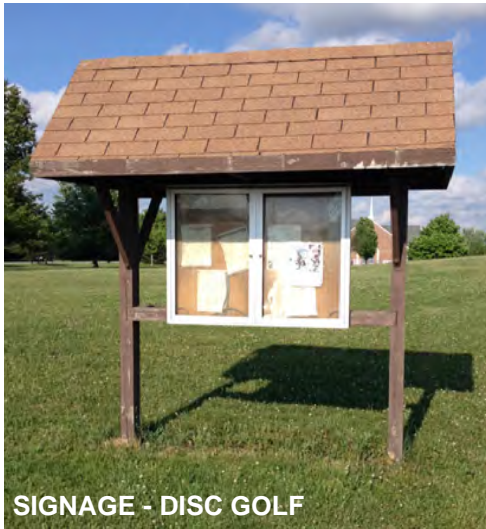
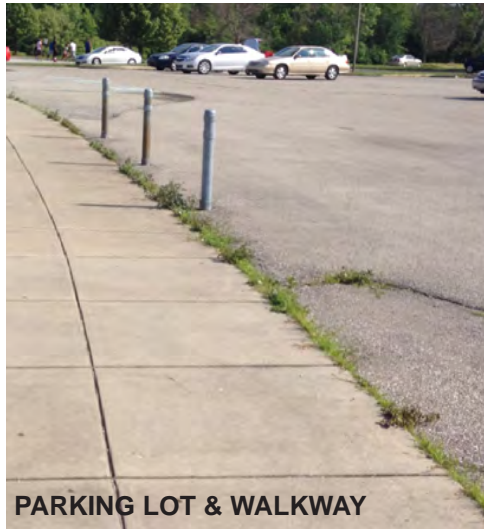
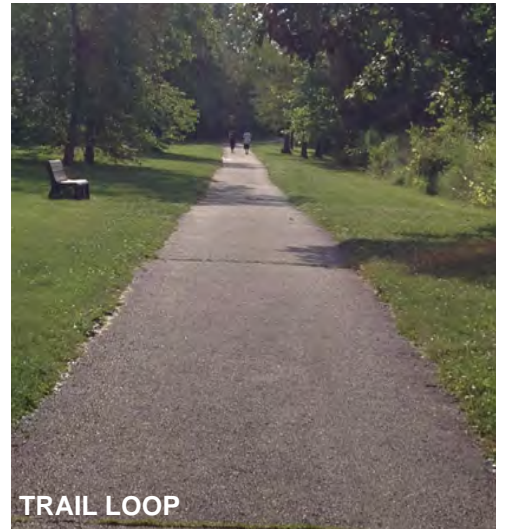
Park Infrastructure

Description	Scale of Conditions	Notes
Roads	2.5	Asphalt is cracking. Crosswalk for trail.
Walks	3	Weeds growing in expansion joints.
Trails	3.5	Paved asphalt, benches alongside trail, mileage marks on pavement (fading), minimal wear.
Parking	2	Asphalt is cracking, medians are full of weeds. Lines are fading. Medians are not maintained well.
Benches	4	Metal base with wood planks, paint is in good condition. Newer plastic/composite benches along trail.
Trash Receptacles	3	Large, blue metal drums. No lids near woods - animals?
Site Lighting	3	Only in parking lot and a few around baseball fields. Seem to be in working condition.
Bike Racks	0	N/A
Park Signage	3	Standard Indy Parks sign. Disc Golf sign at entrance has peeling paint and is lacking course map.
Bridges	0	N/A

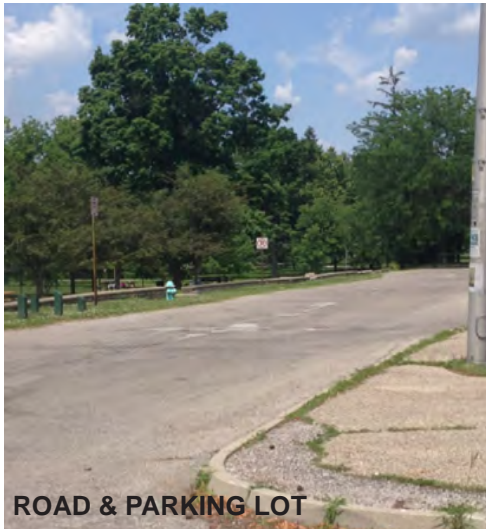
ROAD & PARKING LOT

Description	Scale of Conditions	Notes
Roads	2	Rough asphalt, pot holes and cracking.
Walks	2	Sidewalks in poor shape, steps between parking lot and sidewalk, but not connected.
Trails	2	8/10 mile walk, gravel path, edges are rough, gravel needs replenished.
Parking	3	No medians or trees, asphalt is rough.
Benches	4	Fresh paint, seem to be well maintained.
Trash Receptacles	3	Mix of blue plastic and green metal drums.
Site Lighting	3	Pool lighting, parking lot lighting just at edges, some along one trail.
Bike Racks	3	2 different types - one is difficult to access half of it.
Park Signage	3	Standard Indy Parks sign, Park map sign is along entrance road - not easy to read from vehicles.
Bridges	1	Gravel over double corrugated metal pipes, connects park to neighborhood to the north.

Park Infrastructure General Notes: Roads, parking lots, and sidewalks are worn and cracking. Benches and tables were freshly painted - park had a community day a few days prior to site visit and several maintenance tasks were completed.

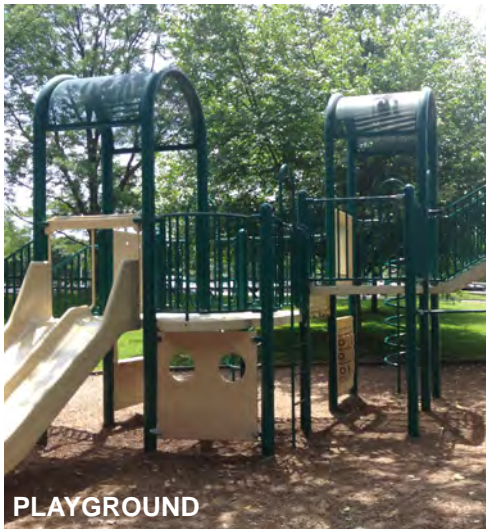
PLAYGROUND

Description	Scale of Conditions	QTY	Notes
Playground	3	1	Older equipment, but sturdy and well maintained.
Basketball Court	0	-	N/A
Tennis Court	4	6	Great condition, look new. In use during visit.
Volleyball Court	4	1	Fresh sand, edges recently cut, net intact, poles are not straight.
Softball Field	0	-	N/A
Soccer Field	2	2	Lines are painted, half a net is missing. Might bring in nets from off field.
Football Field	0	-	N/A
Baseball Field	3.5	1	No seats and tall weeds growing in fence.
Canine Zone	3	1	Looks well maintained. Large shade trees. Drinking fountain for people and dogs.
Spray Area	2	1	One spray jet inside pool. In a disconnected location.
Pool-Outside	4	1	Large size, options for seating in shade. Pool house with concession.
Water Slide	0	-	N/A
Sledding Hill	0	-	N/A
Horseshoes	2	1	Old, backstop is falling apart. Needs sand added - deep hole now.
Disc Golf Holes	0	-	N/A
Nature Center	1	1	Vacant looking building. Available for rent, primarily used for senior activities.

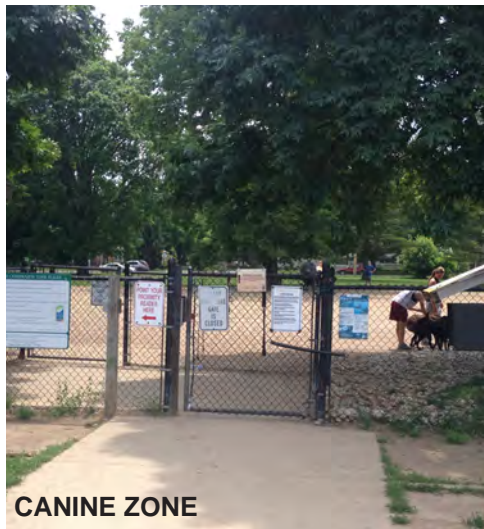
CANINE ZONE

Park Weaknesses
Several infrastructure elements are old and deteriorating - walkways, parking lots, fitness trail, and former family center building (now the nature center). The dog park can be crowded at times.

Facilities Recommendations (Based on Park Assessments & Survey Results)
Improve and expand walking trails to connect to existing amenities, nearby Monon Trail, and surrounding neighborhood. Update and repurpose former family center to accommodate indoor uses shown in survey results. Expand dog park to alleviate crowding. Installing synthetic turf in the soccer fields will reduce muddy areas.

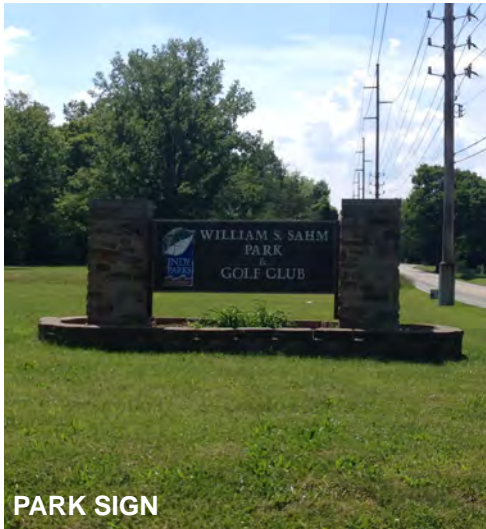
PARK SIGN

Description	Scale of Conditions	Notes
Roads	3	No curbs, asphalt is in good condition, unmarked angled parking along most of the road.
Walks	3	Asphalt walks are cracking, concrete walks are in good condition, seem new.
Trails	3	Trails are paved or unpaved - map shows location. Good condition through woods, but need cleaned off.
Parking	3	Main parking by pool is in good condition, other parking is unmarked.
Benches	3.5	Benches/tables near pool and playground are in good conditions, others are not - peeling paint, rusting.
Trash Receptacles	3	Standard metal drum, quantity is low.
Site Lighting	3	Minimal along road.
Bike Racks	0	N/A
Park Signage	3	Standard Indy parks sign, disc golf sign is old and falling apart.
Bridges	0	N/A

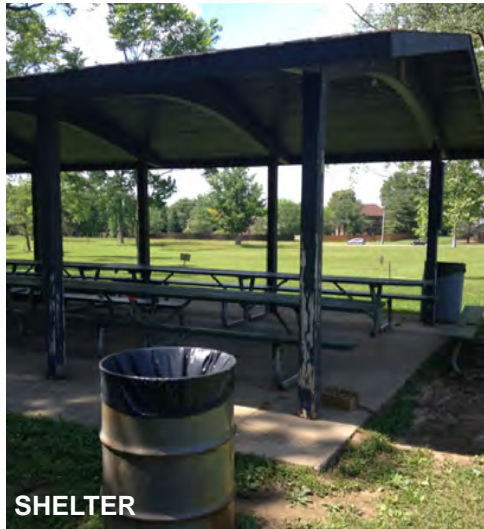
SHELTER

Family Center	2	1	"Corporate Pavilion" rental area/building. Dark building. Has large, sheltered picnic area.
Restroom Facility	3	1	Park has access to restroom at pool house. No others in park.
Picnic Shelter	2	2	Both have peeling pain and rotting wood. One has large hole in roof.
Picnic Clusters	2.5	5+	Picnic areas near playground are freshly painted. Others are peeling and missing trash cans.
Golf Course	4	18 Holes	Golf cart paved paths, mature trees, looks well maintained. Has country club and concession.
Concession Stand	4	1	Concession stand at pool, has access from outside pool.
Programed Park Amenities General Notes: Pool, tennis courts, and soccer fields are new and look well maintained. Other programmed amenities seem to be neglected.

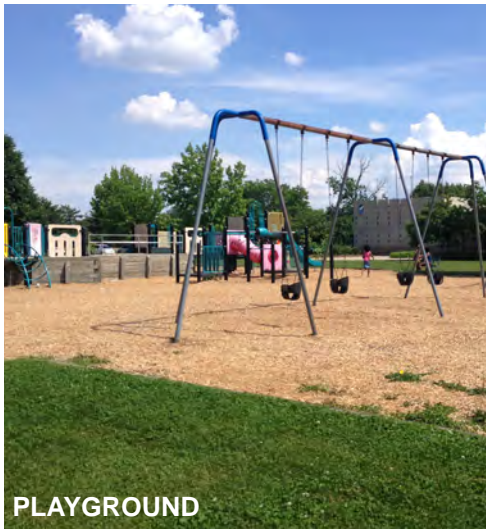
PLAYGROUND

Description	Scale of Conditions	QTY	Notes
Playground	2.5	1	Older, seems stable, mulch is low and full of weeds.
Basketball Court	3	1	Cracking asphalt, near road, baskets are older.
Tennis Court	4	4	Look new, currently in use.
Volleyball Court	3.5	3	Two fenced in courts, clean sand, nets usable, but leaning. Another grass court, no net.
Softball Field	0	-	N/A
Soccer Field	3	6	Nets in tact, 2 picnic tables and 2 trash cans for all fields. No lines. Extra smaller nets stored.
Football Field	0	-	N/A
Baseball Field	0	-	N/A
Canine Zone	0	-	N/A
Spray Area	2	1	One spray fixture in pool area that is not within pool. Old and not in use.
Pool-Outside	4	4	Huge pool, interesting shape, not rectangular. Swimming areas with varying water depths.
Water Slide	4	4	2 large slides, 1 medium, and 1 toddler size. All are working and look well maintained.
Sledding Hill	0	-	N/A
Horseshoes	1	1	Sand area is a large hole, back board is missing wood planks. Not usable.

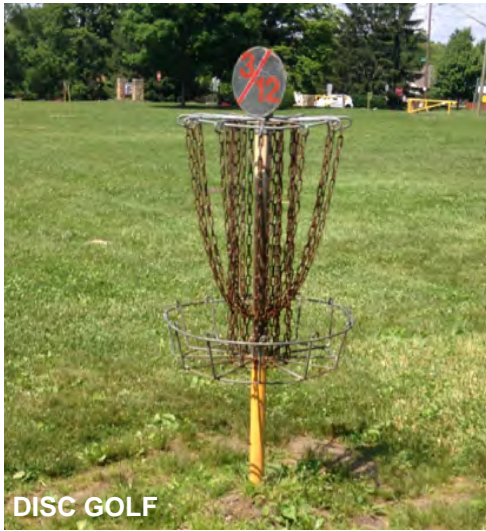
DISC GOLF

Disc Golf Holes	3	12 Holes	Map provided at disc golf sign, goals are in good condition, concrete starting pads.
Nature Center	0	-	N/A

Facilities Recommendations (Based on Park Assessments & Survey Results)
The large park size could be utilized to create a large trail loop to address the lack of community trails in the area. Additional trails/walks should be added to improve neighborhood connections. Existing picnic shelters should be addressed immediately due to unsafe conditions. Disc golf course, basketball courts, and sand volleyball should be improved.

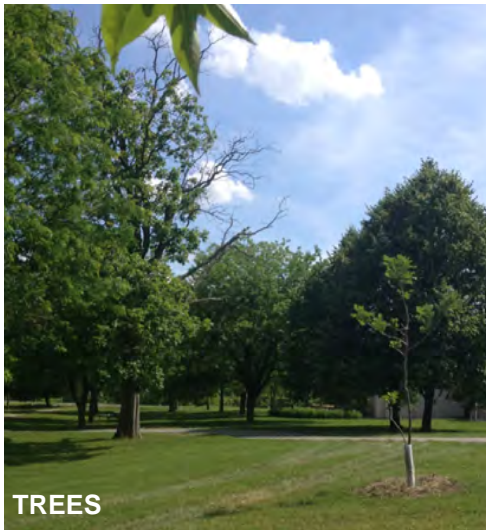
TREES

Park Open Space - Assessment		
Description	Scale of Conditions	Notes
Mowing	3	Some weeds are getting tall. There is an animal (groundhog) digging throughout the disc golf course lawn.
General Tree Conditions	3.5	Large shade trees on the northern half of the park. Dead limbs need pruned. New trees are planted.
Planting Areas	3	Small wetland area with an educational sign. Planting areas around pool are minimal, one is overgrown.
Water Feature	2	There's a small stream running through the golf course, looks like primary drainage for course.
Park Open Space General Notes: Planting beds around park buildings are full of weeds and are overgrown.

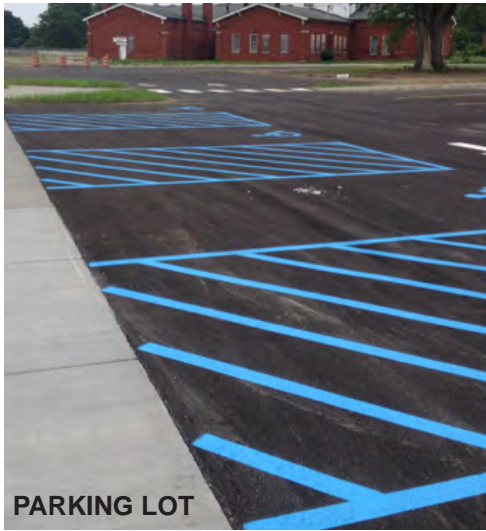
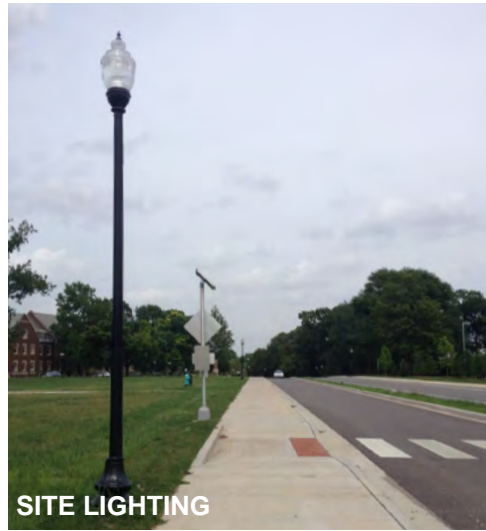
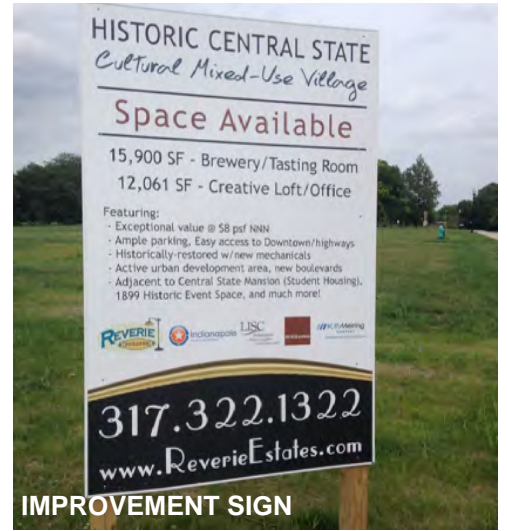
Park Infrastructure

Description	Scale of Conditions	Notes
Roads	4	New road system leading back to park.
Walks	4	New walkways connecting parking lot and road to sports fields.
Trails	0	N/A
Parking	4	New parking lots - some median trees.
Benches	0	N/A
Trash Receptacles	0	N/A
Site Lighting	3	New site lighting.
Bike Racks	0	N/A
Park Signage	0	N/A
Bridges	0	N/A

Facilities Recommendations (Based on Park Assessments & Survey Results)
The park currently lacks signage and wayfinding; this may change once construction on the park is finished.

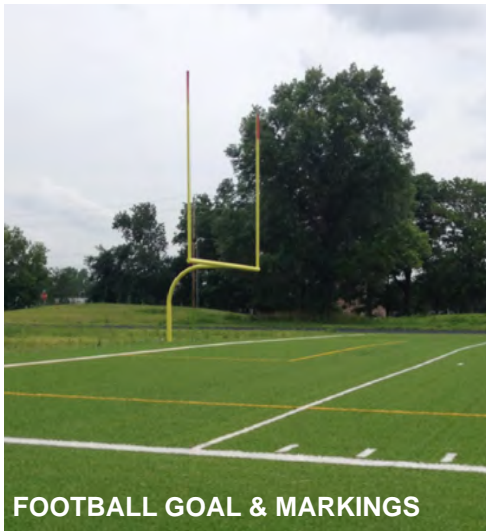
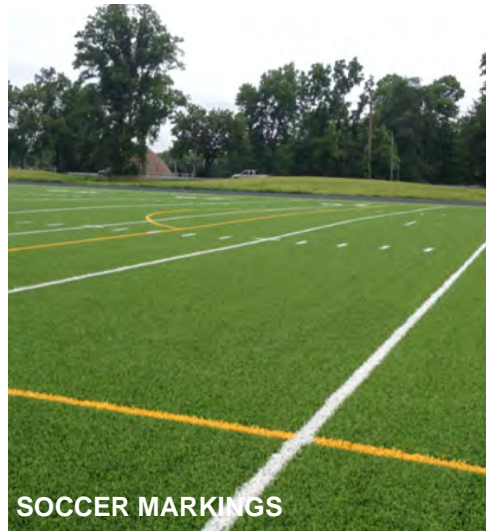
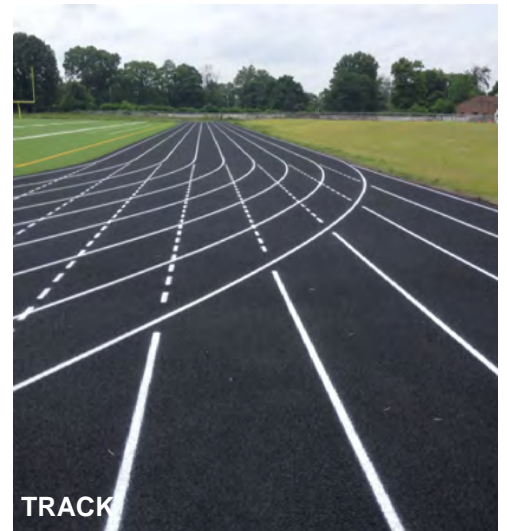
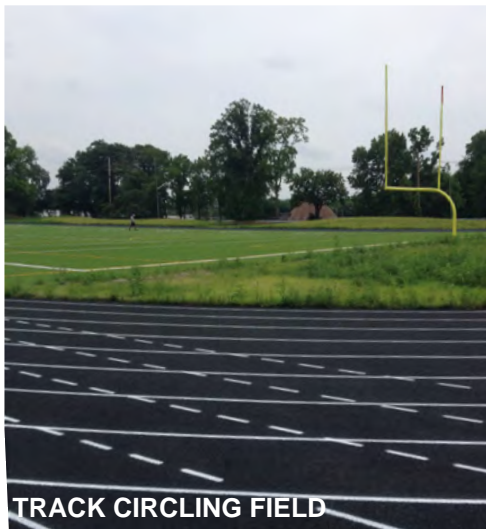
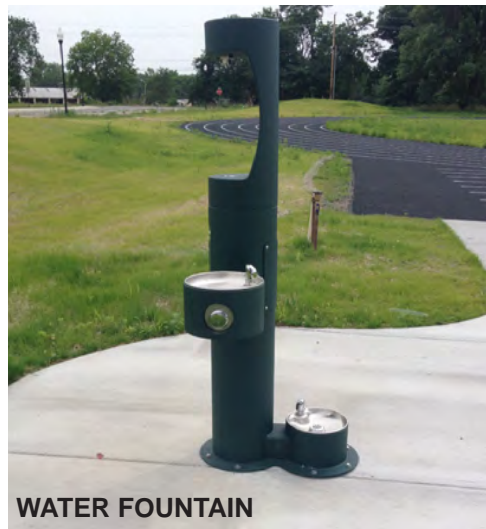
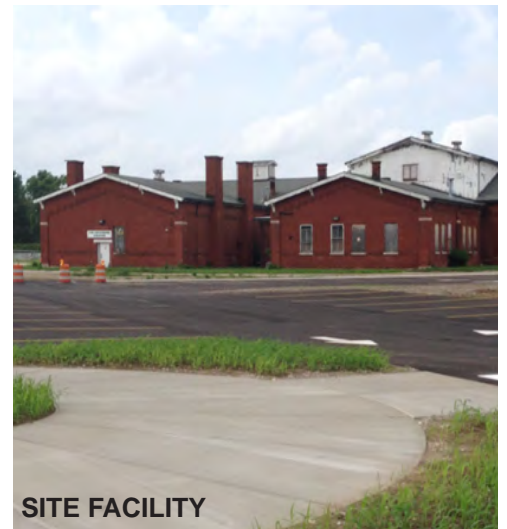
Programmed Park Amenities

Description	Scale of Conditions	QTY	Notes
Playground	0	-	Playground across street at school.
Basketball Court	0	-	Kids-sized basketball courts across street at school.
Tennis Court	0	-	N/A
Volleyball Court	0	-	N/A
Softball Field	0	-	N/A
Soccer Field	4	1	Soccer and football fields are combine on one field, just two separate line systems.
Football Field	4	1	Field is synthetic turf, looks new, some weeds are growing through the turf.
Baseball Field	0	-	N/A
Canine Zone	0	-	N/A
Spray Area	0	-	N/A
Pool-Outside	0	-	N/A
Water Slide	0	-	N/A
Sledding Hill	0	-	N/A
Horseshoes	0	-	N/A
Disc Golf Holes	0	-	N/A
Nature Center	0	-	N/A

Family Center	0	-	N/A
Restroom Facility	0	-	N/A
Picnic Shelter	0	-	N/A
Picnic Clusters	0	-	N/A
Track	4	1	Track encircling football/soccer field. New, great condition.
Programed Park Amenities General Notes: The track/football/soccer field is the only programmed amenity on site.

Park Strategic Recommendations
This park currently accommodates adult fitness activities, limited to football, soccer and track. A stronger connection with the adjacent school would help provide children's activities.

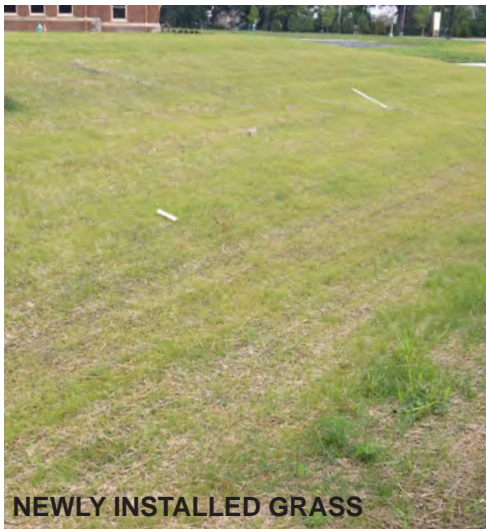
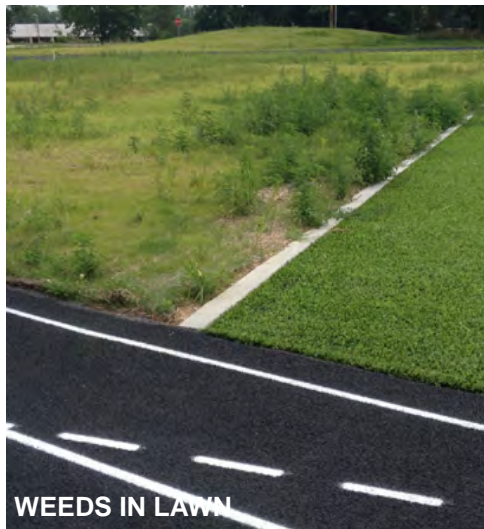
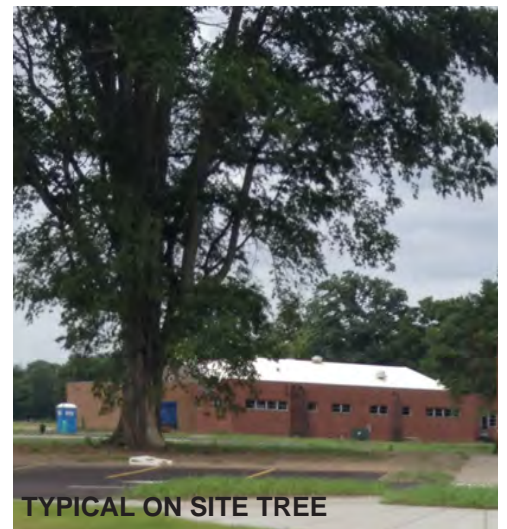
Park Open Space - Assessment		
Description	Scale of Conditions	Notes
Mowing	2	Grass seed and mulch has recently been installed. A lot of weeds are growing instead of grass.
General Tree Conditions	3	There are a few large shade trees - nothing new has been planted.
Planting Areas	0	N/A
Water Feature	0	N/A
Park Open Space General Notes: Park area is small. Looks newly constructed and possibly still under construction.

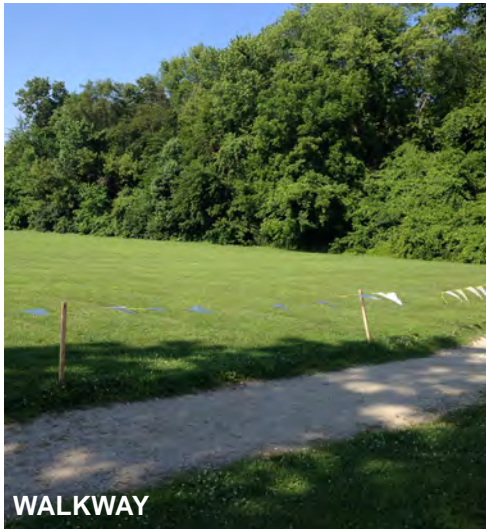
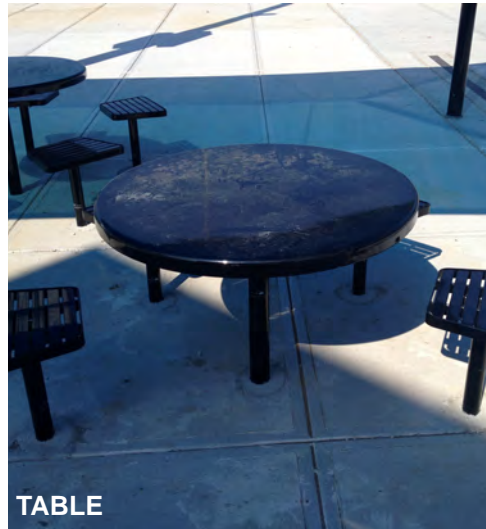
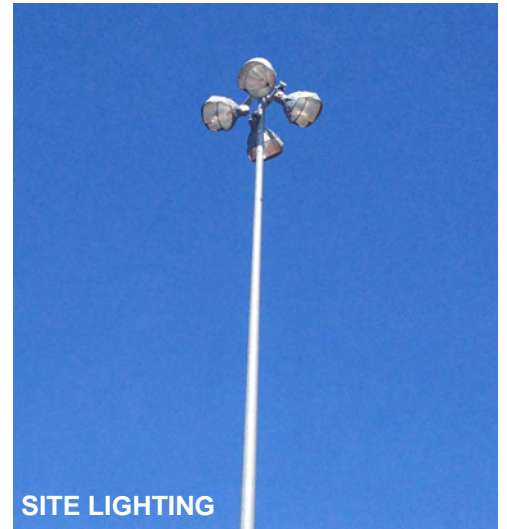
Park Infrastructure

Description	Scale of Conditions	Notes
Roads	2	Road leading into park is cracking and has potholes.
Walks	4	New sidewalks around concessions building and from parking to ball fields.
Trails	0	N/A
Parking	1	Parking lot was under construction at time of park visit.
Benches	4	New benches and tables are installed in concrete around ball fields.
Trash Receptacles	3	New trash receptacles near ball fields. Older, dented, rusty, metal drums near picnic shelter.
Site Lighting	4	Newly installed around ball fields - fields are lit.
Bike Racks	0	N/A
Park Signage	4	Newer sign by entrance with Indy Parks logo.
Bridges	0	N/A

Facilities Recommendations (Based on Park Assessments & Survey Results)
The addition of trails would improve internal circulation and connectivity to the surrounding neighborhood, including Thatcher Park to the north. A walking loop could be created and connected to the existing walking loop of Thatcher Park to create a larger walking loop.

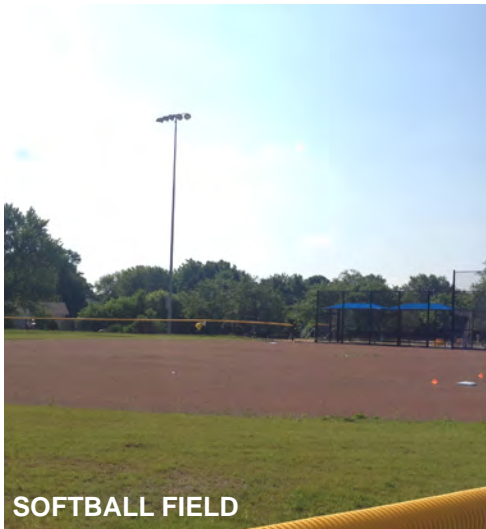
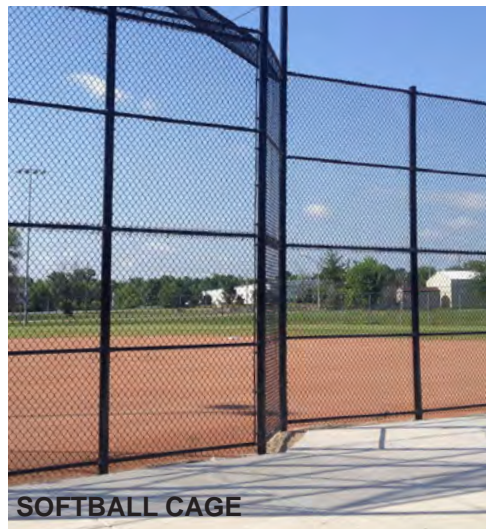
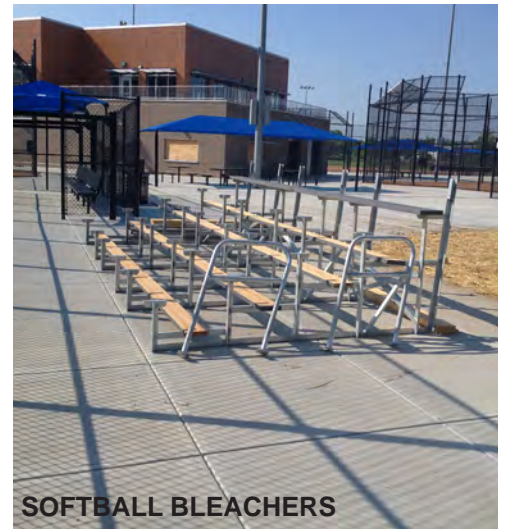
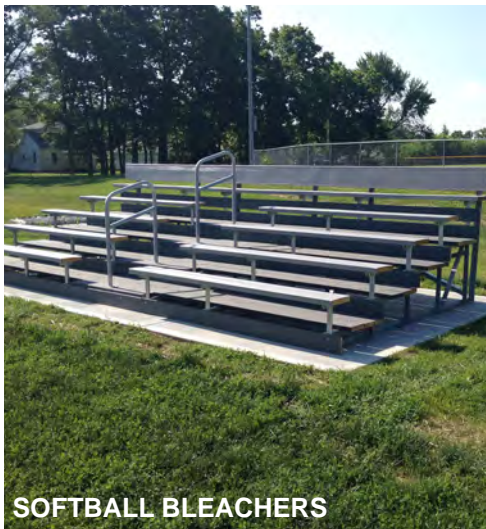
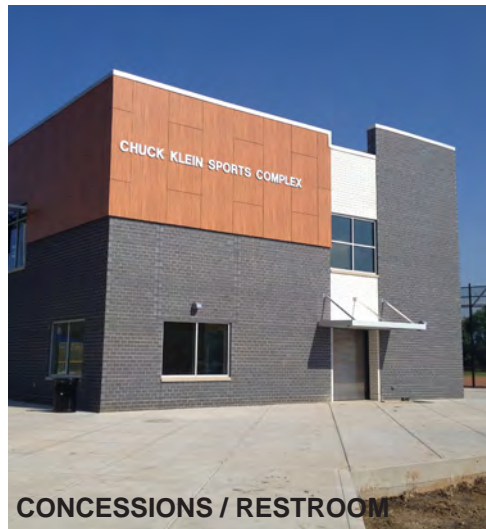
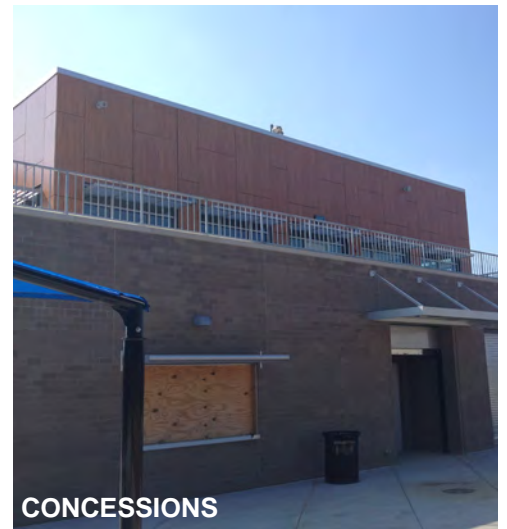
Programmed Park Amenities

Description	Scale of Conditions	QTY	Notes
Playground	0	-	N/A
Basketball Court	0	-	N/A
Tennis Court	0	-	N/A
Volleyball Court	0	-	N/A
Softball Field	4	3	Newly renovated, infields are clean. Concessions building in center of fields.
Soccer Field	2	1	Near back of park, not easily accessible from Chuck Klein, but is from Thatcher to the north.
Football Field	0	-	N/A
Baseball Field	0	-	N/A
Canine Zone	0	-	N/A
Spray Area	0	-	N/A
Pool-Outside	0	-	N/A
Water Slide	0	-	N/A
Sledding Hill	0	-	N/A
Horseshoes	0	-	N/A
Disc Golf Holes	0	-	N/A
Nature Center	0	-	N/A

Park Strategic Recommendations
The park improvements have created new picnic areas and shelters near the ballfields. New shelters could be added to the south of the parking lot to serve as team gathering points before and after games.

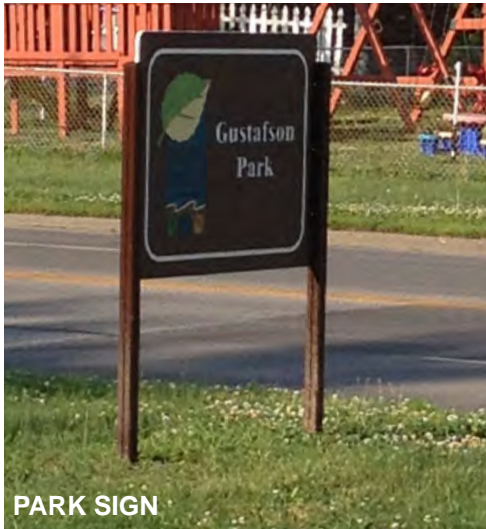
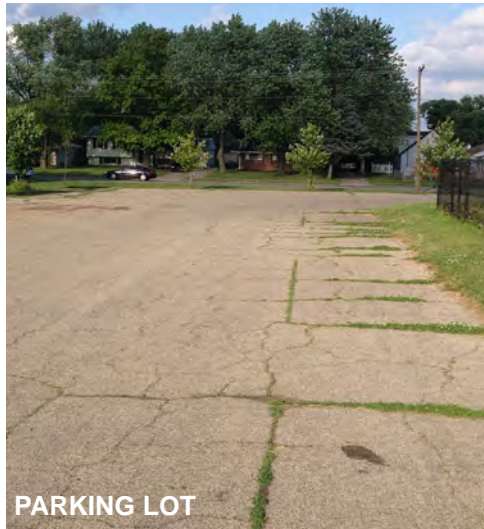
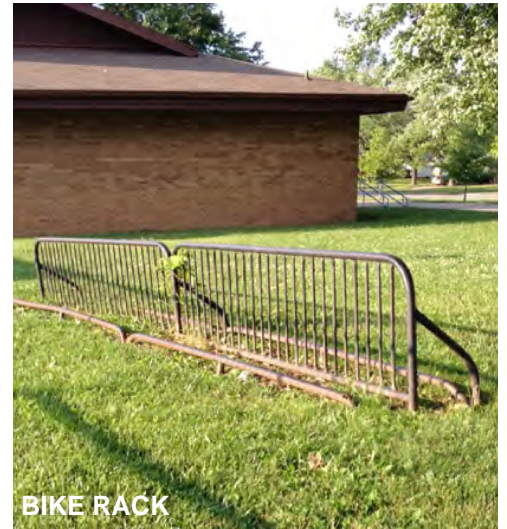
Park Infrastructure

Description	Scale of Conditions	Notes
Roads	3	Main park road is paved. Road to baseball fields is gravel and hard to find.
Walks	2.5	Concrete is in good shape, limited to around pool house and parking lots.
Trails	0	N/A
Parking	2.5	Asphalt cracking, pavement lines are completely faded.
Benches	2	Wood planks with metal frame. Mix of freshly painted and completely falling apart.
Trash Receptacles	2	Few in number, mix of metal and plastic blue drums.
Site Lighting	2	Older, seem to be in working order. Limited to parking lot.
Bike Racks	3	Located near pool house, in the middle of the grass.
Park Signage	3.5	Standard Indy Parks identity signs.
Bridges	2	2 bridges crossing stream - older, deck flexes when crossing. No clear path to bridges.

Facilities Recommendations (Based on Park Assessments & Survey Results)
Baseball fields are well used and well maintained. However, the other sports fields and amenities should be updated to meet the community needs. New trails and walkways should be added to create internal circulation and improve neighborhood connectivity. A trail could be created to connect to Meadowood Park to expand on Meadowood's current walking trail.

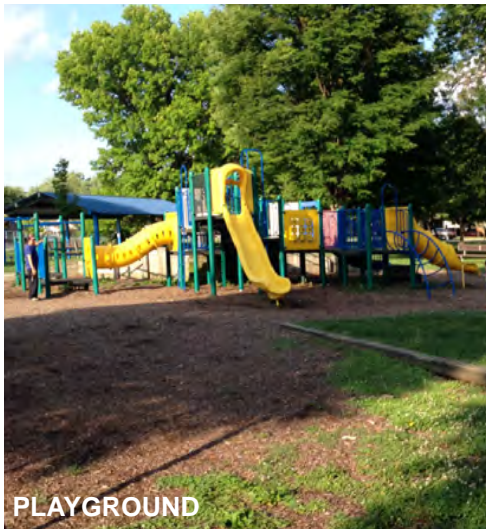
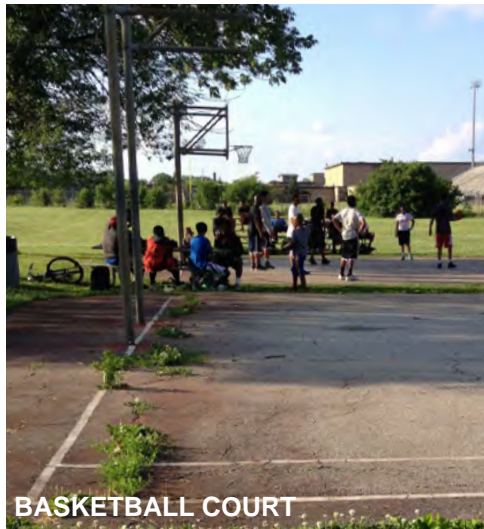
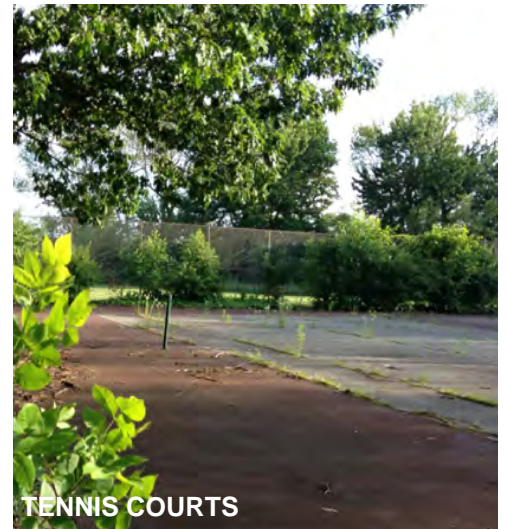
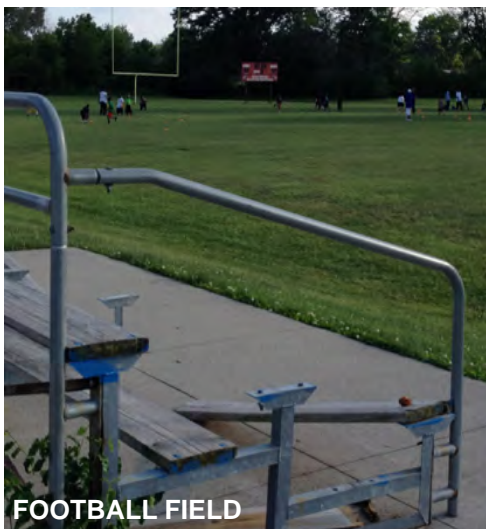
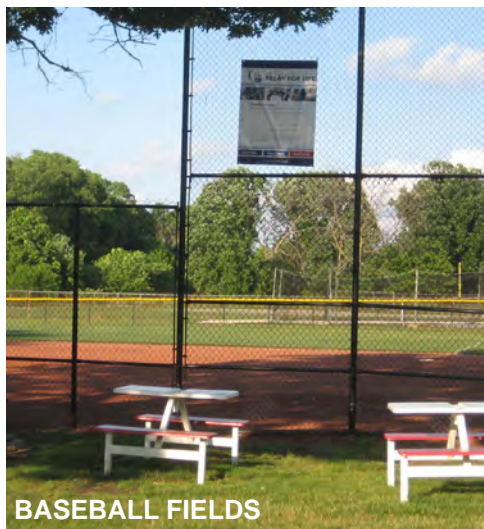
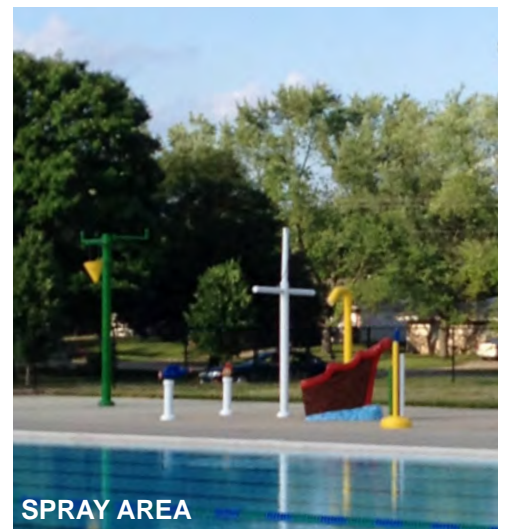
Programmed Park Amenities

Description	Scale of Conditions	QTY	Notes
Playground	3	1	Mulched area is full of weeds. Newer playground. In use during site visit.
Basketball Court	1	1.5	Old, cracking courts, one court is missing baskets. Bleachers on one end.
Tennis Court	1	2	Fence is overgrown with weeds, no nets, court surface is cracking.
Volleyball Court	0	-	N/A
Softball Field	0	-	N/A
Soccer Field	0	-	N/A
Football Field	3	1	Has lines and scoreboard. Bleachers on sideline, but completely falling apart.
Baseball Field	3.5	5	Fields are in good shape. Concession stand with restroom. Some fields do not have seating.
Canine Zone	0	-	N/A
Spray Area	4	1	Inside pool area. Looks new. Turned off during site visit.
Pool-Outside	4	1	Looks clean. Closed during visit. Pool house is older, entrance is dark.
Water Slide	0	-	N/A
Sledding Hill	0	-	N/A
Horseshoes	0	-	N/A
Disc Golf Holes	0	-	N/A
Nature Center	0	-	N/A

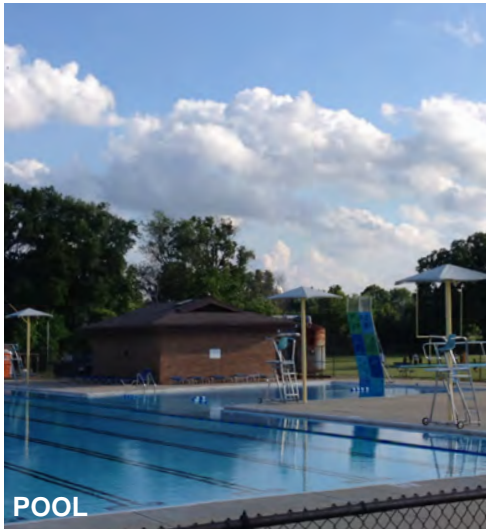
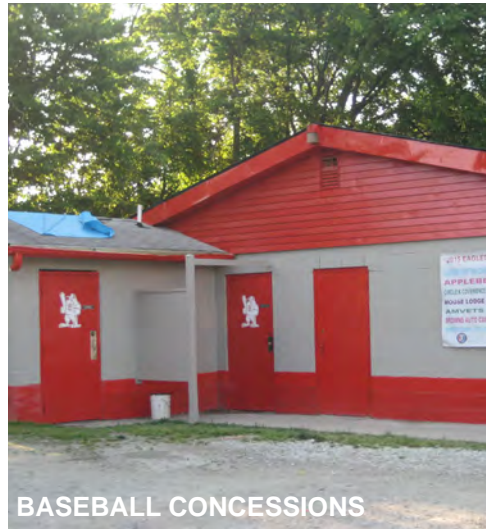
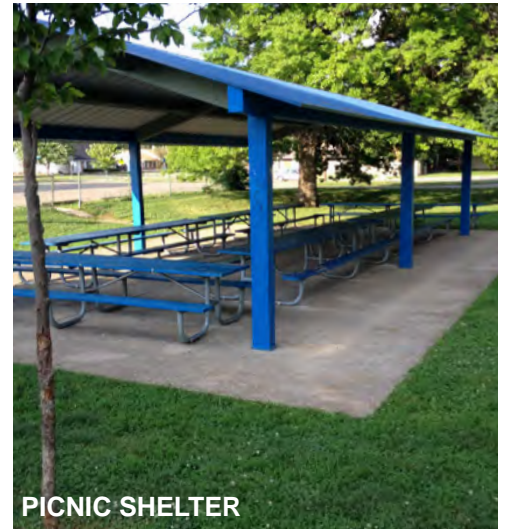
Programmed Park Amenities - Continued

Family Center	0	-	N/A
Restroom Facility	2.5	2	One in pool house - locked during visit. One in baseball concession building - also locked.
Picnic Shelter	3.5	1	Minimal wear, near playground. Has access to grill.
Picnic Clusters	3	4	No trash cans near picnic clusters. 2 near playground, 2 at football concession stand.
Programed Park Amenities General Notes: Playground and pool area looks updated, but other park amenities look neglected. Hard to navigate from parking lot to basketball courts - need to pass through football field.

Park Strategic Recommendations
Natural areas could be added to this park to create outdoor educational opportunities for the adjacent schools. Clearing brush along the stream will open views and create a better connection between the currently separated areas of the park. The pool house should be updated to a larger facility, housing an indoor pool and fitness center.

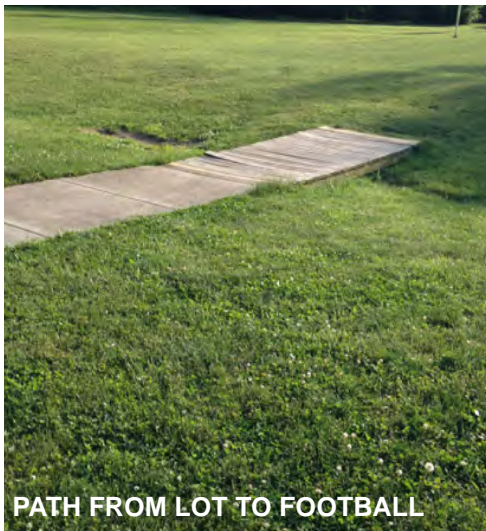
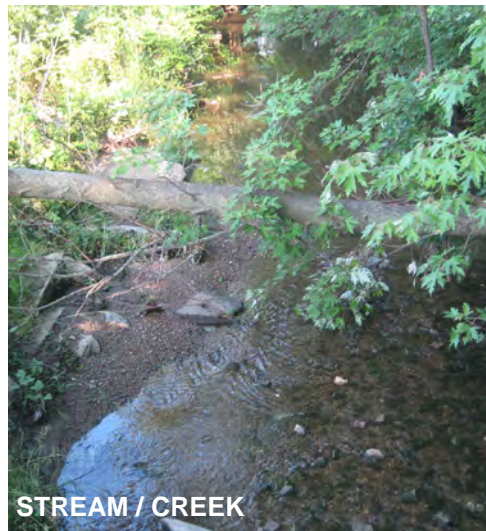
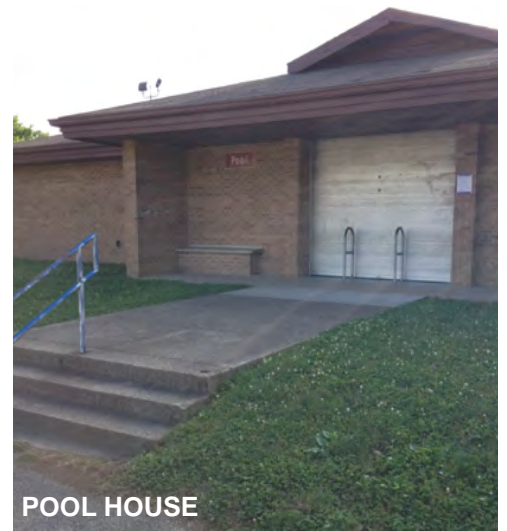
Park Open Space - Assessment		
Description	Scale of Conditions	Notes
Mowing	3	Looks recently mowed. Ball fields look great. Back area of park (northwest corner) needs mowed.
General Tree Conditions	2.5	Dead limbs. No active tree replanting.
Planting Areas	0	N/A
Water Feature	2	Little access to stream, only at footbridges. Smells mucky.
Park Open Space General Notes: Back area of park (NW corner) seems to be neglected - no clear path to area, needs mowed.

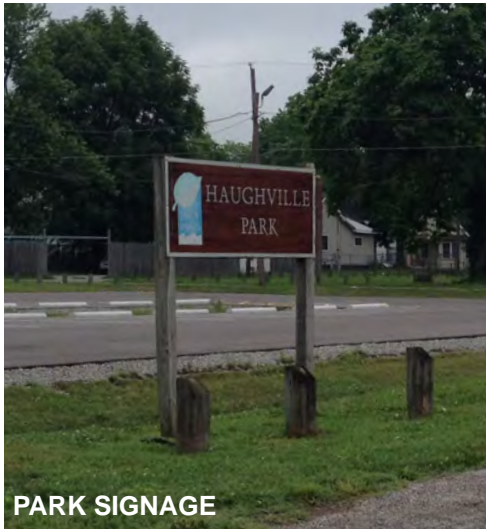
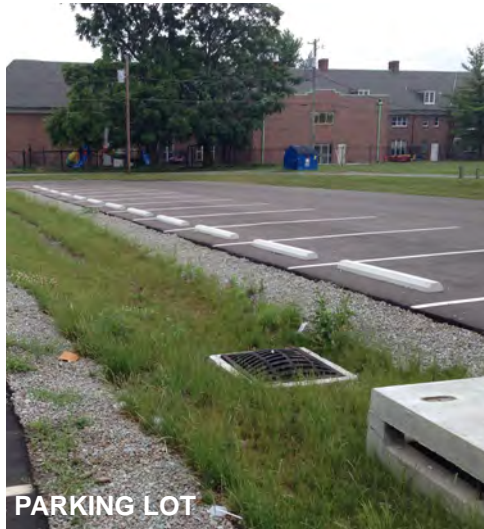
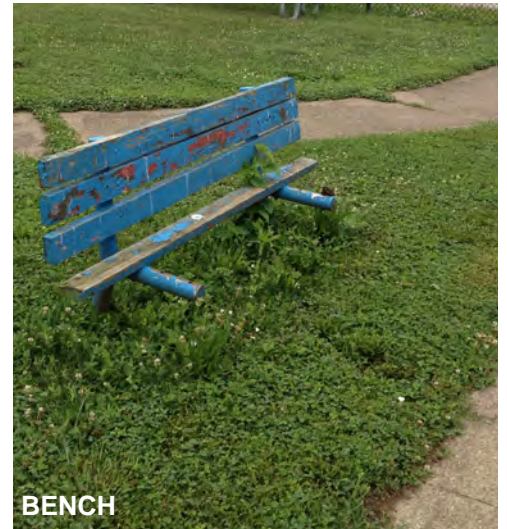
Park Infrastructure

Description	Scale of Conditions	Notes
Roads	0	N/A
Walks	4	Majority of walks in park were recently replaced.
Trails	0	N/A
Parking	4	Parking was recently replaced and provided vegetated bioswales between parking aisles.
Benches	2	A few benches were recently replaced but many older benches have missing or broken wood planks
Trash Receptacles	2	Mix of blue plastic and metal drums. Appears to be a need for more receptacles.
Site Lighting	2	Very minimal site lighting at the edges of park and at new restroom facility.
Bike Racks	0	N/A
Park Signage	3	Standard Indy Parks sign and park improvements sign.
Bridges	0	N/A

Facilities Recommendations (Based on Park Assessments & Survey Results)
The park needs multi-use path improvements to create better internal circulation and connections to the surrounding neighborhood. The unused ball fields could be redeveloped as a soccer facility to meet community needs. The addition of walking trails in the park would create additional outdoor recreation.
