City of Indianapolis Park, Recreation and Open Space Plan
Park Inventory & Assessment

PIKE TOWNSHIP ASSESSED PARKS

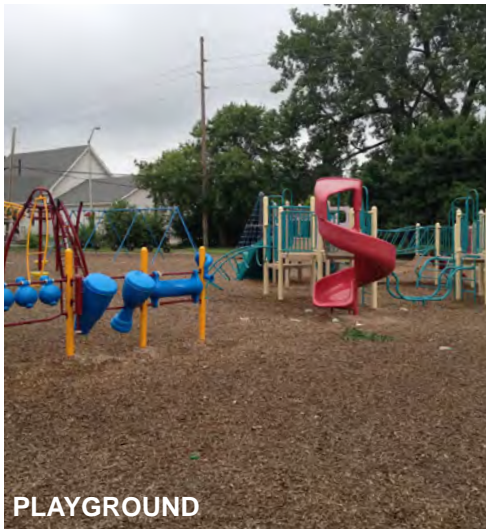
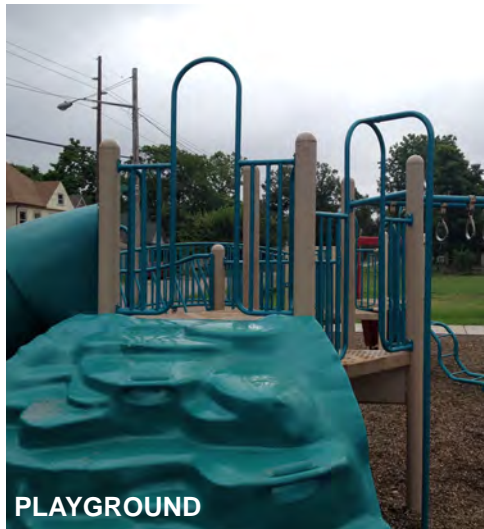
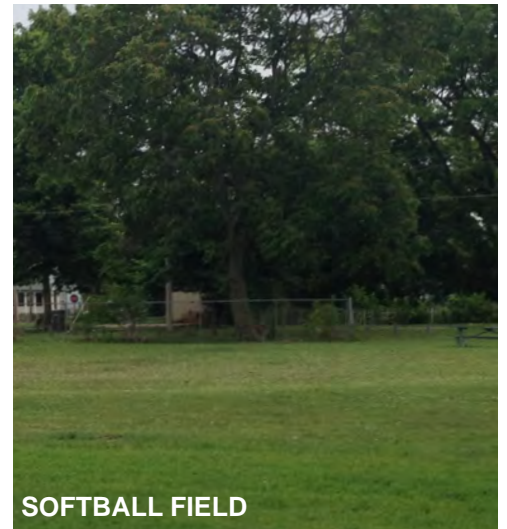
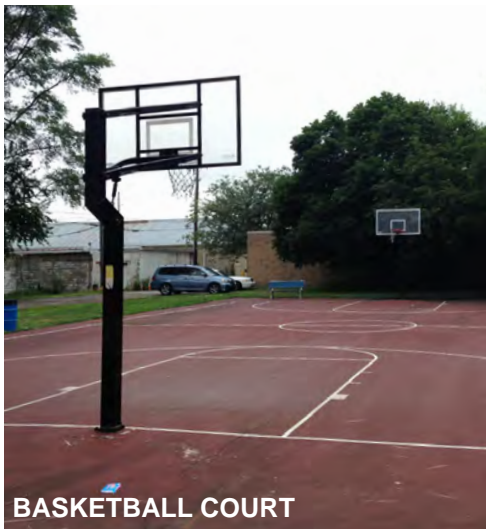
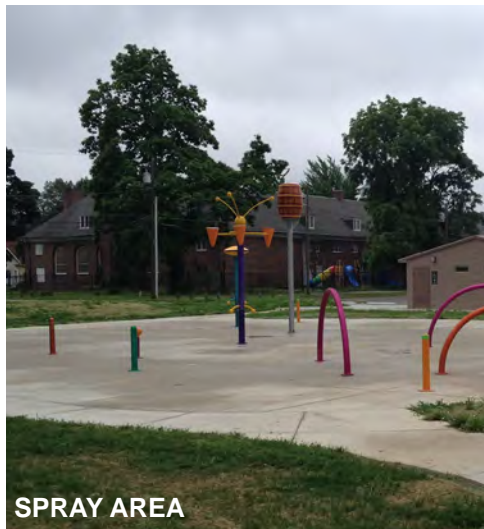
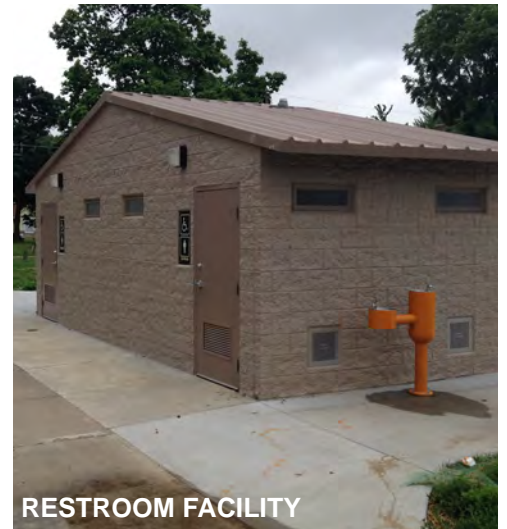
Programmed Park Amenities

Description	Scale of Conditions	QTY	Notes
Playground	4	1	One large playground - 2 play structures, 2 swing sets, music attraction and climbing element.
Basketball Court	3	2	Surface is still in good condition with minimal cracking. A lot of litter present in the area.
Tennis Court	0	-	N/A
Volleyball Court	0	-	N/A
Softball Field	1	1	Infield is completely covered with weeds and lawn. Backstop and fencing are starting to fail.
Soccer Field	0	-	N/A
Football Field	0	-	N/A
Baseball Field	0	-	N/A
Canine Zone	0	-	N/A
Spray Area	4	1	Spray Area was recently installed. A lot of litter present in the area.
Pool-Outside	0	-	N/A
Water Slide	0	-	N/A
Sledding Hill	0	-	N/A
Horseshoes	0	-	N/A
Disc Golf Holes	0	-	N/A

Facilities Recommendations (Based on Park Assessments & Survey Results)
The park needs multi-use path improvements to create better internal circulation and connections to the surrounding neighborhood. The unused ball fields could be redeveloped as a soccer facility to meet community needs. The addition of walking trails in the park would create additional outdoor recreation.

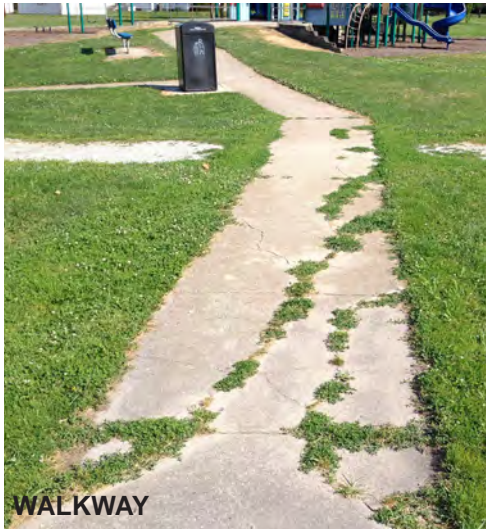
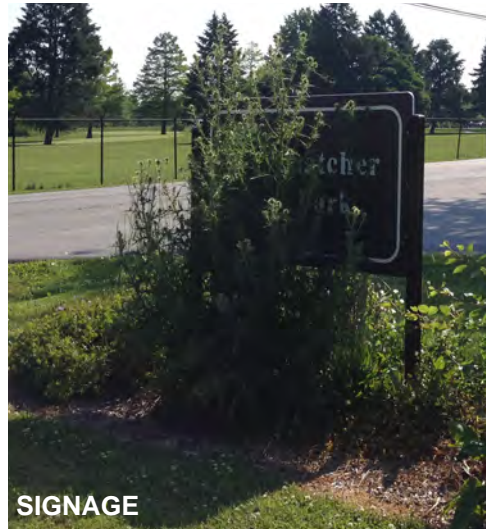
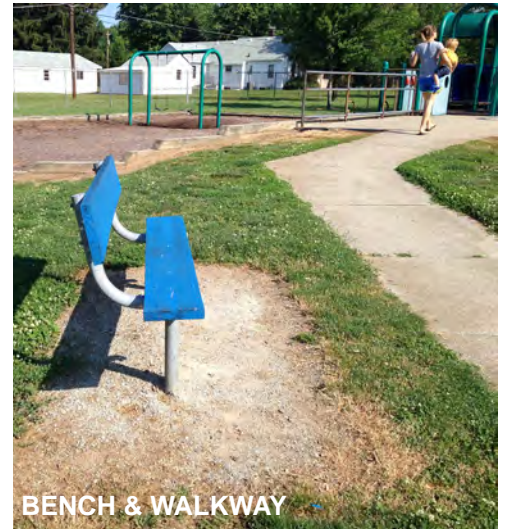
Description	Scale of Conditions	Notes
Roads	3	No curbs, asphalt has minimal cracking.
Walks	2	Heavy cracking in concrete with a lot of weeds growth
Trails	1	Crushed stone walking trails need new base.
Parking	2	Some cracking present and pavement markings have faded.
Benches	3	Mix of wood and plastic topped benches. Both appear to be in good shape.
Trash Receptacles	3	Mix of plastic / metal barrels and solar trash compactors
Site Lighting	2	Lighting appears operational. Only located a parking lots and baseball fields.
Bike Racks	0	N/A
Park Signage	2	Standard Indy Parks sign but completely blocked by vegetation.
Bridges	3	Wooden bridge over drainage ditch at walking trail.

Park Infrastructure General Notes: Most of park infrastructure is in fair to good shape but park trails and walks are in poor condition.

Facilities Recommendations (Based on Park Assessments & Survey Results)
Improving and adding to the existing trails within the park with improve park circulation and connectivity. The park lacks connection to the surrounding neighborhood.

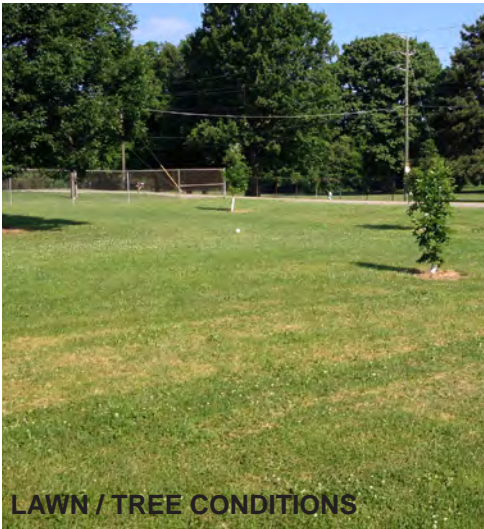
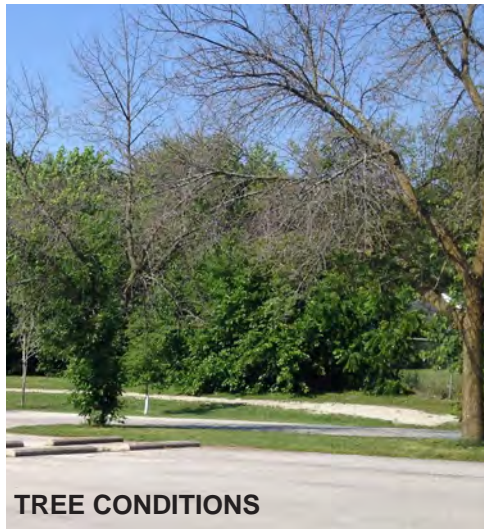
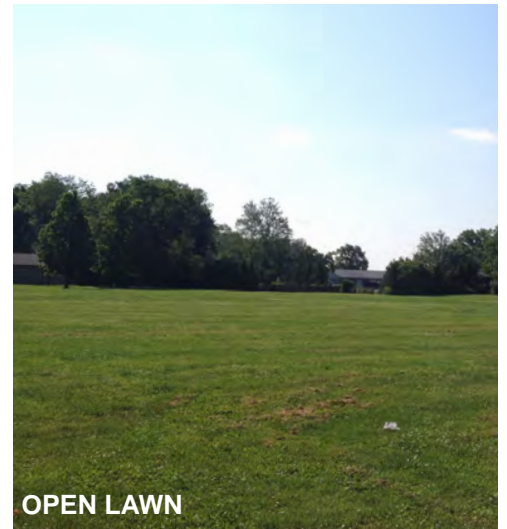
Park Open Space - Assessment		
Description	Scale of Conditions	Notes
Mowing	3	Park was recently mowed and trimmed. Has some clover issues and grass clipping clumps.
General Tree Conditions	2	A number of dead trees need to be removed. Additional tree planting may be needed.
Planting Areas	0	N/A
Water Feature	0	N/A
Park Open Space General Notes: Park is primarily open space with a handful of large shade trees.

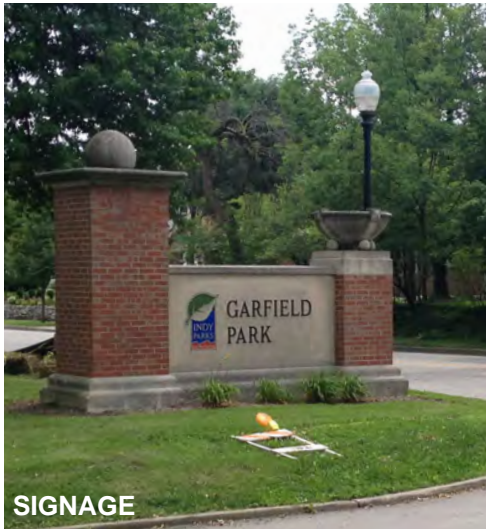
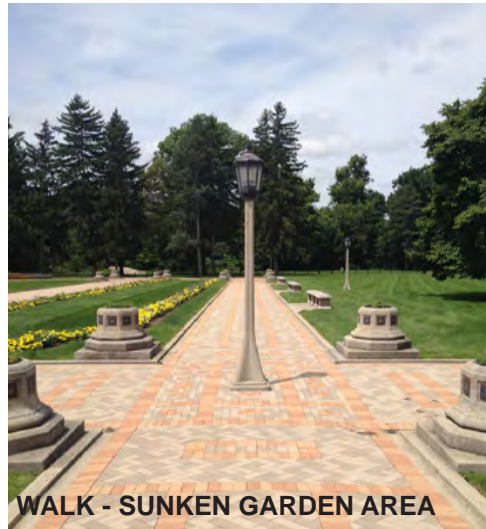
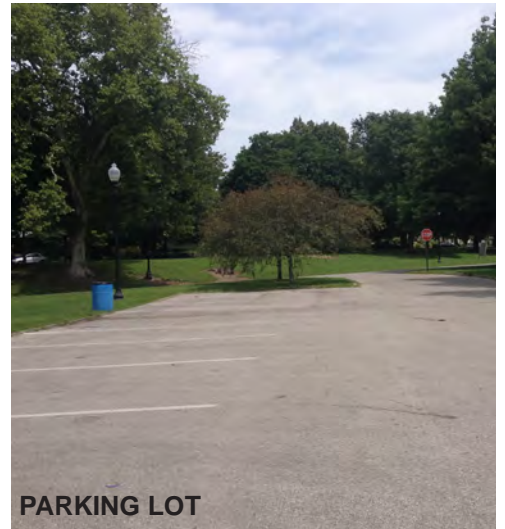
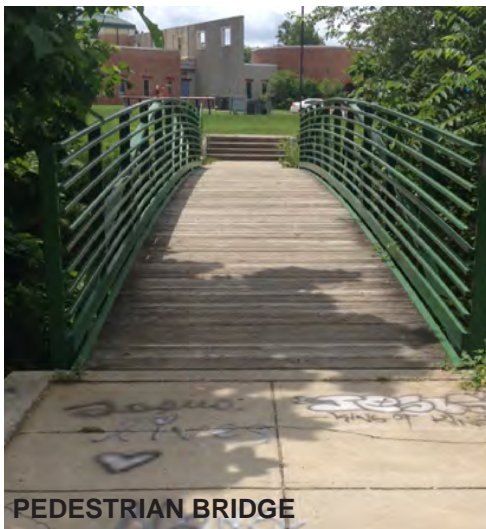
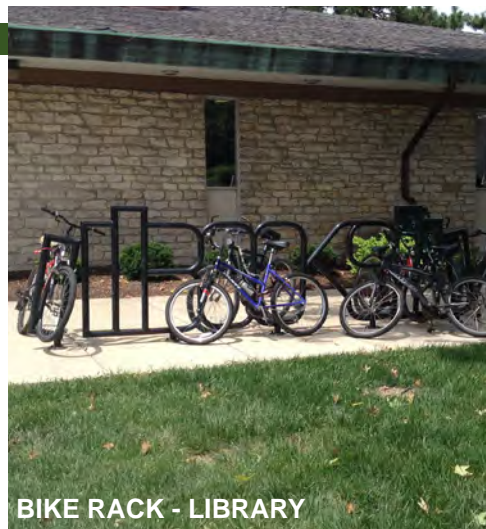
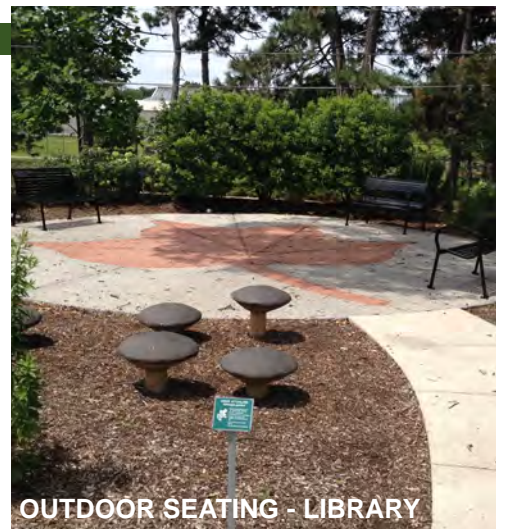
Park Infrastructure

Description	Scale of Conditions	Notes
Roads	4	Minimal asphalt cracking, several roads have curbs. Clear pavement markings.
Walks	2	Walks in sunken garden are excellent. Some walks are holding water and eroding at edges.
Trails	3	Small amount. Most are paved and in excellent condition. Some are gravel and have weeds.
Parking	4	Pavement marking and lighting. Some paint markings are fading, but otherwise in great condition.
Benches	3	Several different types of benches throughout the park. Some older styles are rusting and rotting.
Trash Receptacles	3	Some black, ornate, metal trash receptacles, others are blue plastic or metal drums.
Site Lighting	4	Acorn style - seems to be maintained and in working order. Different style in some parking lots.
Bike Racks	3	Newer library bike rack, full of bicycles. Older one located near middle of park, not bolted down and empty.
Park Signage	4	Brick and concrete signs with Indy Parks logo. Good condition, but some have words covered by plants.

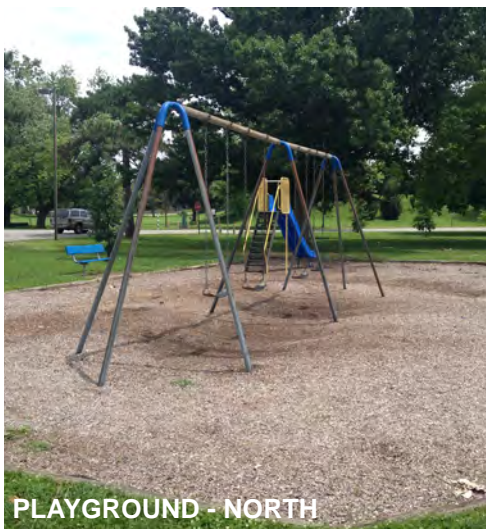
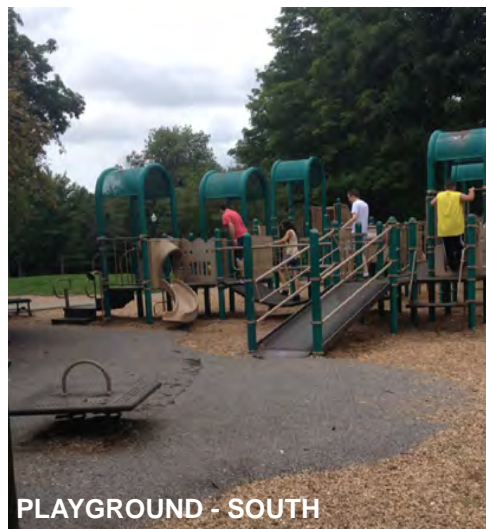
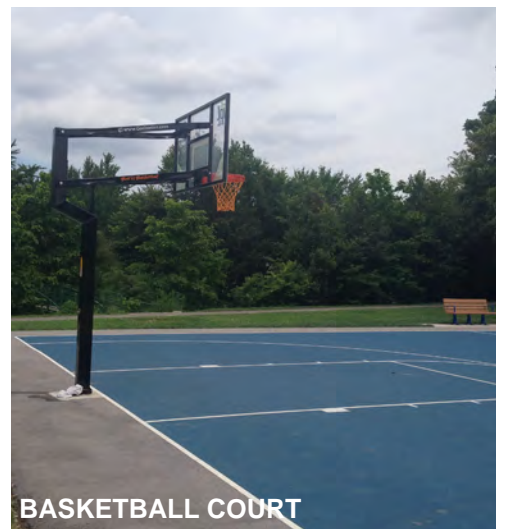
Programmed Park Amenities

Description	Scale of Conditions	QTY	Notes
Playground	3	2	One playground consisted of just swings. Other was newer and in use. Weeds and flooding.
Basketball Court	4	1	Brand new.
Tennis Court	4	8	Brand new. In use during site visit.
Volleyball Court	4	1	Sand is edged with timbers, net is secure, no weeds.
Softball Field	2	2	Fence and some infield, no bases or pitching mound.
Soccer Field	0	-	N/A
Football Field	0	-	N/A
Baseball Field	0	-	N/A
Canine Zone	0	-	N/A
Spray Area	4	1	In pool area, shallow pool with spray jets. Separated from larger pool. In use during visit.
Pool-Outside	4	1	Swim lanes, water slides, concrete or lawn seating with umbrellas. In use during site visit.
Water Slide	4	2	Medium height. In use during site visit.
Sledding Hill	3	1	Close to parking. No path leading to hill or seating nearby.
Horseshoes	4	4	Backboard is intact, concrete surrounding sand pit, some weeds.
Disc Golf Holes	0	-	N/A

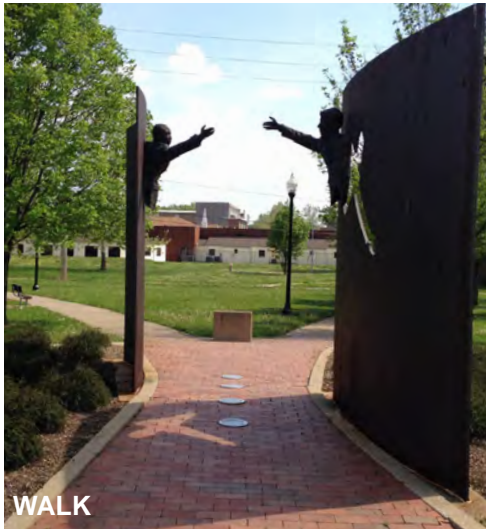
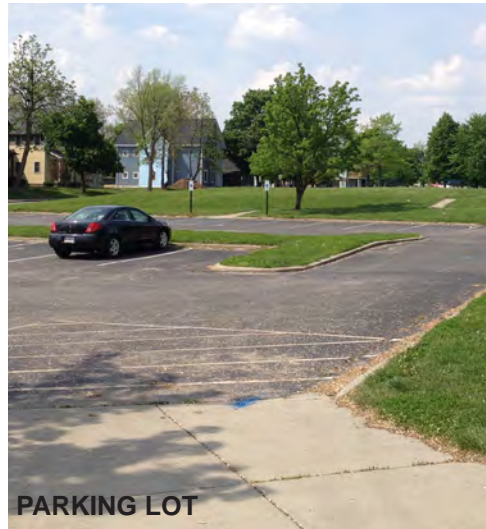
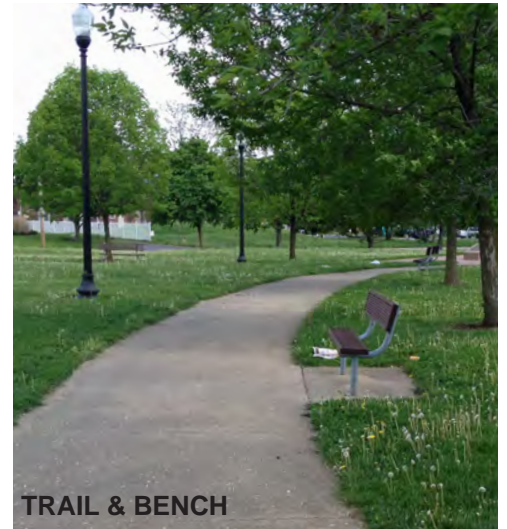
Park Infrastructure

Description	Scale of Conditions	Notes
Roads	0	No roads pass through the park.
Walks	2	Newer walks leading to Peace Memorial are great, others are cracking, sinking and have weeds in joints.
Trails	0	N/A
Parking	3	Asphalt is in good condition, striping is visible. Weeds in joints.
Benches	1.5	Mix of different table types and colors - some are red/beige, brown, or blue. Older, peeling paint.
Trash Receptacles	2	Large metal drums. Some are new and painted blue, some are old and completely rusted.
Site Lighting	3	A mix of acorn lights and cobra lights. Seem to be in working condition.
Bike Racks	0	N/A
Park Signage	2	New sign, does not have Indy Parks logo.
Bridges	0	N/A

Facilities Recommendations (Based on Park Assessments & Survey Results)
Park circulation and connectivity can be improved with the addition of new trails and walkways. This would also create better connections to the surrounding neighborhood and school. Native planting areas could be incorporated to reduce mowing and to create an educational opportunity for the adjacent school.

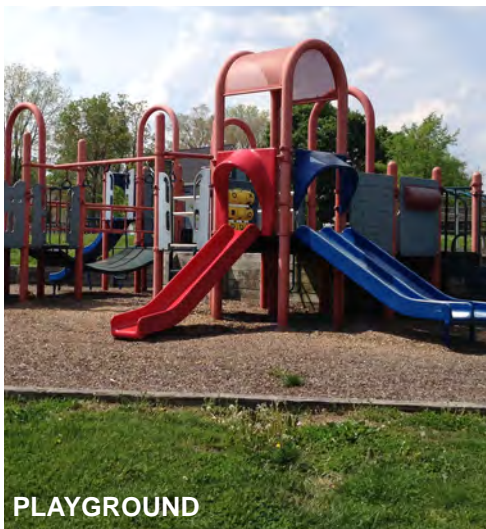
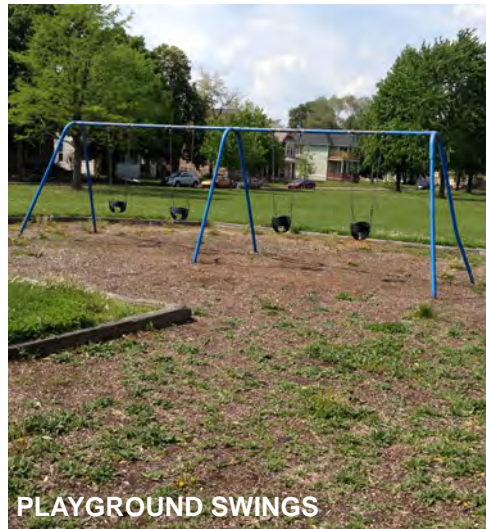
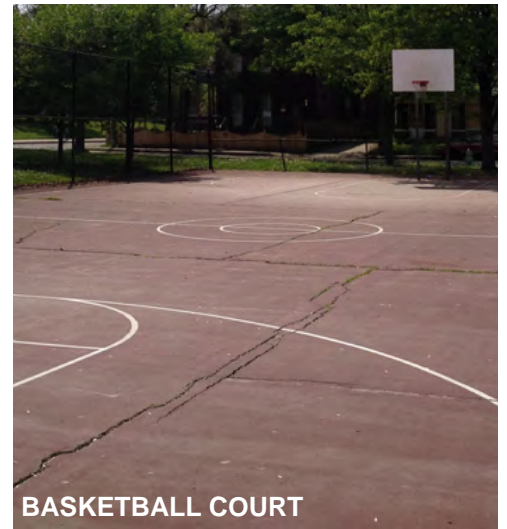
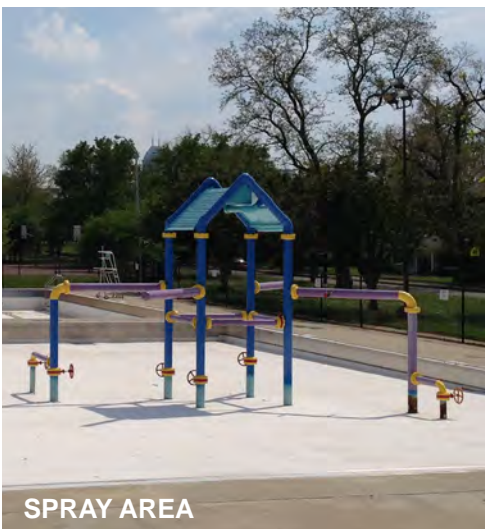
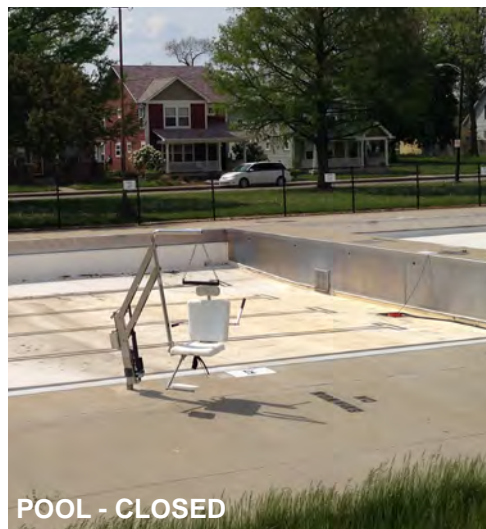
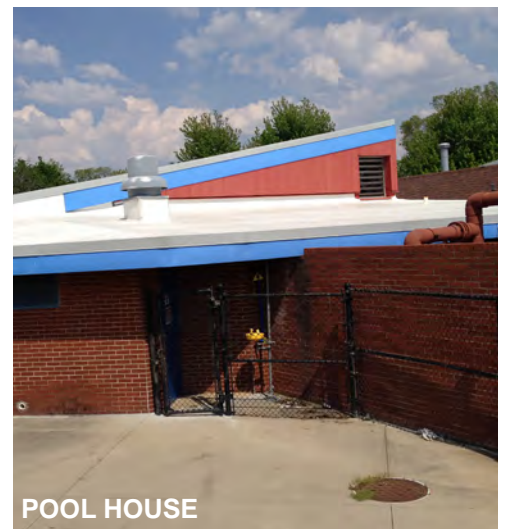
Programmed Park Amenities

Description	Scale of Conditions	QTY	Notes
Playground	1	2	Older play set and a swing set - some graffiti, weeds throughout mulch, needs more mulch.
Basketball Court	2	2	Older with cracking surface. Graffiti on a backboard.
Tennis Court	0	-	N/A
Volleyball Court	0	-	N/A
Softball Field	0	-	N/A
Soccer Field	0	-	N/A
Football Field	0	-	N/A
Baseball Field	0	-	N/A
Canine Zone	0	-	N/A
Spray Area	2.5	1	One fixture inside pool area, looks newer. Pool is not open, so no water at time of visit.
Pool-Outside	2	1	Older pool, small and no shaded seating.
Water Slide	0	-	N/A
Sledding Hill	0	-	N/A
Horseshoes	0	-	N/A
Disc Golf Holes	0	-	N/A
Nature Center	0	-	N/A

Family Center	2	1	Older facility, combined with pool house. Entrance is not clear - No signage.
Restroom Facility	2	1	Located at pool house, doors locked.
Picnic Shelter	2	2	Some rotting wood, no walks or parking for shelters.
Picnic Clusters	1	2	Older, fixed tables next to grill. No shade.
Memorial	3	1	Peace Memorial - Newer, weeds in walk pavers, rust from sculpture on concrete.
Programed Park Amenities General Notes: Several park amenities are older and worn. More than half of the park is dedicated to open lawn. There have been a few new additions to the park surrounding the Peace Memorial.

Park Strategic Recommendations
The deteriorating amenities and large size of the park can accommodate a large indoor/outdoor pool and fitness facility. There is also a need for a new, safe playground. The historic significance of this park can lead to the establishment of this park as a NPS Historic Site; this would generate awareness and interest. Creating a connection to the Monon Trail by adding directional signage would draw trail users to the park.

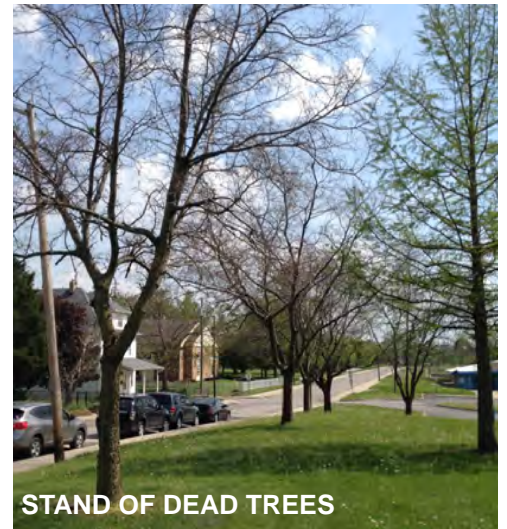
Park Open Space - Assessment		
Description	Scale of Conditions	Notes
Mowing	1	Grass is tall, has not been mowed for some time. Clover in lawn is tall.
General Tree Conditions	2	Several large, dead trees and limbs.
Planting Areas	3	Only planting areas are located at the Peace Memorial.
Water Feature	0	N/A
Park Open Space General Notes: Lacking some general maintenance - mowing and dead tree/limb removal. There is graffiti on the playground. A small anti-violence memorial has "destroyed" guns embedded in concrete, it is apparent that the concrete has been chipped away as an attempt to remove the guns.

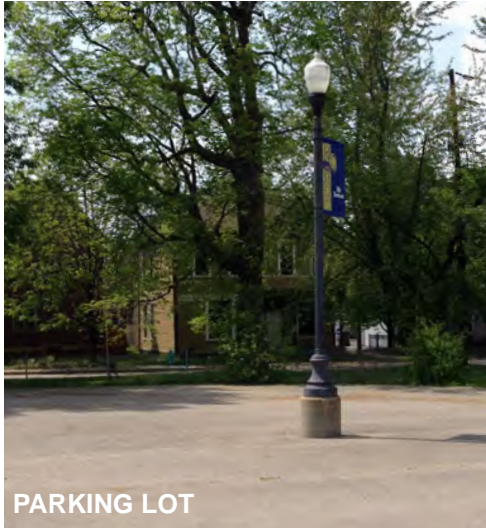
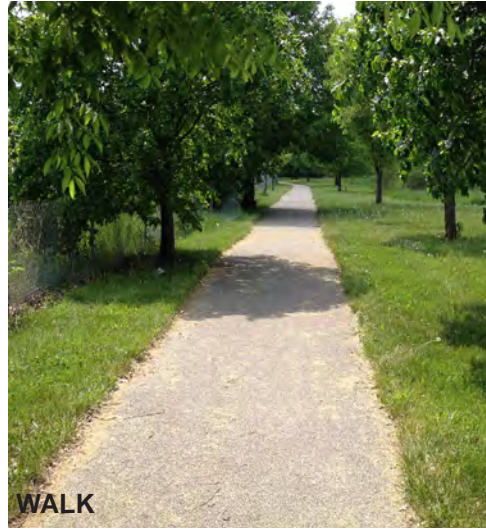
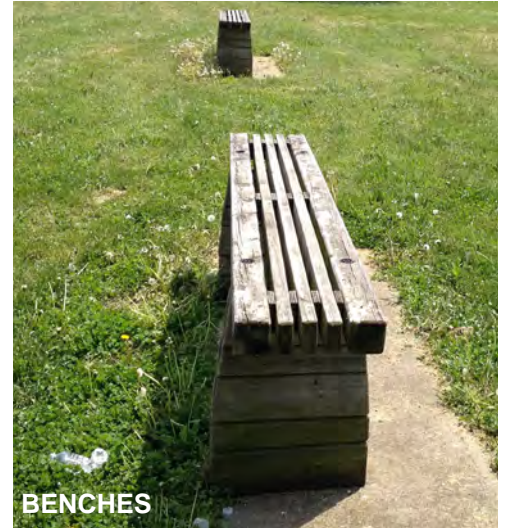
Park Infrastructure

Description	Scale of Conditions	Notes
Roads	0	N/A
Walks	0	N/A
Trails	3	Asphalt trails, minor cracking present.
Parking	3	Asphalt lot, pavement in good condition. Parking lines not visible
Benches	3	Mix of wood and metal base with wood plank tops. Wood planks need fresh coat of paint / sealant.
Trash Receptacles	4	Metal receptacle on concrete base. Minimal fading present.
Site Lighting	3	Acorn style fixtures on concrete base. Appears to be in working condition. Limited to parking lot.
Bike Racks	3	1 rack on site with limited concrete paving at base.
Park Signage	3	Standard Indy Park sign - in good condition. Limited visibility do to overgrown vegetation.
Bridges	0	N/A

Facilities Recommendations (Based on Park Assessments & Survey Results)
Walkways and trails need to be added to strengthen the neighborhood connectivity to the park. The proximity of the Monon Trail creates an opportunity to draw trail users into the park. This could be facilitated by the addition of park signage at the trailhead.

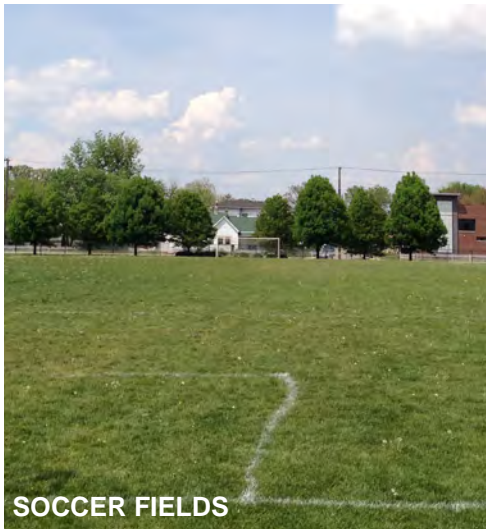
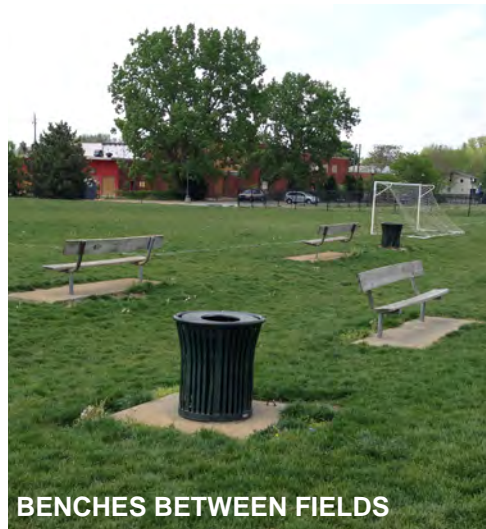
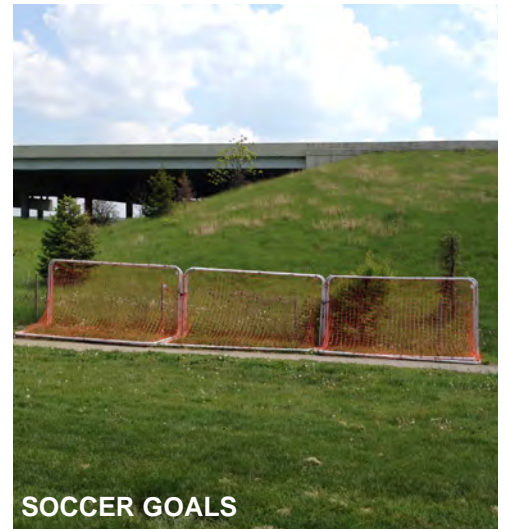
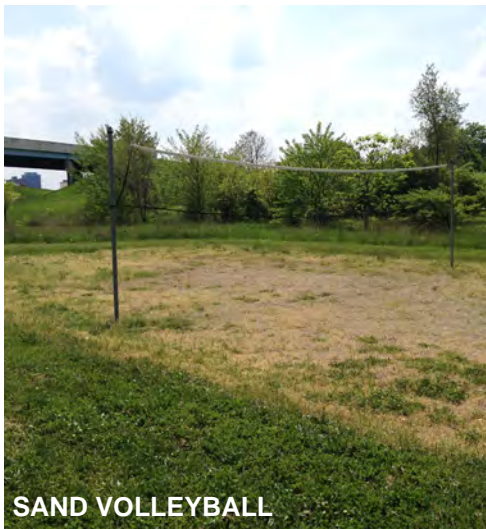
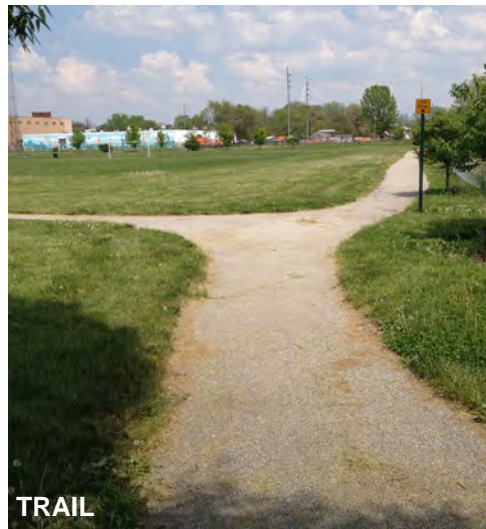
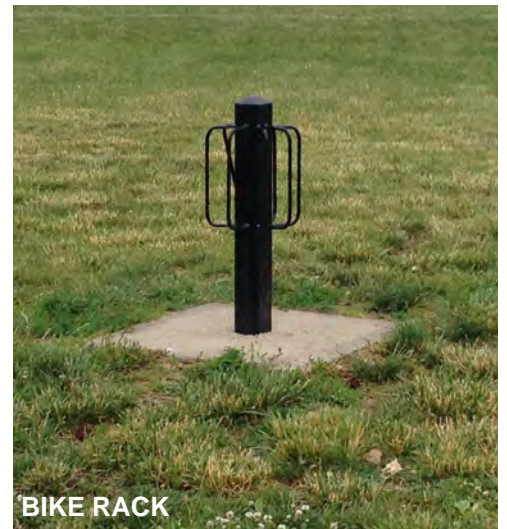
Programmed Park Amenities

Description	Scale of Conditions	QTY	Notes
Playground	0	-	N/A
Basketball Court	0	-	N/A
Tennis Court	0	-	N/A
Volleyball Court	2	1	Sand court is covered with weeds. Net and posts in good condition. Plans for update in 2016.
Softball Field	0	-	N/A
Soccer Field	4	3	Fields are well maintained and in great shape. Fields can be configured for 9 youth fields.
Football Field	0	-	N/A
Baseball Field	0	-	N/A
Canine Zone	0	-	N/A
Spray Area	0	-	N/A
Pool-Outside	0	-	N/A
Water Slide	0	-	N/A
Sledding Hill	0	-	N/A
Horseshoes	0	-	N/A
Disc Golf Holes	0	-	N/A
Nature Center	0	-	N/A

Park Strategic Recommendations
Additional amenities should be added to transform this park into a sports complex, rather than just soccer fields. Adding additional sports fields or creating multi-use fields will attract a more diverse range of park users. The addition of picnic shelters would create shaded seating areas and a gather point for teams before and after games.

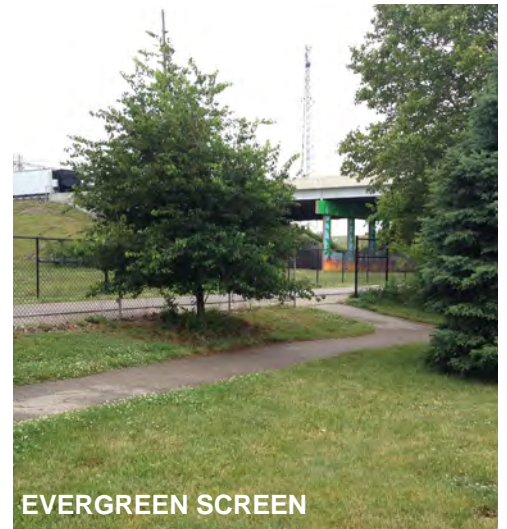
Park Open Space - Assessment		
Description	Scale of Conditions	Notes
Mowing	3	Fields were recently mowed and well kept.
General Tree Conditions	3	Minimal trees located on site.
Planting Areas	0	N/A
Water Feature	0	N/A
Park Open Space General Notes: Park's open space is well maintained.

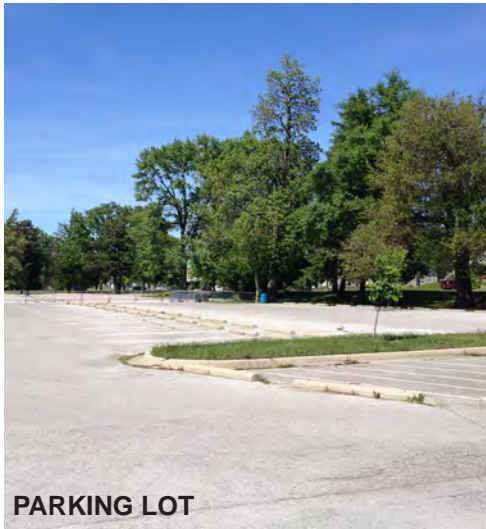
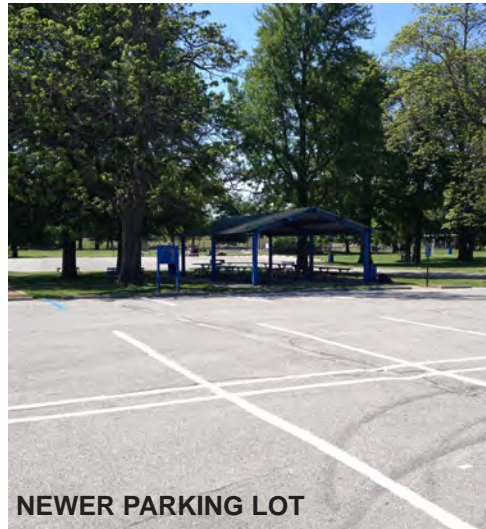
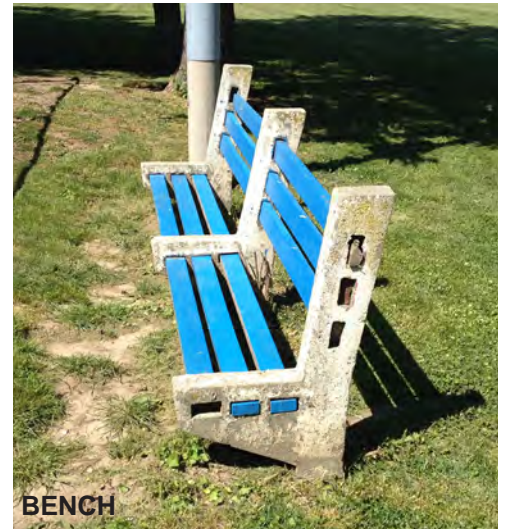
Park Infrastructure

Description	Scale of Conditions	Notes
Roads	3	No curbs, asphalt has minimal cracking.
Walks	3	Concrete walks appear to be in good condition.
Trails	0	
Parking	3	Some cracking present and pavement markings are slightly faded in 2 lots.
Benches	2	Wood topped benches. Some appear to be breaking and in need of replacement.
Trash Receptacles	3	Mix of plastic / metal barrels.
Site Lighting	3	Lighting appears operational. Located throughout the park. Most sports fields are have lighting.
Bike Racks	0	N/A
Park Signage	2	Standard Indy Parks signage.

Facilities Recommendations (Based on Park Assessments & Survey Results)
Trails should be added to improve park circulation and to connect the park to the adjacent White River Trail. Closing part of the White River Parkway Drive should be considered to allow seamless park connection to the White River. Boardwalks, fishing piers, and/or overlooks can be added along the river to connect the community to the natural feature.

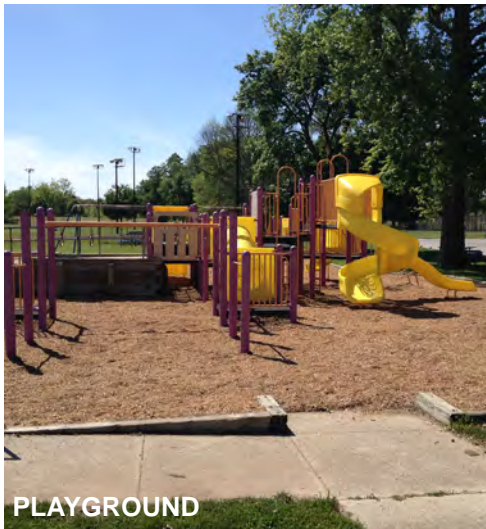
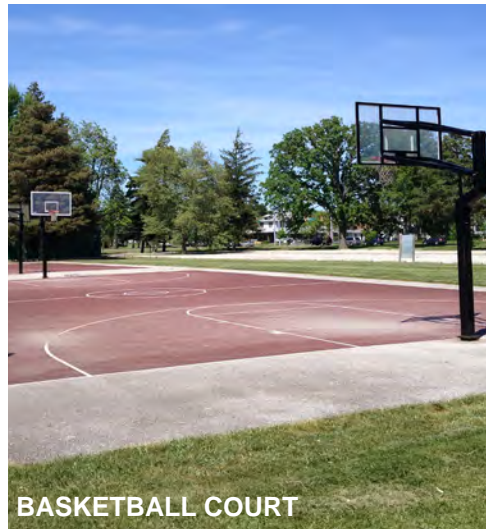
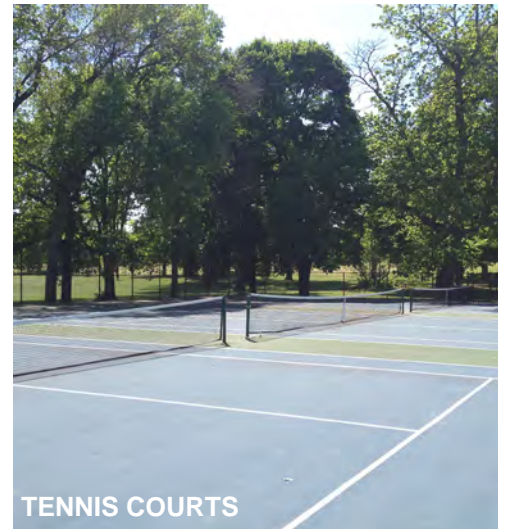
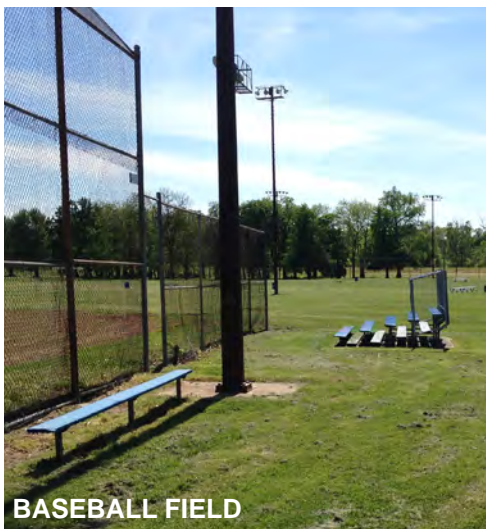
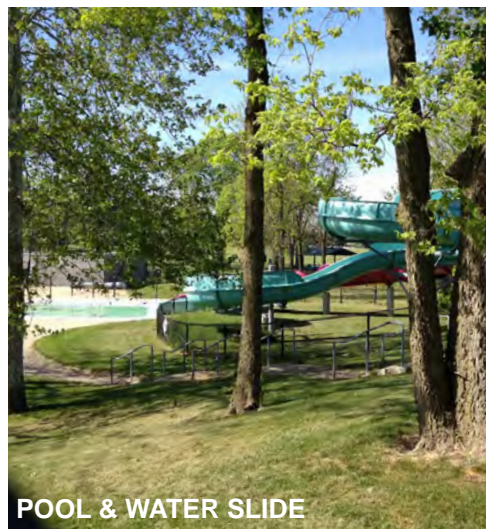
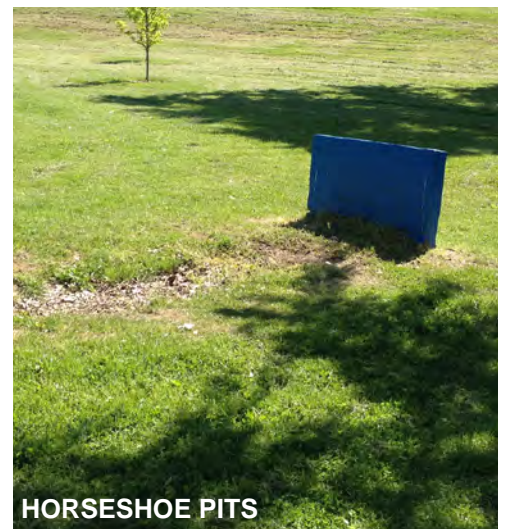
Programmed Park Amenities

Description	Scale of Conditions	QTY	Notes
Playground	3	2	Older equipment but well maintained. Includes play structure and multiple swings. Fresh mulch
Basketball Court	3	2	Minimal pavement cracking and updated basketball hoops.
Tennis Court	4	12	Courts were recently updated and in great shape. Courts are lit and used by local schools.
Volleyball Court	0	-	N/A
Softball Field	2	7	Many of the infields need a lot of work. Some completely cover with weeds. Many fields are lit.
Soccer Field	0	-	N/A
Football Field	2	3	All fields share space with baseball and goal post are falling. 2 of fields are lit.
Baseball Field	2	2	Fields are lit but infields need work.
Canine Zone	0	-	N/A
Spray Area	3	1	Appears to be well maintained and in working order.
Pool-Outside	3	1	Shaded seating options - shade trees. Appears to be well maintained.
Water Slide	4	1	Large size. Appears to be well maintained.
Sledding Hill	0	-	N/A
Horseshoes	1	2	Appears to be unusable and should be replaced.

Park Strategic Recommendations
The historic Taggart Memorial can be restored and expanded to create a signature community gathering space or rental facility. A community garden could be added to address the food dessert south of the park. The fields and shelters should be reorganized to maximize the useable park space. A stronger connections should be made to the box hill course to the west. The a toboggan run could be added to the box hill course to create a revenue-generating winter activity.

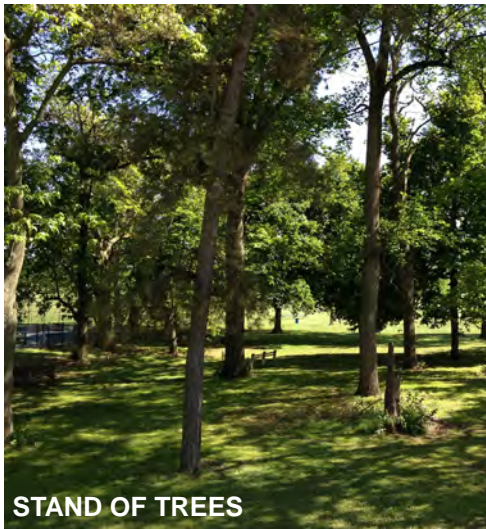
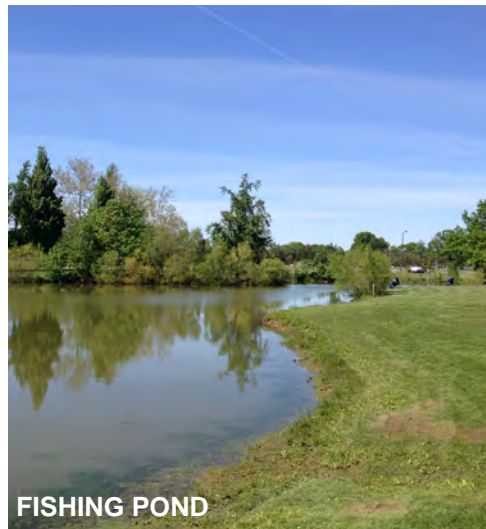
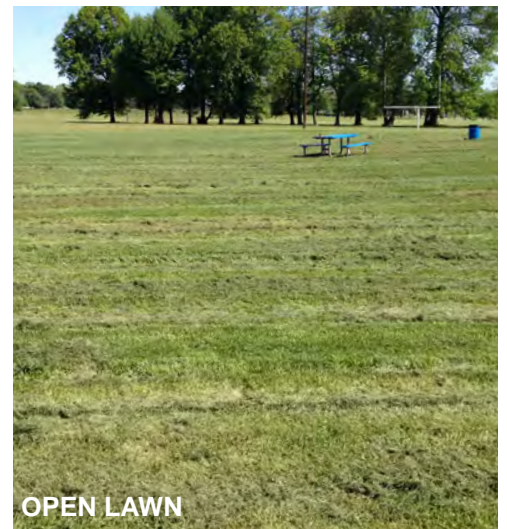
Park Open Space - Assessment		
Description	Scale of Conditions	Notes
Mowing	3	Park was recently mowed and trimmed.
General Tree Conditions	2	A lot of dead trees need to be removed.
Planting Areas	2	Located at front of Family Center and South Playground.
Water Feature	2	Some algae present in fishing pond.
Park Open Space General Notes: Park has a good mix of open space, water feature and programmed spaces.

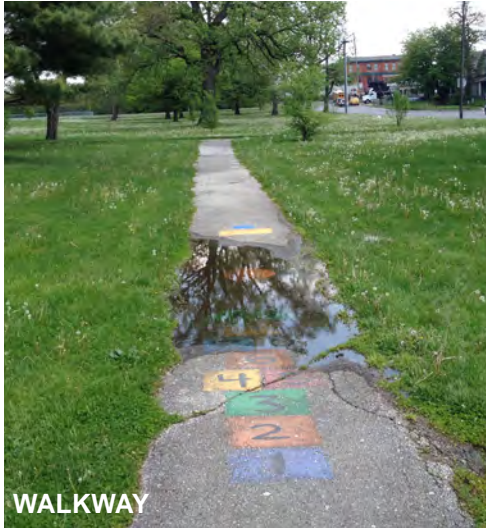
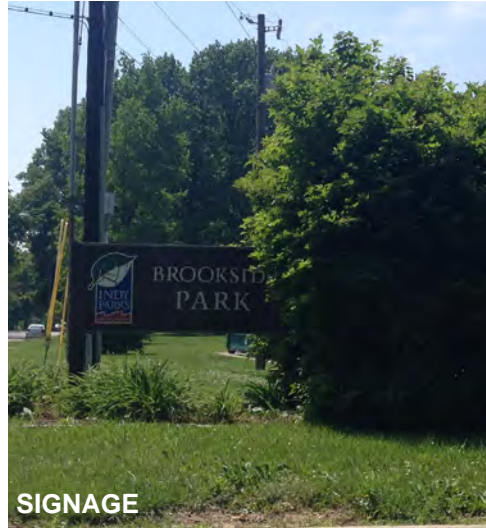
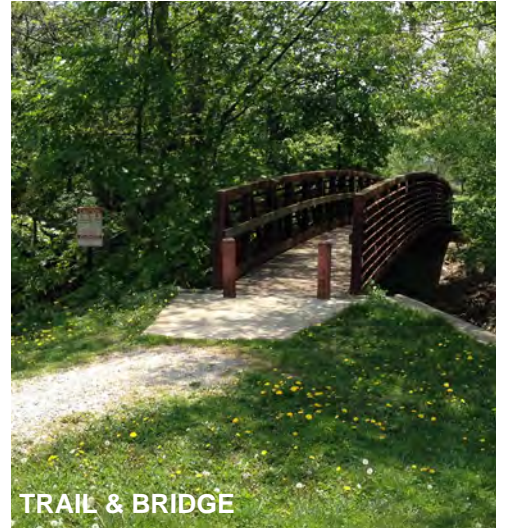
Description	Scale of Conditions	Notes
Roads	2	Pavement has potholes, missing/sinking curbs, deteriorating edges, and is cracking.
Walks	2	Sidewalks leading to main entrances of buildings/pool are in good shape, others leading to roads and behind buildings are cracking and falling apart. Roads within park do not have sidewalks.
Trails	2	Trails are paved, but holding water in areas. A few trail entrances are blocked with concrete traffic barriers.
Parking	2.5	Paved lots are in good condition. Primary baseball lot is gravel with undefined edges; needs more gravel.
Benches	2	Benches are wood 2x8's on steel posts. Some are sturdy and freshly painted, others are rotting through.
Trash Receptacles	2	Simple, blue plastic containers. Most are located near picnic shelters, none near baseball fields.
Site Lighting	3	Cobra heads mounted to ornate, possibly original posts that are significantly rusted. Appear to work.

Bike Racks	0	N/A
Park Signage	3	One park identification sign, standard wooden Indy Parks sign. Could use more.
Bridges	2	Wood on the decking needs repaired - large pieces have broken off creating large gaps.

Park Infrastructure General Notes: Park was established in 1898. There is a mix of historic elements with updated amenities. Historic elements include the family center and the gateway at the north entrance of the park. Some of the park infrastructure is in need of repair or a regular maintenance program. Items needing attention are playgrounds, deteriorating trails and walkways that are holding water.

Park Opportunities
Park infrastructure needs maintenance, including several roads and walks are deteriorating. Vegetation also needs maintenance - several large dead trees and limbs, along with dense vegetation surrounding the Pogue's Run, hindering connection to the waterway. Clearing brush along the stream will open views. The park would also benefit from new playground equipment.

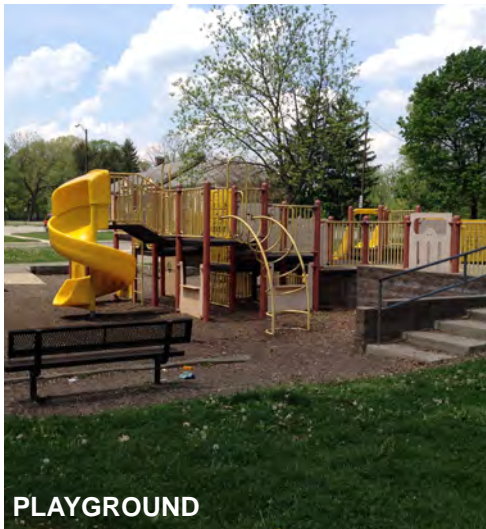
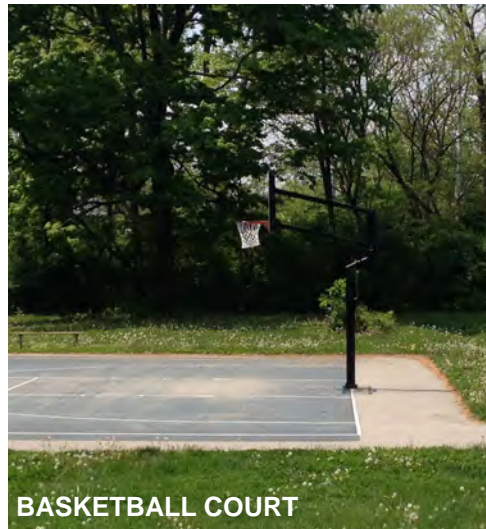
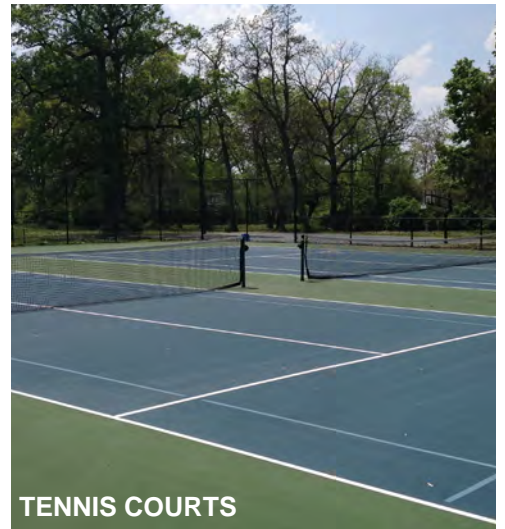
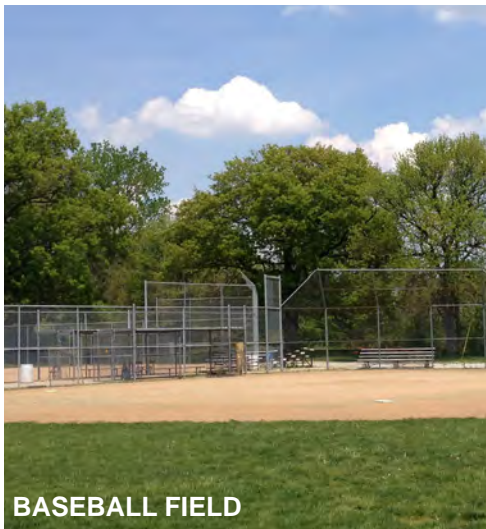
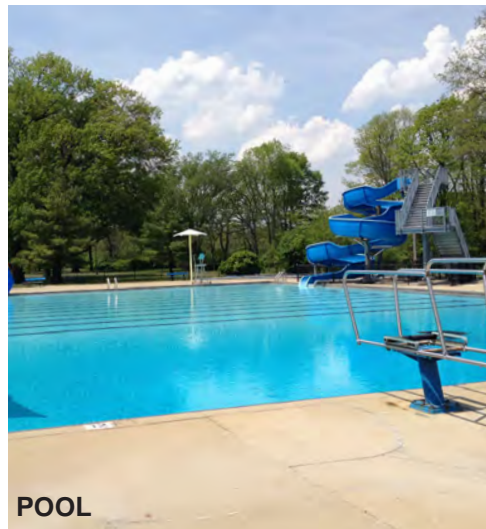
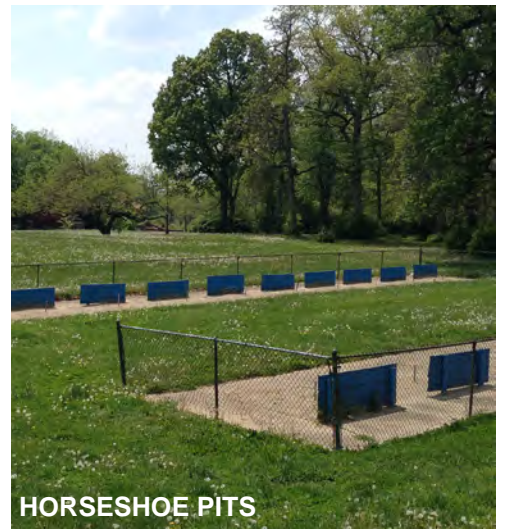
Programmed Park Amenities

Description	Scale of Conditions	QTY	Notes
Playground	2	2	Equipment in good, working condition. Weeds in mulch and standing water in some areas.
Basketball Court	2.5	3	One court is old, without court markings. One new court and a new half court in good condition
Tennis Court	4	4	Look brand new. There aren't sidewalks leading to the courts.
Volleyball Court	1	1	There are old net poles, but no net or court markings.
Softball Field	0	-	N/A
Soccer Field	0	-	N/A
Football Field	0	-	N/A
Baseball Field	2 Fields at 4, 1 at 2	3	Two are very well kept. One needs mowing, weeding, overgrowth cut, and the infield drug.
Canine Zone	0	-	N/A
Spray Area	0	-	N/A
Pool-Outside	3	1	Pool is in good condition. Has a splash zone, rock wall and slide, but not a lot of shade.
Water Slide	4	1	Good working condition.
Sledding Hill	2	1	Nice slope for sledding, but no amenities nearby - benches, shelter.
Horseshoes	1	10	Old and in disrepair.

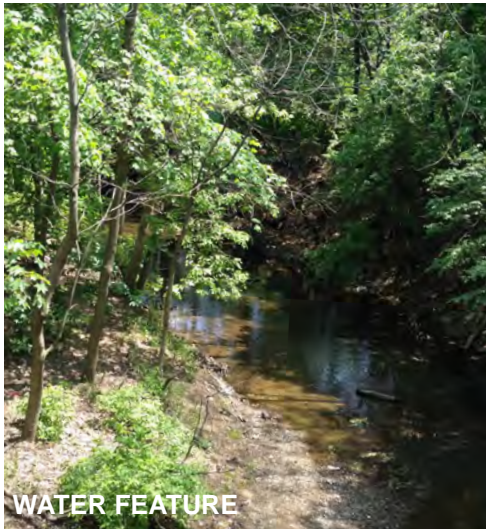
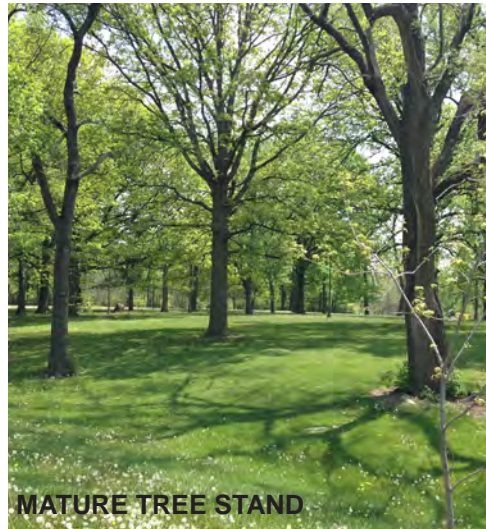
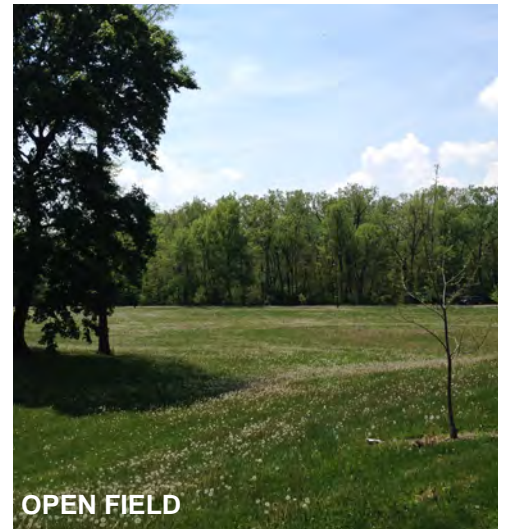
Park Open Space - Assessment		
Description	Scale of Conditions	Notes
Mowing	1	Mowing has not started this season.
General Tree Conditions	2	Old stands of trees. Pruning is needed to remove dead limbs/trees.
Planting Areas	2	Shrubs are overgrown beside pool entrance.
Water Feature	3	Pogue's Run meanders through the middle of the park. Left in natural state with little trash on banks.
Park Open Space General Notes: The park has open areas of lawn surrounding several stands of mature trees, growing centrally in the park and along Pogue's Run. A number of the trees are dead or have dead limbs. There are few planting beds in the park with minimal amounts of shrubs and perennials.

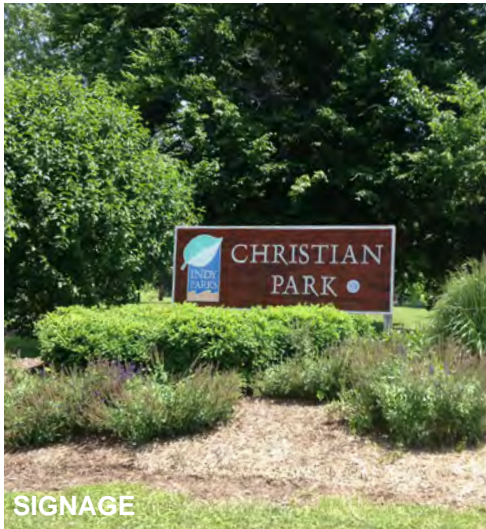
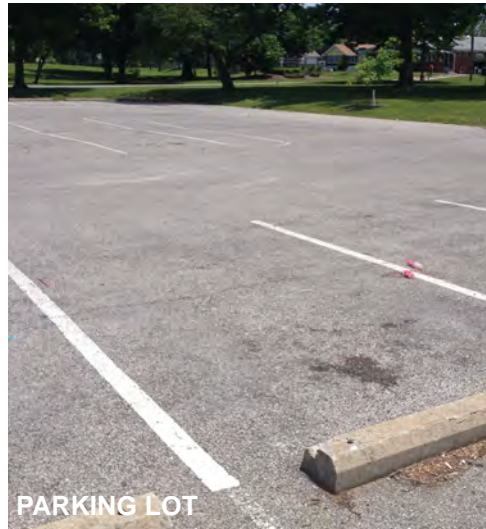
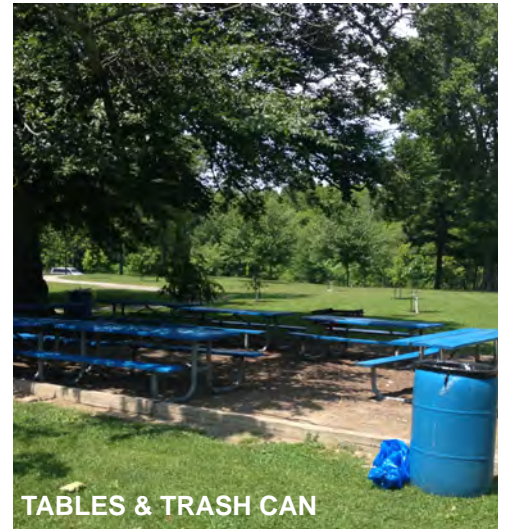
Park Infrastructure

Description	Scale of Conditions	Notes
Roads	2	Park is surrounded by roads, only one passes through the park. These roads have potholes and washout.
Walks	4	Concrete walks are in good condition. Park has a memorial walk.
Trails	4	Asphalt trails, some cracking and evidence of standing water.
Parking	2.5	Parking lots are in good condition, seems that many cars park along street. Two lots along road, one-way but not clear, no striping.
Benches	3	Wood planks on metal frame, paint is peeling.
Trash Receptacles	3	Blue plastic bins. May not be enough - a lot of trash throughout park.
Site Lighting	3	Located only in parking lots and along street. Appear to be working.
Bike Racks	0	N/A
Park Signage	4	Standard Indy Parks sign. Metal archways along memorial walk.
Bridges	2	New concrete road bridge. Footbridge is older, wood planks have been replaced, but there are large gaps.
