City of Indianapolis Park, Recreation and Open Space Plan
Park Inventory & Assessment

PIKE TOWNSHIP ASSESSED PARKS

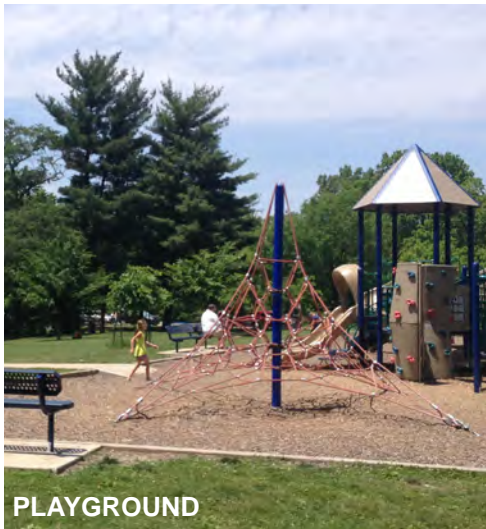
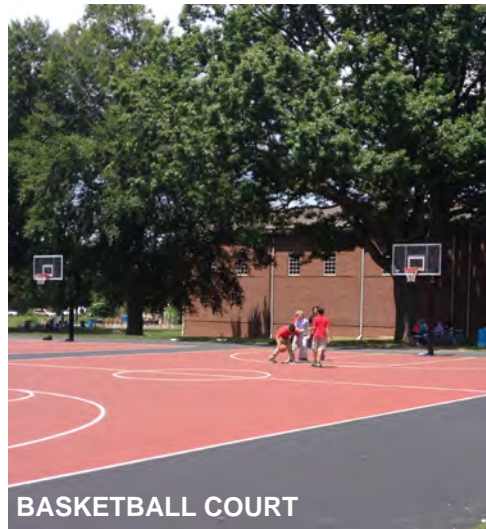
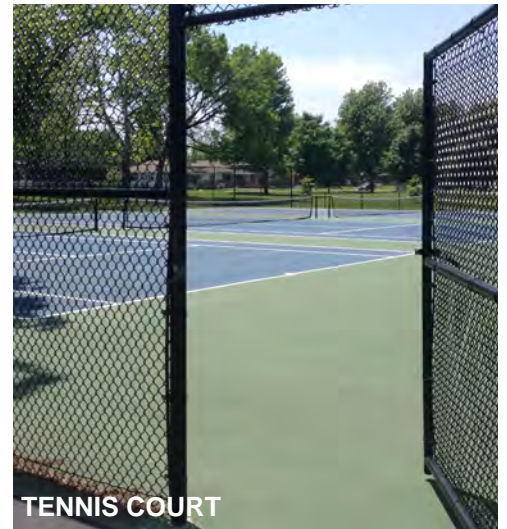
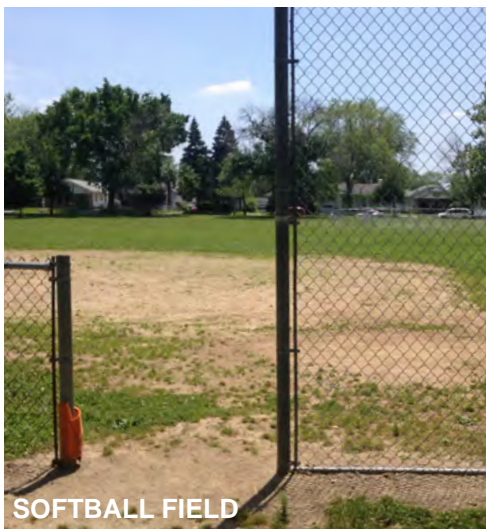
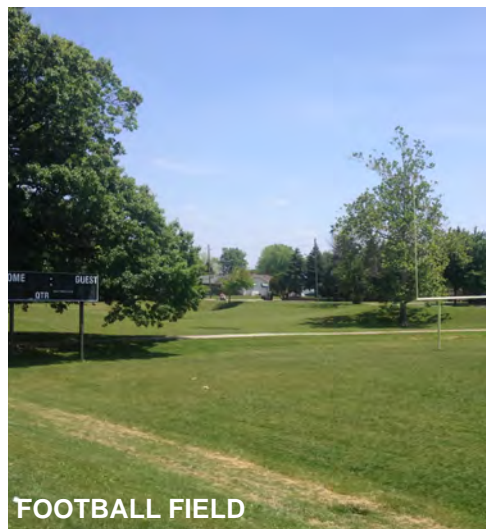
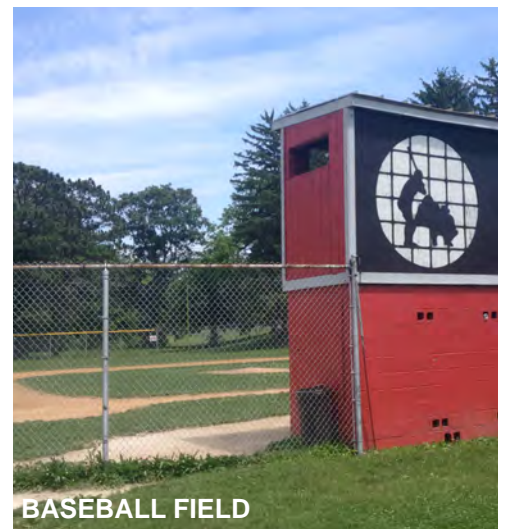
Programmed Park Amenities

Description	Scale of Conditions	QTY	Notes
Playground	4	2	New, large-sized playground next to family center. Far east playground is older, mulch is weed
Basketball Court	4	2	New surface and baskets. One also inside family center. Both in use during site visit.
Tennis Court	4	3	Look new.
Volleyball Court	0	-	N/A
Softball Field	2	3	Infields are full of weeds and need more sand. Two fields are abandoned.
Soccer Field	0	-	N/A
Football Field	2	1	Field is sunken for raised seating on grass. Goals, but no striping. Concession stand.
Baseball Field	3	3	No spectator seats, looks ready for the season.
Canine Zone	0	-	N/A
Spray Area	4	1	New and colorful. Spectators can site under large shade tree. In use during visit.
Pool-Outside	0	-	N/A
Water Slide	0	-	N/A
Sledding Hill	0	-	N/A
Horseshoes	0	-	N/A
Disc Golf Holes	0	-	N/A

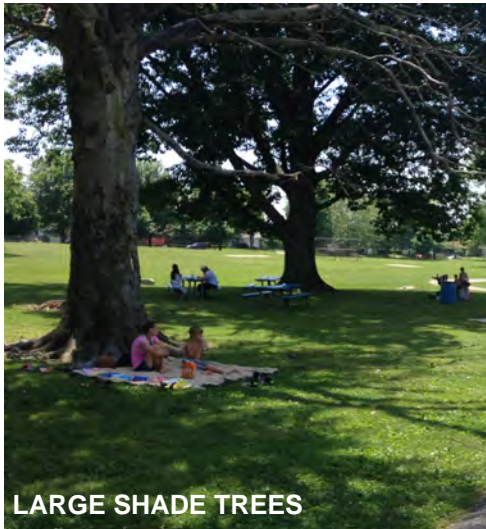
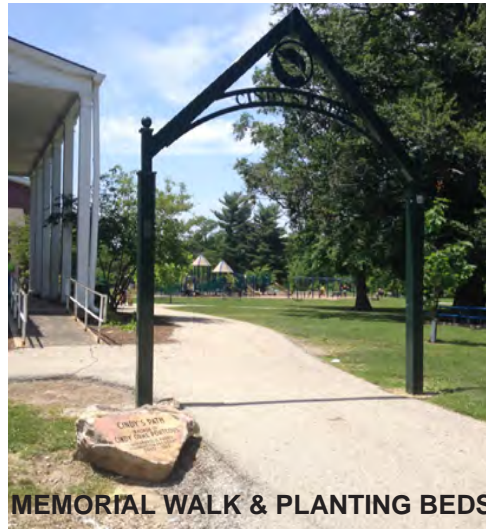
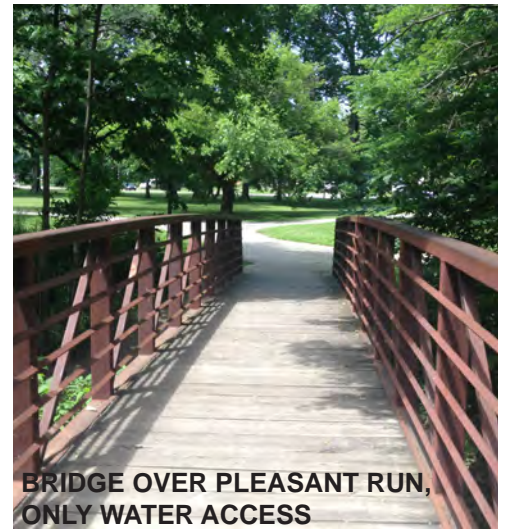
Park Open Space - Assessment		
Description	Scale of Conditions	Notes
Mowing	4	Recently mowed.
General Tree Conditions	3	Big old trees, some newly planted trees. Dead limbs need cut out.
Planting Areas	3	Sparse plantings around family center. Need mulch.
Water Feature	3	Pleasant Run - has trash along banks. Only access was along trail at the bridges.
Park Open Space General Notes: Nice older tree stands. Trash is everywhere in the park.

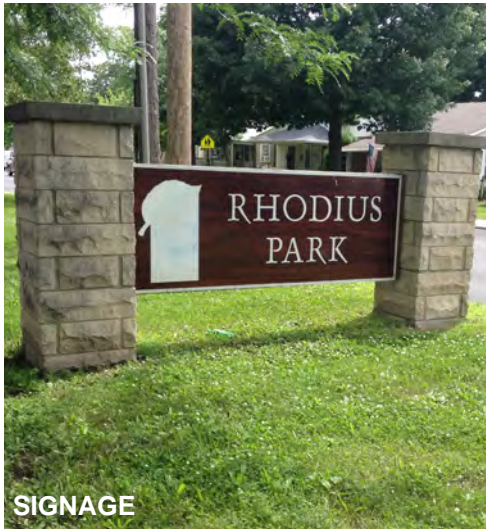
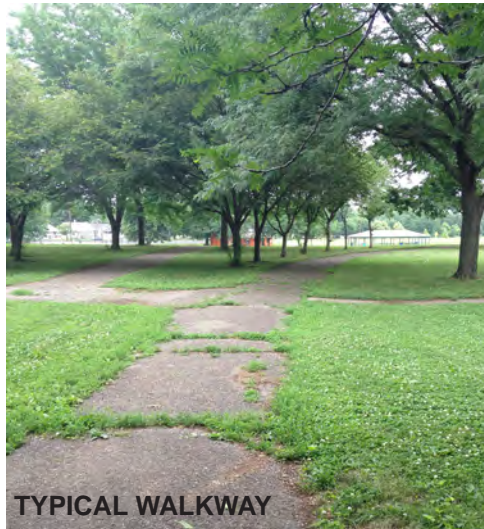
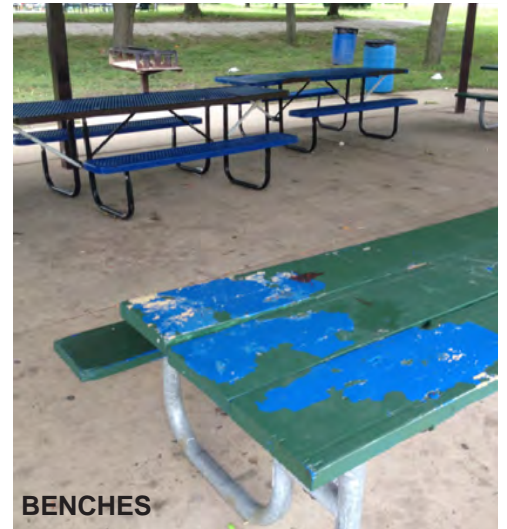
Description	Scale of Conditions	Notes
Roads	2	Single lane road to pool area, leads to a small lot. Park is surrounded by roads - used for parking.
Walks	2	Concrete walks are crumbling, weeds in expansion joints. Some walks are old, thin asphalt, with undefined edges.
Trails	2	Trails consist are made of gravel or thin asphalt. Gravel trails have been recently topped off.
Parking	3	Small lots, some markings - share parking lot at school, parking along streets.
Benches	3+	Good shape. A few different types.
Trash Receptacles	3	Blue plastic drums. Note to "please keep our park clean" on trash receptacles.
Site Lighting	3+	Lights in parking lot and along primary walks.
Bike Racks	0	N/A
Park Signage	3	Signs at north, south, and west borders. Good condition, but Indy Parks logo is fading.
Bridges	0	N/A

Park Infrastructure General Notes: General infrastructure is older and wearing down, i.e. cracking pavement, crumbling sidewalks, and pool house.

Facilities Recommendations (Based on Park Assessments & Survey Results)
This park need overall sidewalk and trail improvements to create safe connections to and throughout the park. Several of the walkways are falling apart. Pool and pool house need to be renovated.

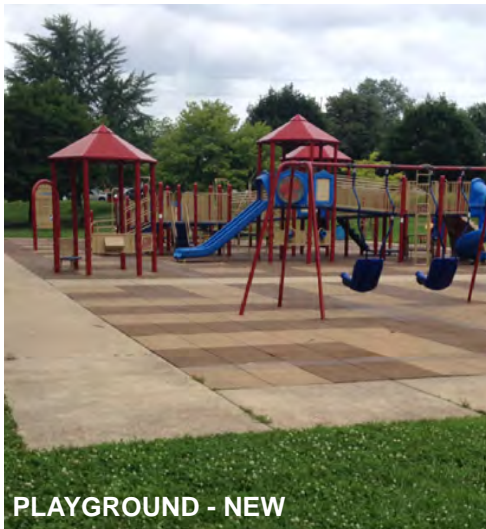
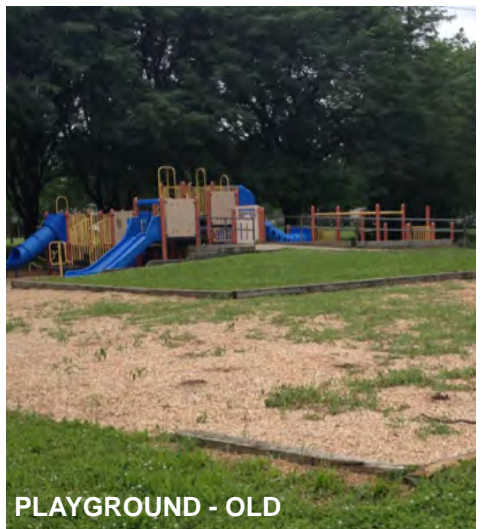
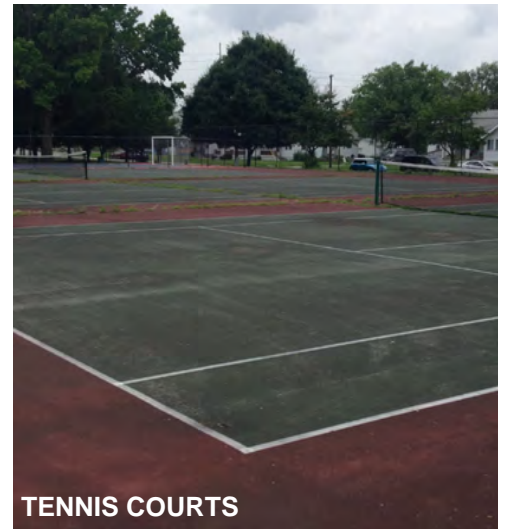
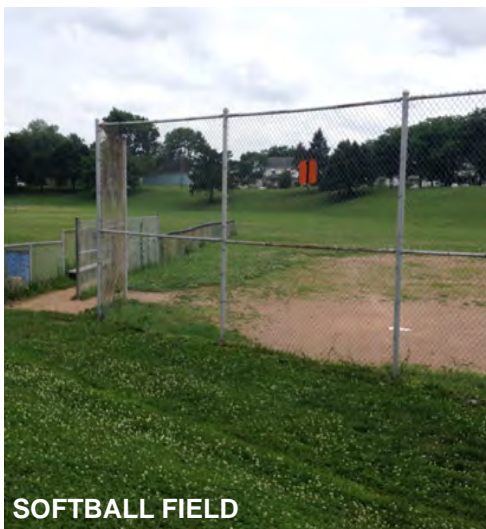
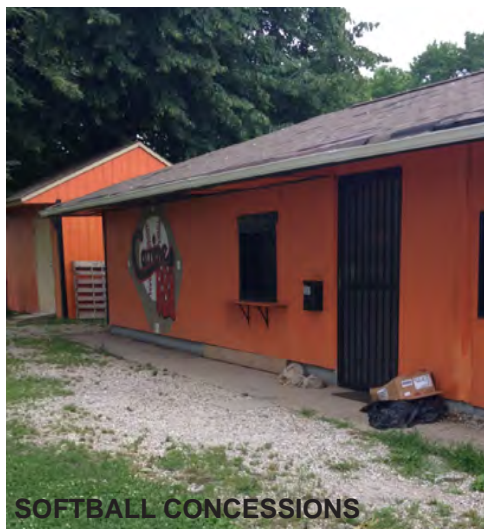
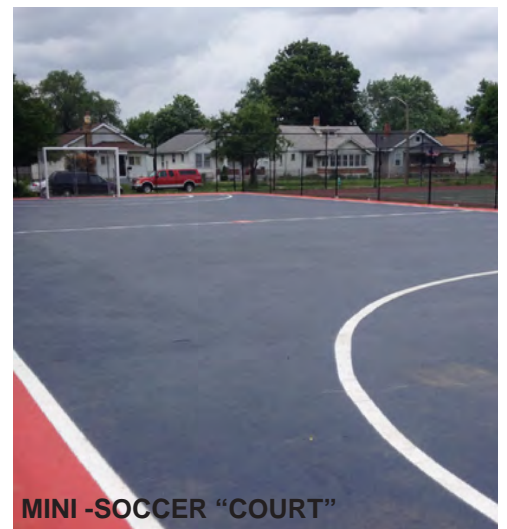
Programmed Park Amenities

Description	Scale of Conditions	QTY	Notes
Playground	3	2	One new on rubber matting (some weeds in joints) & one older, new mulch with a lot of weeds.
Basketball Court	0	-	N/A
Tennis Court	2.5	3	Cracks on surface, missing one net. Weeds in surface cracks and overgrown in fence.
Volleyball Court	0	-	N/A
Softball Field	2	4	No infield, some lights.
Soccer Field	4	0.5	New mini-field converted from tennis court. Sponsored by Indy Eleven team.
Football Field	0	-	N/A
Baseball Field	2	1	No infield, some lights and available seating. Concession stand.
Canine Zone	0	-	N/A
Spray Area	0	-	N/A
Pool-Outside	3.5	1	Shaded seating options, diving board, pool house. No spray area or slides.
Water Slide	0	-	N/A
Sledding Hill	4	1	Long hill curving around ball fields, decent slope. Accessible from street.
Horseshoes	1	2	3 of the 4 backboards are in tack. No poles or sand pits.
Disc Golf Holes	0	-	N/A

Nature Center	0	-	N/A
Family Center	2	1	Building looks to be used as a pool house only. Dated building - dark and uninviting.
Restroom Facility	3	2	Inside pool house. Some portables near ball fields.
Picnic Shelter	3	2	Seem well maintained. No walks leading to shelters. Near grills. Mismatched tables.
Picnic Clusters	3	2	In shaded locations. Trash around picnic clusters and shelters.
Programed Park Amenities General Notes: Ball fields and tennis courts need maintenance and repairs. Several of the amenities are dated. Pool was the only amenity being used during site visit.

Park Strategic Recommendations
The existing family center and pool can be replaced with a new facility that includes indoor fitness and pool, along with a new outdoor pool with a spray area. Signage on I-70 should be added to bring attention to the park's location.

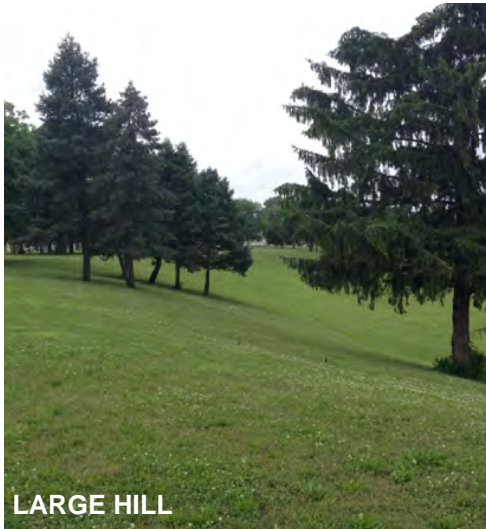
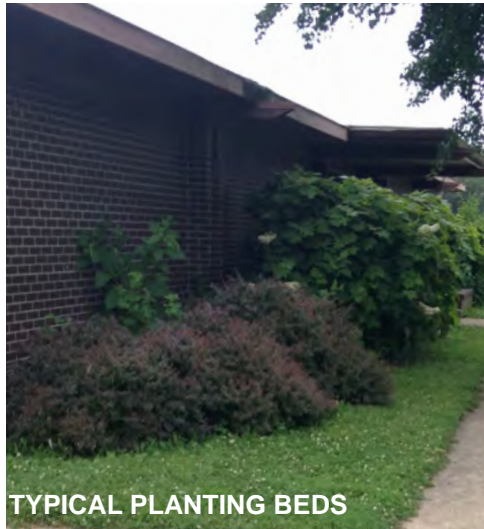
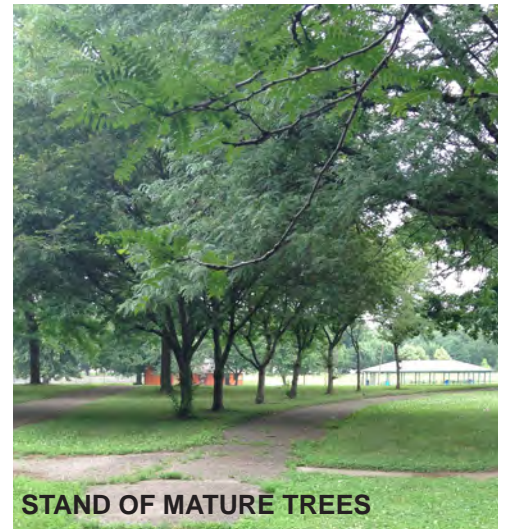
Park Open Space - Assessment		
Description	Scale of Conditions	Notes
Mowing	2	Grass is tall. Several fallen branches in lawn.
General Tree Conditions	3.5	Good condition overall. A lot of large dead limbs in trees and in lawn. Some suckering. KIB has planted trees along southern road.
Planting Areas	2	All planting beds are overgrown and grass has destroyed bed edges. Several weeds.
Water Feature	0	N/A
Park Open Space General Notes: Large lawn areas and several nice stands of large trees. Recent storms have knocked dead limbs from trees on lawn and walkways.

Park Weaknesses
Several dead trees and limbs are located throughout the park. Planting beds have deteriorated along with the trails, walkways and ballfields.

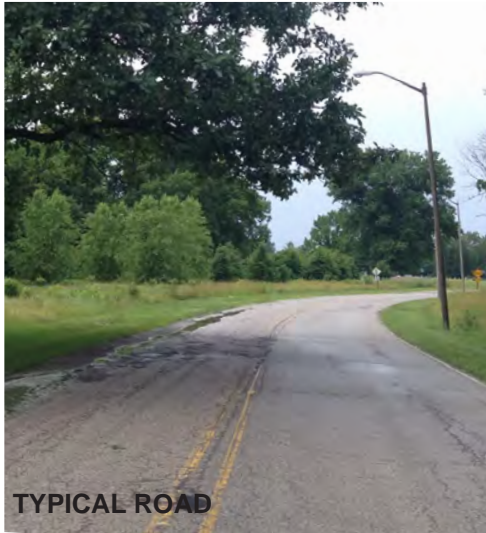
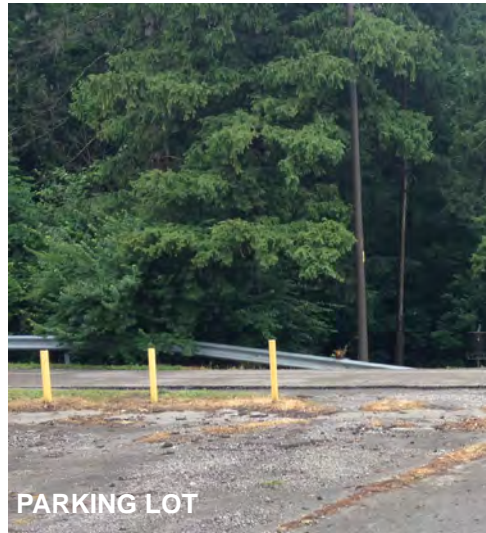
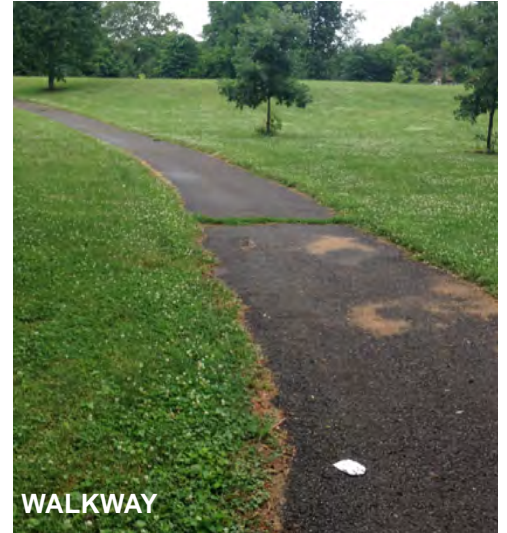
Description	Scale of Conditions	Notes
Roads	2.5	Asphalt is crumbling, full of potholes, and failing. Some are abandoned. Main roads do have speed bumps.
Walks	3	Walks are limited to area around family center.
Trails	3	Asphalt trails, edged are undefined and crumbling.
Parking	3	Several lots, mainly asphalt. No pavement markings or lights except at family center.
Benches	2	Different styles of benches/tables throughout park, and several are broken. Bleachers at basketball courts.
Trash Receptacles	2.5	Primarily blue plastic drums. Some were knocked over.
Site Lighting	3	Along roads and main parking for family center. Seems to be in working condition.
Bike Racks	0	N/A
Park Signage	3.5	Standard Indy Parks sign - in good condition. Disc golf sign in fading, paint peeling.
Bridges	3	2 footbridges - 1 near playground is older, some planks were recently replaced. 1 concrete at gardens.

Park Infrastructure General Notes: Very large park, roads access most of it, but the pavement is very worn down and patchy. There are no walkways from the parking lots to the basketball courts or one of the playgrounds.

Older, deteriorating infrastructure throughout the park - primarily roads and trails. The poor circulation throughout the park creates several unprogrammed and unused spaces.

This park has the opportunity to become a large community signature park. The natural habitats within this park could be improved with the addition of a nature center. These areas could be further activated by incorporating an outdoor element such as a ropes course or rock climbing wall. Additional shelters and rental space would help generate revenue. Additional trails could be added to increase connectivity and to create a large walking loop. A large food desert encompasses the west side of the park; this could be alleviated by adding a community garden or grocery store.

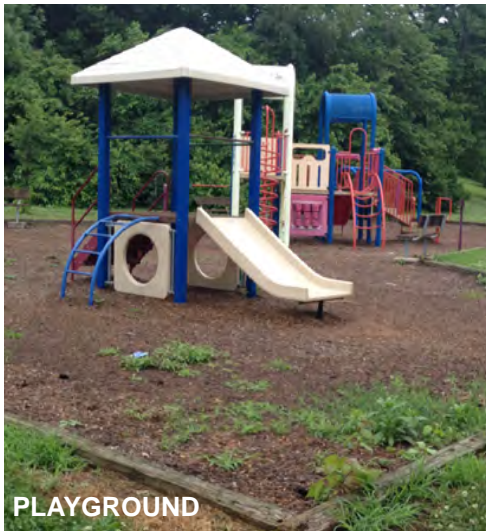
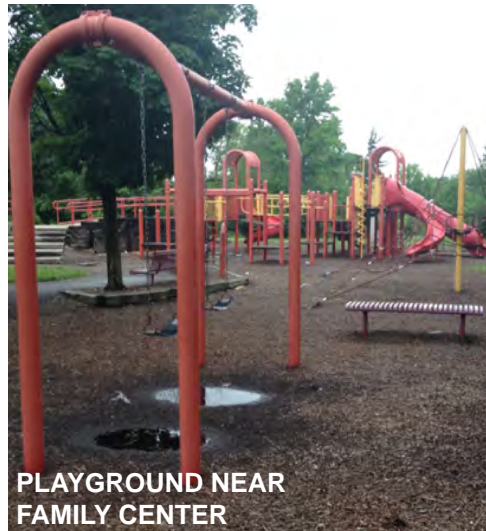
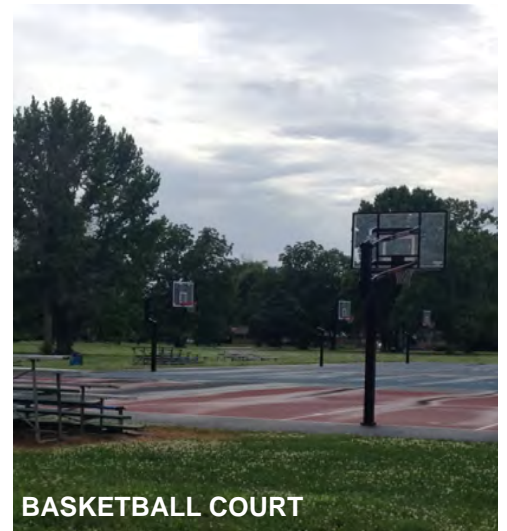
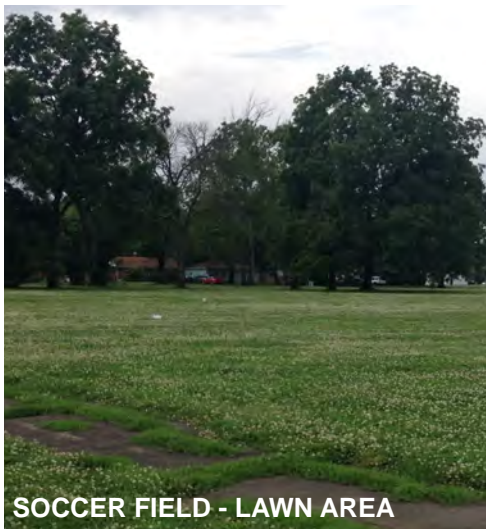
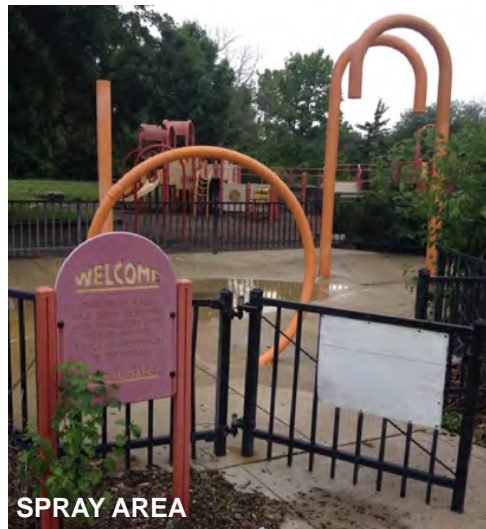
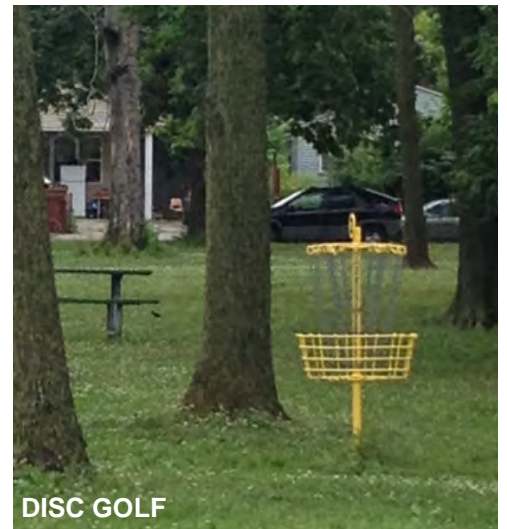
Programmed Park Amenities

Description	Scale of Conditions	QTY	Notes
Playground	3	2	Older, sun faded playground. Newer set near family center. Both weedy with standing water.
Basketball Court	4	4	3 full courts, 2 half courts. Look new. Have bleachers surrounding courts - falling apart.
Tennis Court	0	-	N/A
Volleyball Court	0	-	N/A
Softball Field	0	-	N/A
Soccer Field	1	1	On map near basketball courts - no goals or painted lines, just grass.
Football Field	0	-	N/A
Baseball Field	0	-	N/A
Canine Zone	0	-	N/A
Spray Area	2	1	Next to family center playground, only 2 jets. Awkward location.
Pool-Outside	0	-	N/A
Water Slide	0	-	N/A
Sledding Hill	0	-	N/A
Horseshoes	0	-	N/A
Disc Golf Holes	3.5	18 Holes	Mix of old and new goals. No map for course. "Best course in the area" - user.
Nature Center	0	-	N/A

Family Center	4	1	Large, newer facility. Basketball court, game room, fitness room, boxing ring. Kid programs.
Restroom Facility	1	1.5	One in family center, another facility by pond. Dark and looks abandoned.
Picnic Shelter	3.5	3	All near grills and trash cans. Minimal wear. Limbs on roofs, trash cans turned over.
Picnic Clusters	2	3	Several broken tables. Some clusters do not have trash cans.
Programed Park Amenities General Notes: Several items are mismatched and broken. Trash located in playground and around picnic areas.

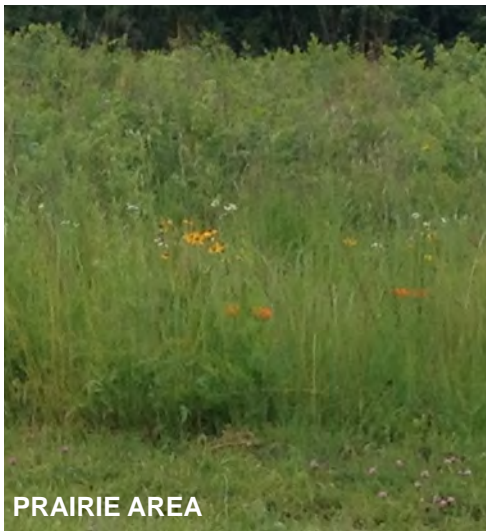
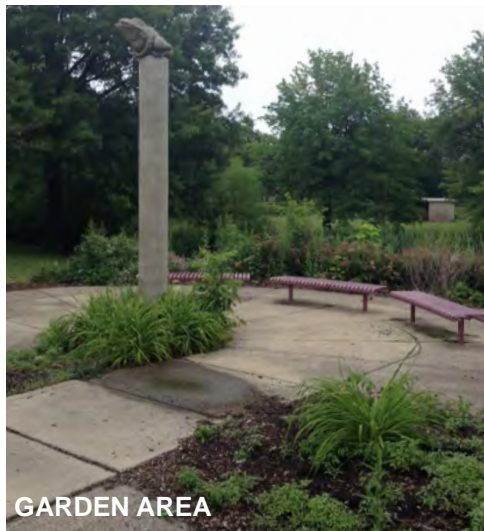
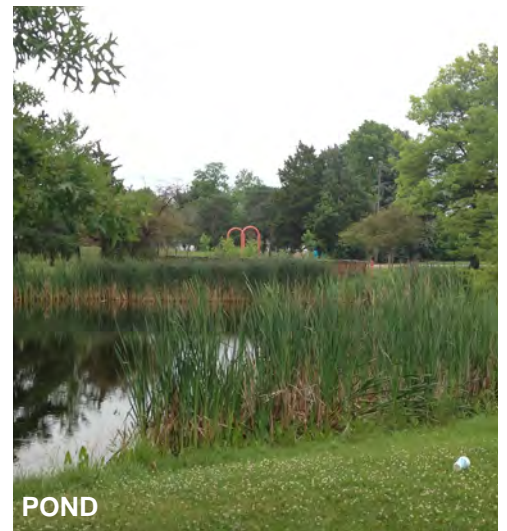
Park Open Space

Description	Scale of Conditions	Notes
Mowing	2	Grass is tall, needs mowed. Trash in lawn areas.
General Tree Conditions	2	Older, large shade trees. Dead trees and limbs need cut. No new trees planted.
Planting Areas	2	Garden areas near/around family center playground. Mulch is low and weeds in beds. Prairie area.
Water Feature	3	Pond within a garden area. Some trash and overgrowth along banks.

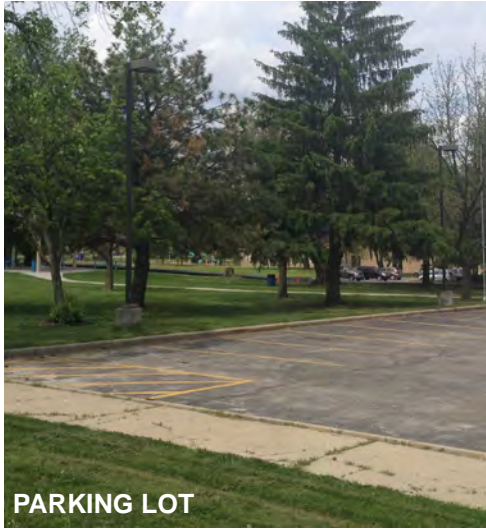
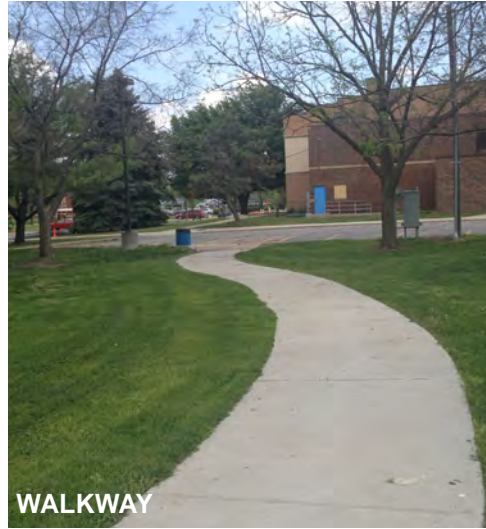
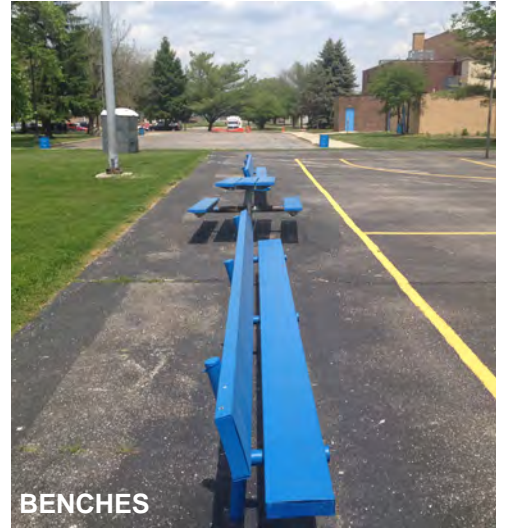
Park Infrastructure

Description	Scale of Conditions	Notes
Roads	0	No roads run through the site.
Walks	2	Walks are limited - located at perimeter and the family center only. Cracking and joints have weeds.
Trails	0	N/A
Parking	3	Located at family center. Asphalt is cracking and fading. Striping is also fading.
Benches	3	Wood planks on metal frame. All were recently painted. Bleachers have some broken seating planks.
Trash Receptacles	2	Mix of blue plastic and metal drums.
Site Lighting	3	Located only at basketball courts, seem to be in working order.
Bike Racks	0	N/A
Park Signage	2	Standard Indy Parks sign. Logo is fading, weeds surrounding fence posts.
Bridges	0	N/A

Facilities Recommendation (Based on Park Assessments & Survey Results)
Additional trails and sidewalks would increase park connectivity internally and to the surrounding neighborhoods.

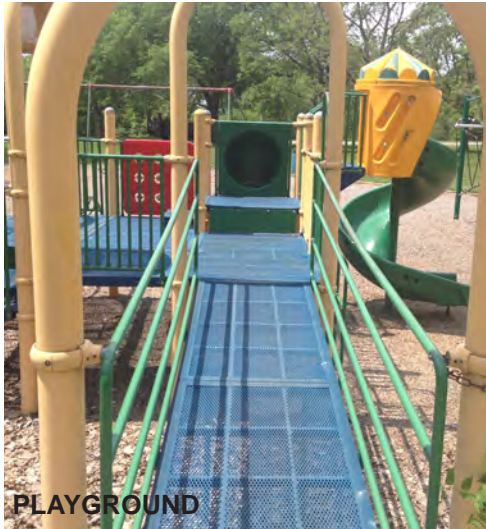
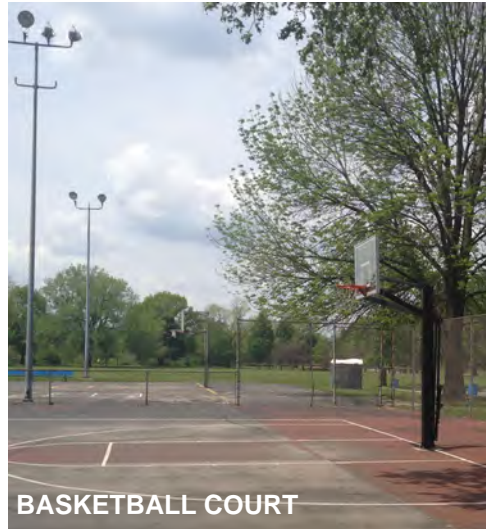
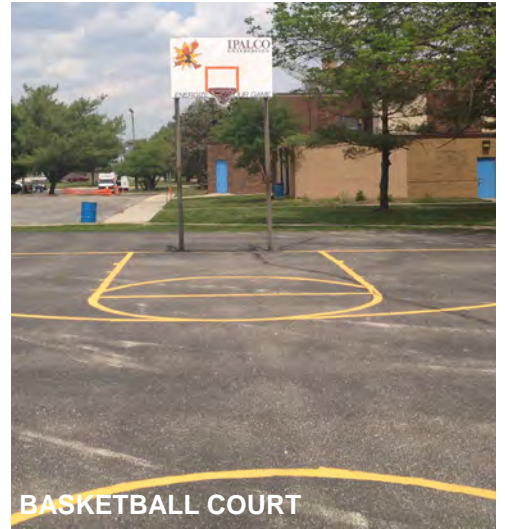
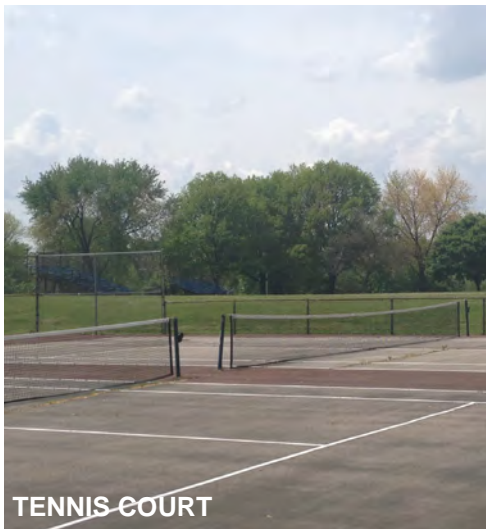
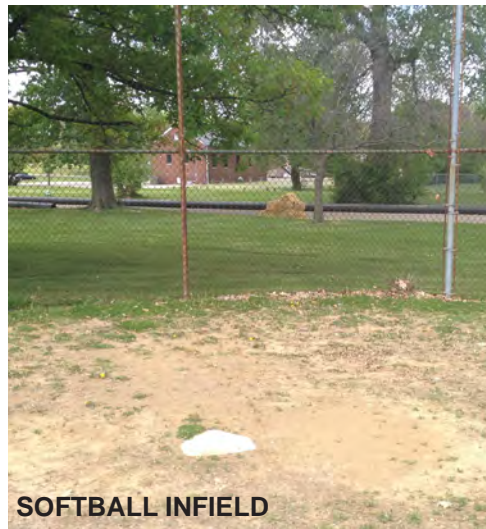
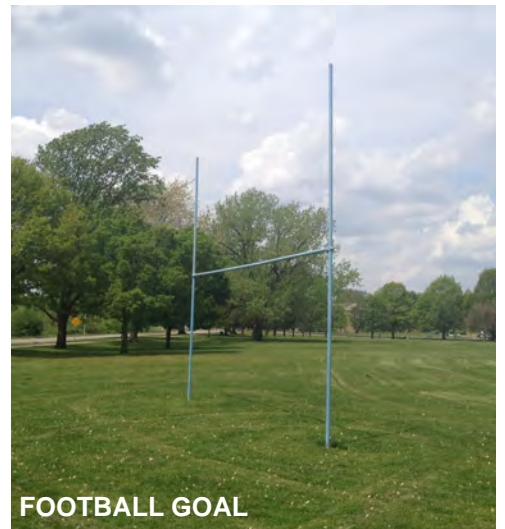
Programmed Park Amenities

Description	Scale of Conditions	QTY	Notes
Playground	2	1	Older structure - flat surface flexed when walking across. Some newer structures surrounding.
Basketball Court	2	2	Surface is fading and some minor cracking present.
Tennis Court	2	2	Surface is fading and some minor cracking present.
Volleyball Court	0	-	N/A
Softball Field	2	2	Infield is full of weeds and grass. Backstop is falling apart. Bleachers have broken planks.
Soccer Field	0	-	N/A
Football Field	2	1	Older goal post. No scoreboard or painted lines.
Baseball Field	0	-	N/A
Canine Zone	0	-	N/A
Spray Area	0	-	N/A
Pool-Outside	0	-	N/A
Water Slide	0	-	N/A
Sledding Hill	0	-	N/A
Horseshoes	2	2	Freshly painted, some missing boards on backstop. Needs sand.
Disc Golf Holes	0	-	N/A
Nature Center	0	-	N/A

Family Center	3	1	Outside appears in good condition.
Restroom Facility	2	1	Located in family center and a portable restroom onsite.
Picnic Shelter	3	2	Older shelter near playground, newer within open lawn area. Freshly painted.
Picnic Clusters	0	-	N/A
Programed Park Amenities General Notes: Several of the amenities appear older and could use maintenance or replacement.

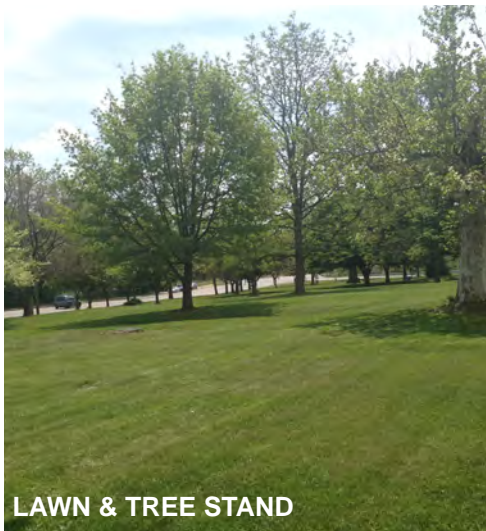
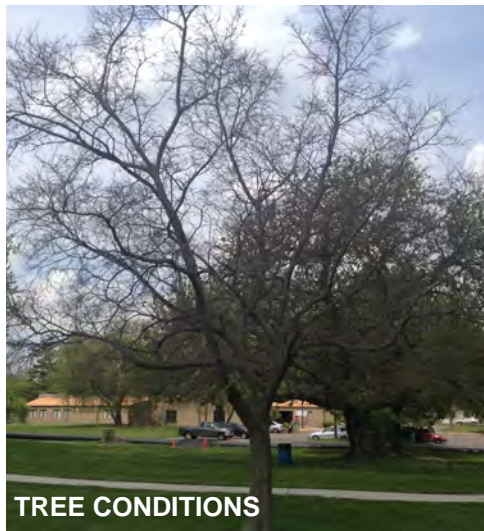
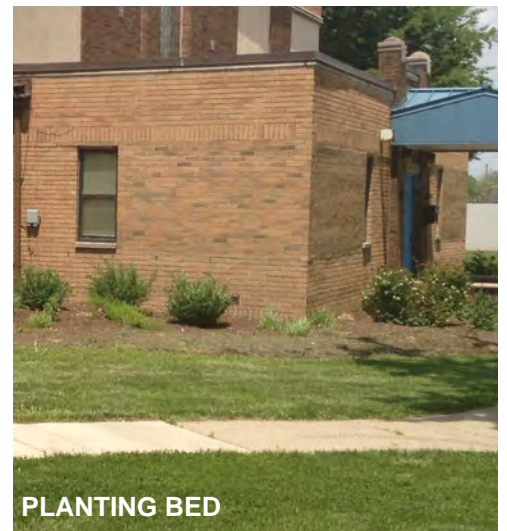
Park Open Space - Assessment		
Description	Scale of Conditions	Notes
Mowing	3	Large open lawn space. Recently mowed, but not underneath bleachers.
General Tree Conditions	3	Large, mature stand of trees near playground - need dead limbs removed.
Planting Areas	3	Recently planted and mulched. Plant material is minimal.
Water Feature	0	N/A
Park Open Space General Notes: Primarily large open lawn with a handful of mature shade trees.

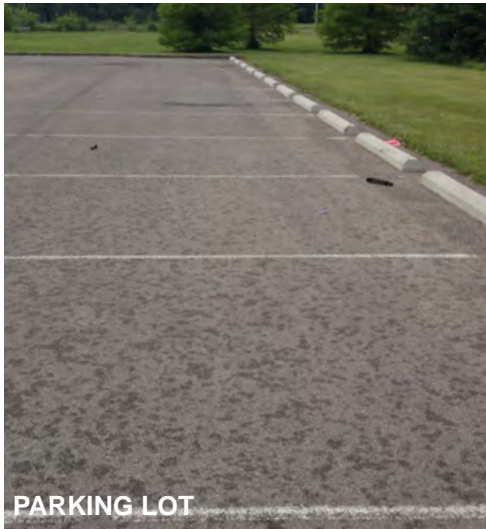
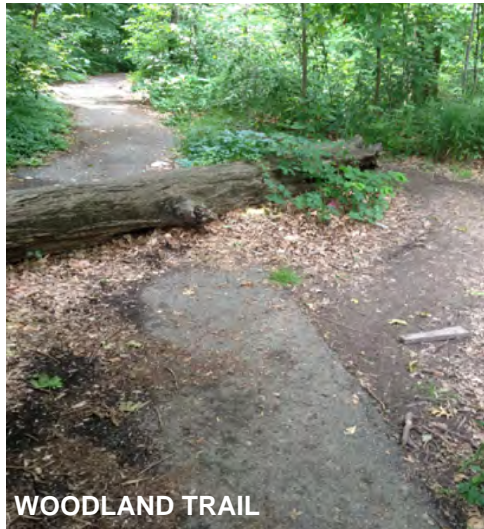
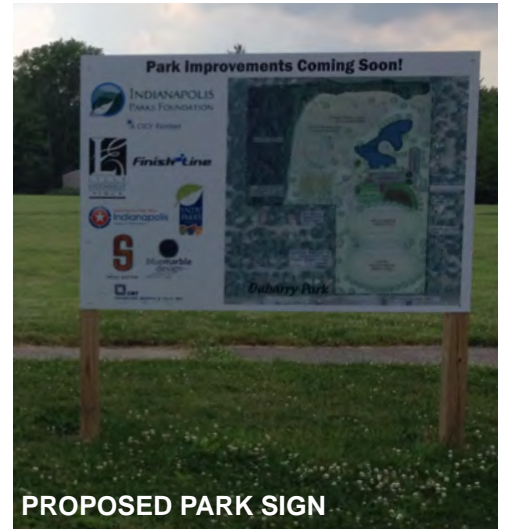
Park Infrastructure

Description	Scale of Conditions	Notes
Roads	4	Good condition from entrance to park. Roads through neighborhood are rough - full of potholes.
Walks	1	Cracking concrete, joints are full of weeds. Path from parking lot to restroom is unfinished.
Trails	2	Mowed trail through prairie, asphalt path in woods. Fallen tree over woodland trail, footpath around tree.
Parking	4	New lot, clear paint, stop blocks.
Benches	2	Peeling paint and soft wood. Bleachers at football field are unsafe.
Trash Receptacles	0	No trash receptacles on site.
Site Lighting	4	Seems new around parking lot - few lights around park area.
Bike Racks	0	N/A
Park Signage	3	Park sign in good condition. No signs leading to park - hard to find. Sign with proposed improvements.
Bridges	0	N/A

Facilities Recommendations (Based on Park Assessments & Survey Results)
The park has limited trails, most are mowed paths. The addition of new trails would increase connectivity internally and to the surrounding neighborhood. The existing shelters should be replaced with new, safe shelters and picnic areas.

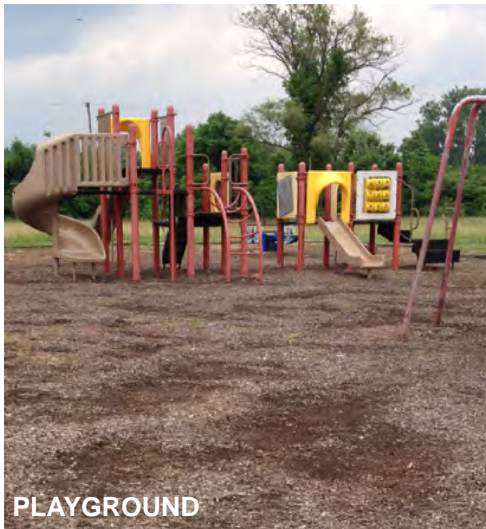
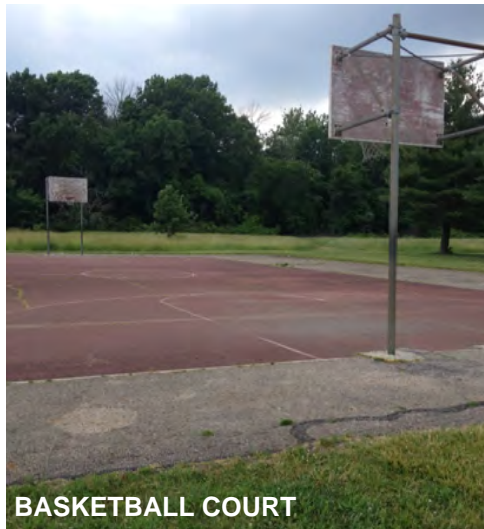
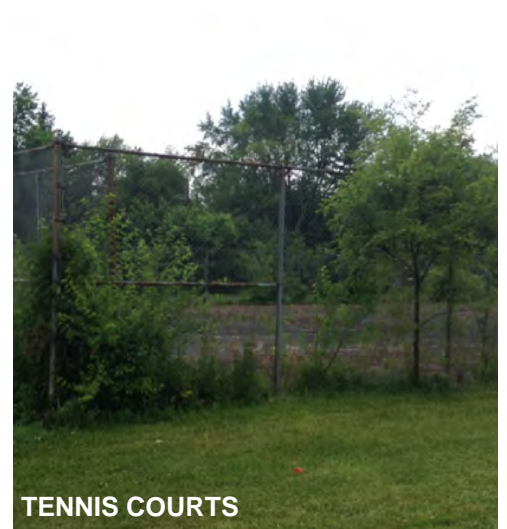
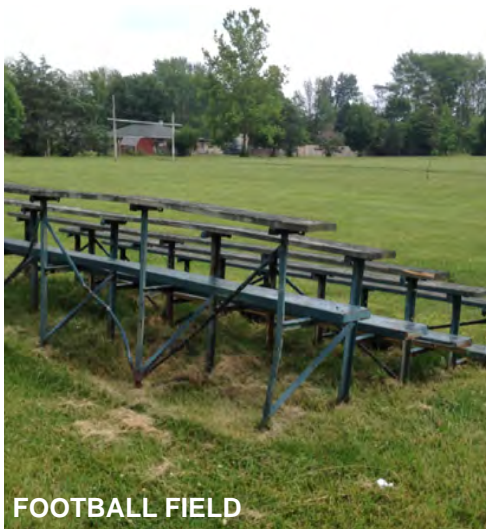
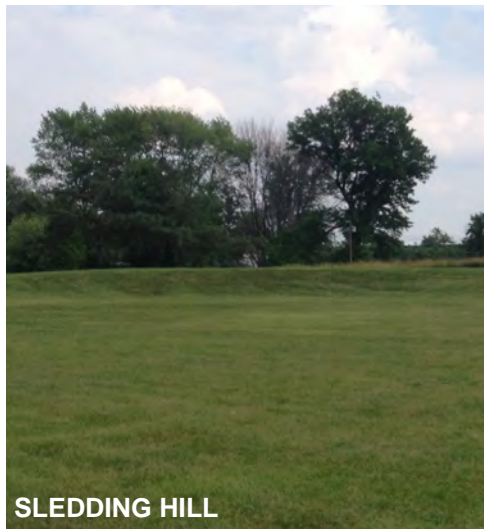
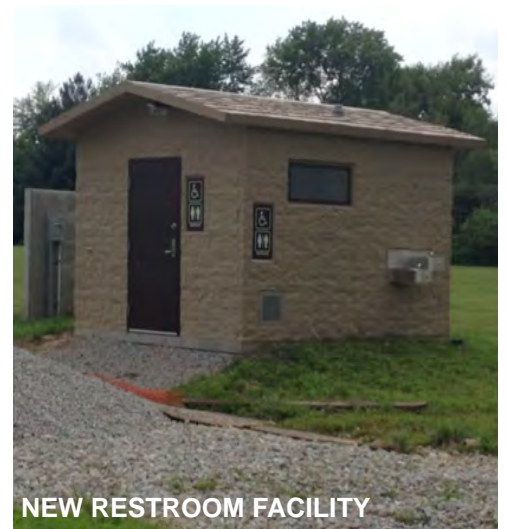
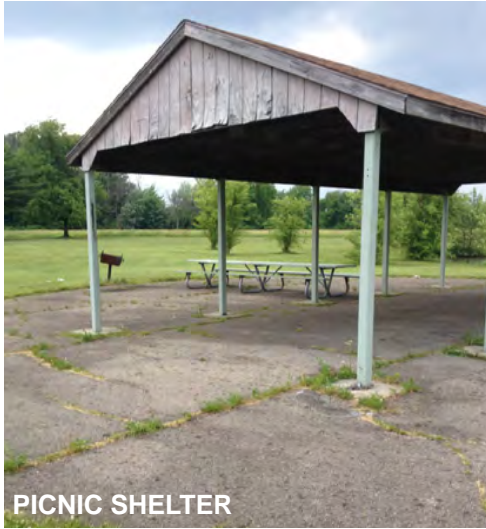
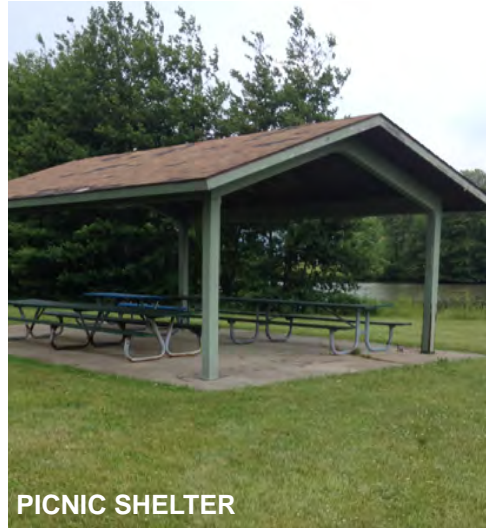
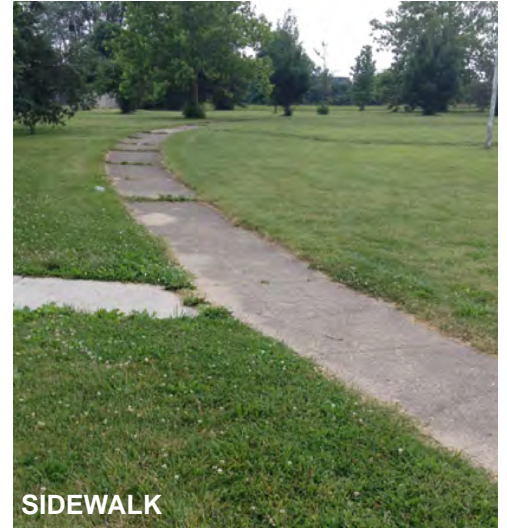
Programmed Park Amenities

Description	Scale of Conditions	QTY	Notes
Playground	2	1	Older playset, mulch is clean, but evidence of flooding. In use during visit.
Basketball Court	2	1	Cracking court surface with weeds. Net and backboard are intact, but older.
Tennis Court	1	4	No nets, surface is cracking with weeds, and the fence is full of overgrown weeds.
Volleyball Court	0	-	N/A
Softball Field	0	-	N/A
Soccer Field	0	-	N/A
Football Field	2	1	Goal posts and bleachers, both are old and falling apart.
Baseball Field	0	-	N/A
Canine Zone	0	-	N/A
Spray Area	0	-	N/A
Pool-Outside	0	-	N/A
Water Slide	0	-	N/A
Sledding Hill	3	1	Short hill that may be used for sledding, sidewalk leads to it. No benches or shelter.
Horseshoes	0	-	N/A
Disc Golf Holes	0	-	N/A

Nature Center	0	-	N/A
Family Center	0	-	N/A
Restroom Facility	3	1	Brand new, unfinished walk leading from parking lot to doors. Drinking fountain; doors locked.
Picnic Shelter	2	2	Concrete flooring is rough, wood is unpainted and rotting. Several roof shingles are missing.
Picnic Clusters	0	-	N/A
Programed Park Amenities General Notes: All sports fields and courts are old and worn down. Playground and basketball courts appear to be used regularly. Shelters look unsafe.

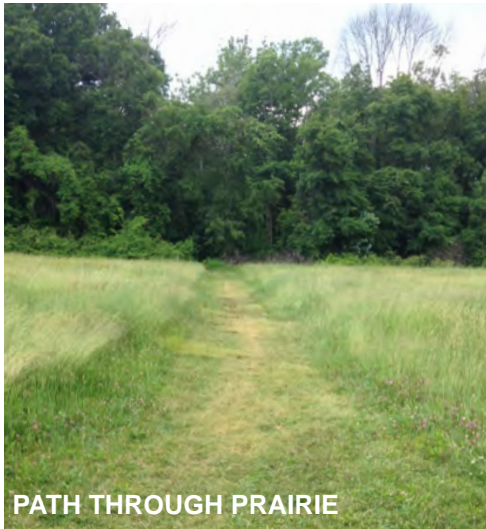
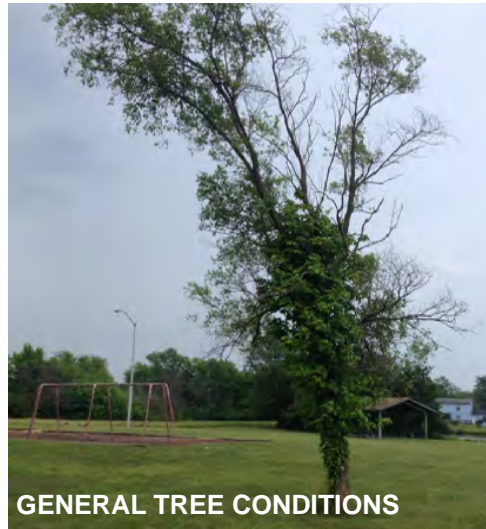
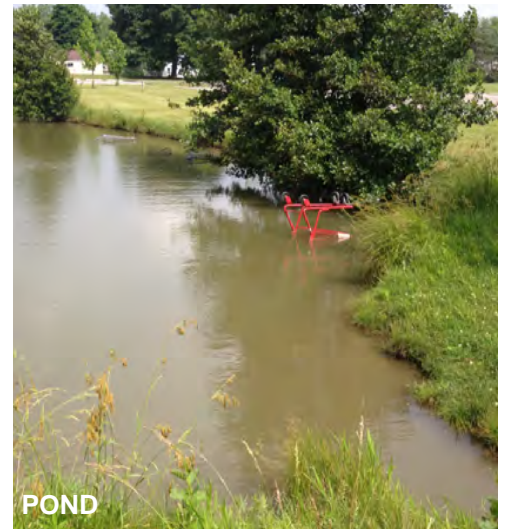
Park Open Space - Assessment		
Description	Scale of Conditions	Notes
Mowing	4	Recently mowed. Path to woods is clear and wide.
General Tree Conditions	2	Dead trees and several dead limbs. Dead tree has fallen on trail in woods.. No newly planted trees.
Planting Areas	2	No planting beds, but there is a prairie area. Doesn't seem to be a large variety of plants in prairie.
Water Feature	1	Pond - full of trash and shopping carts. Tree/shrubs along edge are overgrown and suckering.
Park Open Space General Notes: General tree maintenance is needed, throughout park and along pond area. There are no trash receptacles in the park, so there is a lot of trash throughout.

Park Strategic Recommendations
Directional signage to the park is needed; the park is hidden and difficult to find. The park's existing natural forested and prairie areas could be improved with additional plantings. There is a need for a new playground and sports fields as there are no other parks accommodating this need nearby. Some of these changes will be completed with the 2016 park renovation.

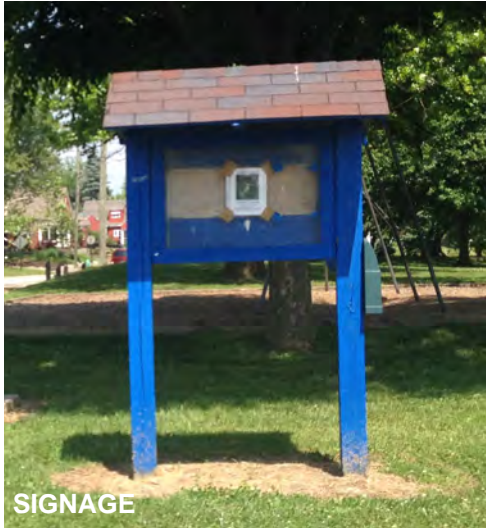
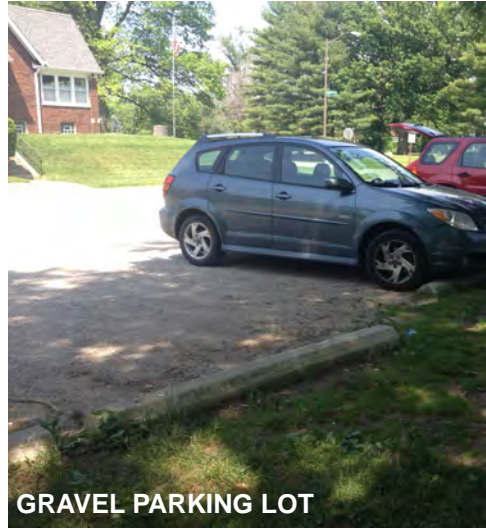
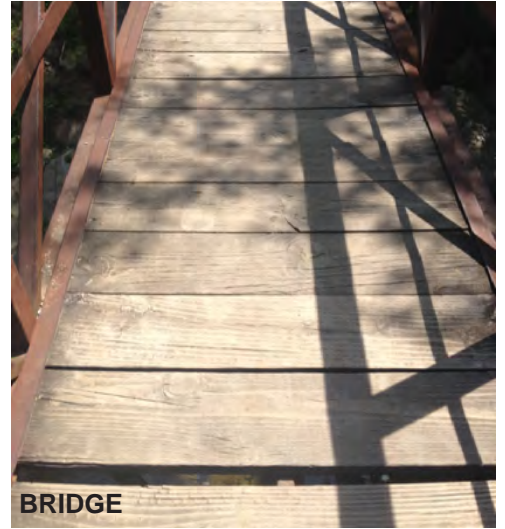
Park Infrastructure

Description	Scale of Conditions	Notes
Roads	1	Rough gravel road behind ice rink, use unclear. Ends in middle of park. No defined edge, full of weeds.
Walks	3	Paved walks are in good condition. Concrete sidewalks are sinking in places.
Trails	1	Gravel trail, undefined edge, does not provide stable footing.
Parking	1-4	Primary lot is paved and in good condition, designed for one way traffic, but not clearly marked. Other parking lots are gravel, undefined edge.
Benches	2	Mix of wood planks on metal base or complete metal bench. Metal benches are rusting through.
Trash Receptacles	3	Blue plastic, quantity seems low.
Site Lighting	3	Appear to be in working order, limited to main parking lot and path down hill.
Bike Racks	0	N/A
Park Signage	3	Identity signs are good, others are random or empty/blank.
Bridges	3	Older plank style on metal frame. Stable, but planks flex when crossing.

Facilities Recommendation (Based on Park Assessments & Survey Results)
The existing walking trail through the park is well used, but in poor shape; most of the trails are gravel. Improving and adding trails will create better connections to the surrounding neighborhood. New playground equipment is needed in the northeast corner of the park. Ball fields need to be greatly improved.

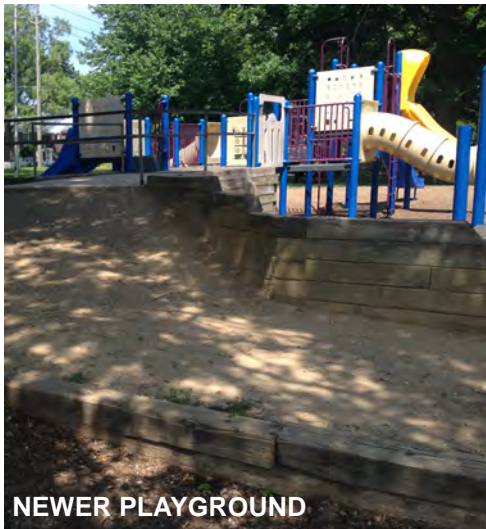
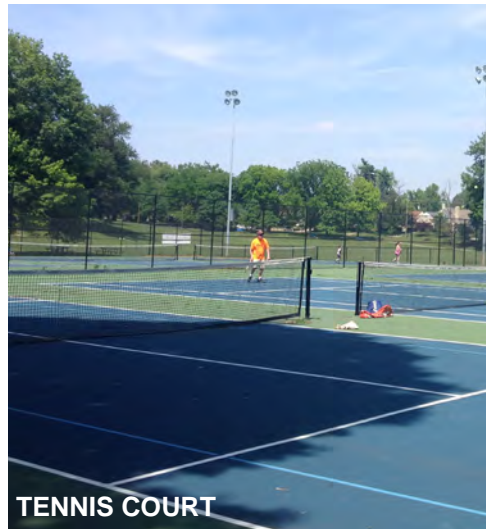
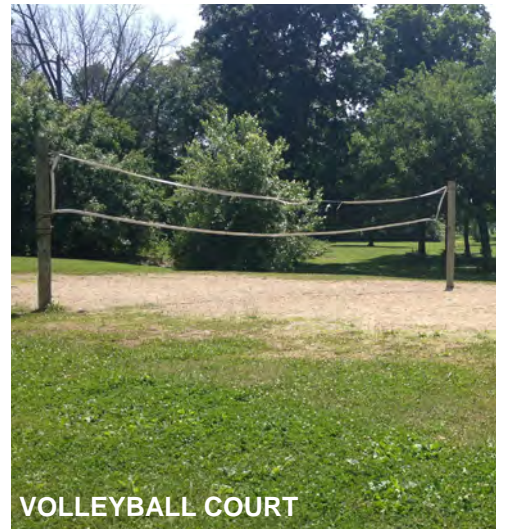
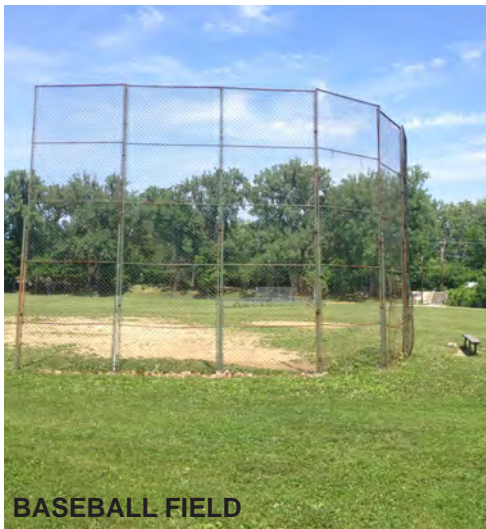
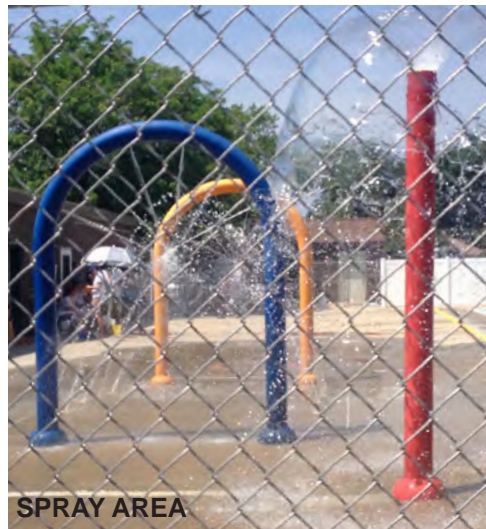
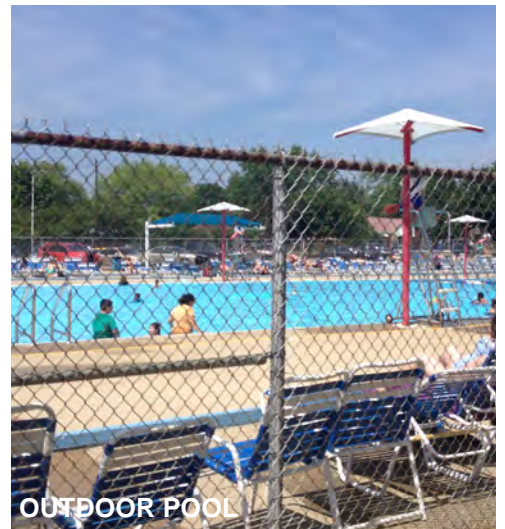
Programmed Park Amenities

Description	Scale of Conditions	QTY	Notes
Playground	3	2	Older, but well maintained. One is in full sun, the other in shade.
Basketball Court	0	-	N/A
Tennis Court	4	8	6 regular sized courts, 2 kid-sized. Look new and were in use during visit.
Volleyball Court	2	1	Net is tearing, sand is full of weeds, boundary is undefined.
Softball Field	2	1	Cage and some infield. Needs sand and weed removal.
Soccer Field	0	-	N/A
Football Field	1	1	Goals present, field is unmarked grass.
Baseball Field	1	1	Only cage is present, no infield.
Canine Zone	0	-	N/A
Spray Area	3	1	Within pool area, small in size and working. Not being used.
Pool-Outside	3.5	1	Large-sized pool, has a rock wall. Several seats, but not very much shade is provided.
Water Slide	0	-	N/A
Sledding Hill	4	1	Different slopes, close to main parking lot, benches nearby.
Horseshoes	0	-	N/A
Disc Golf Holes	0	-	N/A
