City of Indianapolis Park, Recreation and Open Space Plan
Park Inventory & Assessment

PIKE TOWNSHIP ASSESSED PARKS

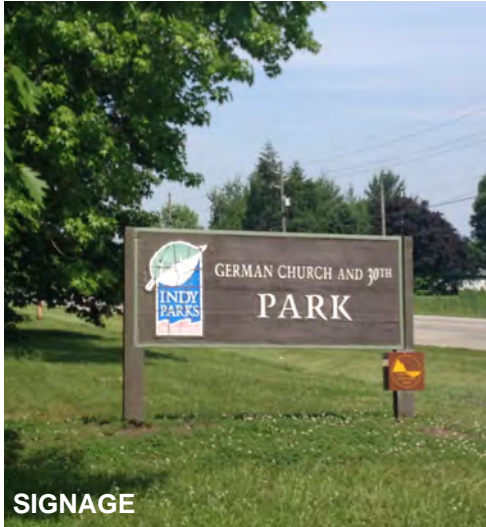
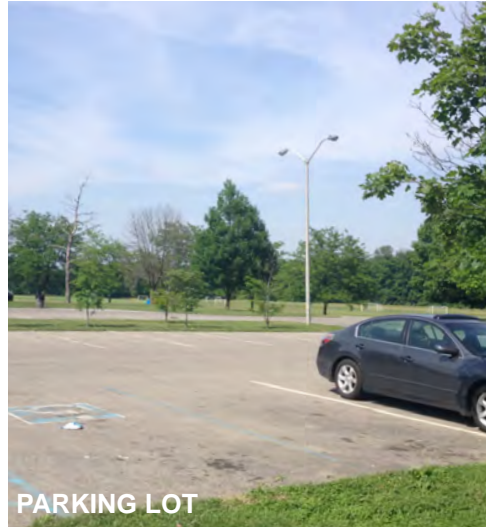
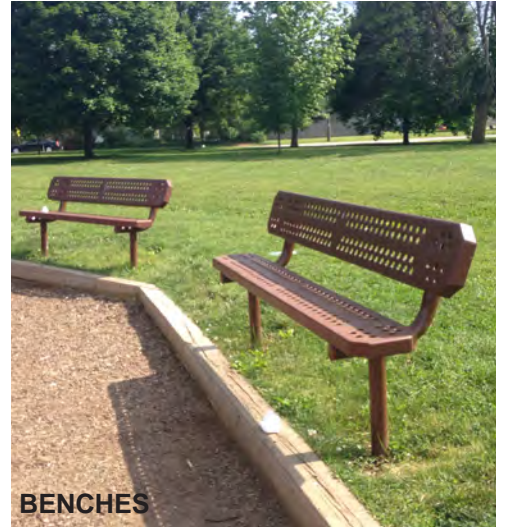
Description	Scale of Conditions	Notes
Roads	2+	Fresh pavement, and pavement markings, edges seem unstable.
Walks	3	Concrete in good condition, some washout in playground area.
Trails	1	Gravel road leading to wetland area of Grassy Creek, used as trail. Boardwalk in wetland, inaccessible.
Parking	4	Lots are new, clean striping, accessible to playground.
Benches	3+	Mix of different types, in good condition. Benches next to tennis court are falling apart.
Trash Receptacles	3	Some are blue or white plastic and some are brown metal.
Site Lighting	3	Only in parking lot, looks new.
Bike Racks	0	N/A
Park Signage	2	Good condition, but not clear on park name. No signs for Grassy Creek.
Bridges	0	N/A

Park Infrastructure General Notes: Primary park area is easy to find - labeled as 30th and German Church Road Park. The northern part of the park, Grassy Creek wetland area, is difficult to find and access. The only entrance found is on the northern boundary, between an apartment complex and a neighborhood - no signs marked the entrance, but a gravel road/path leads back to the wetland area.

The park needs additional parking and rentable shelters. Park signs need to be updated to reflect the correct park name. Additional wayfinding signs area also needed. The deteriorating tennis courts could be repurposed to add an additional outdoor activity.

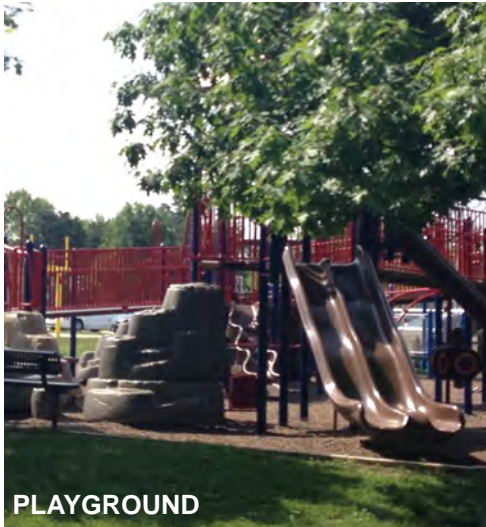
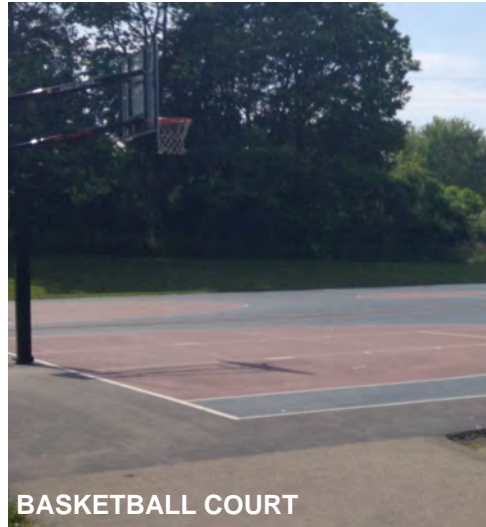
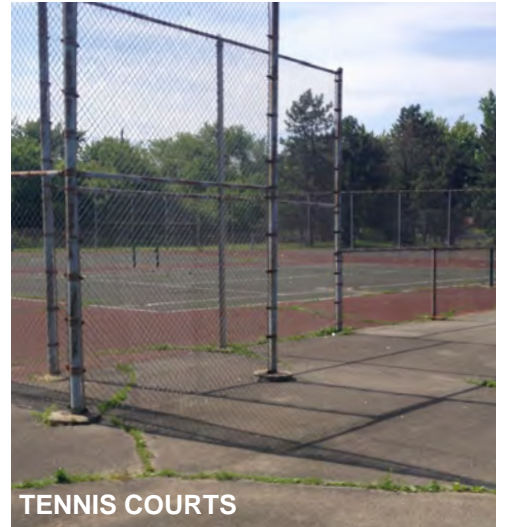
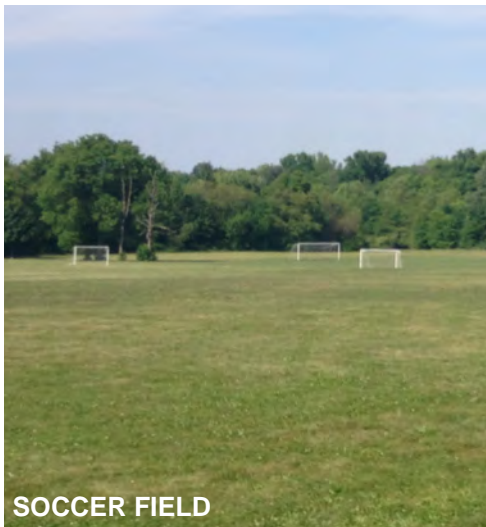
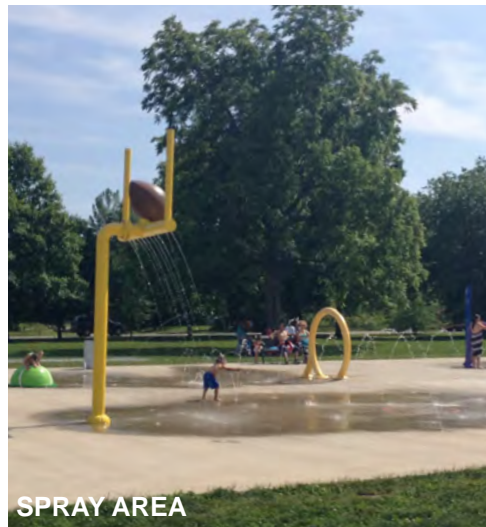
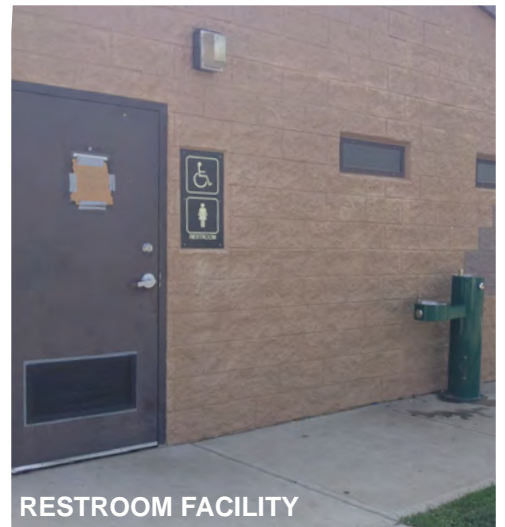
Programmed Park Amenities

Description	Scale of Conditions	QTY	Notes
Playground	4	1	Older smaller set, next to a new larger set. Some weeds and flooding in mulched play area.
Basketball Court	4	2	New, good condition. In use during visit.
Tennis Court	1	4	No nets, cracking, weeds, concrete walks and benches are falling apart.
Volleyball Court	0	-	N/A
Softball Field	0	-	N/A
Soccer Field	2.5	4	2 full sized fields, 2 kid sized fields. No benches or shade provided. Some nets are missing
Football Field	1	1	1 goal post, no lines.
Baseball Field	0	-	N/A
Canine Zone	0	-	N/A
Spray Area	4	1	Small, but colorful and in good condition, some peeling paint. No shade provided for watchers.
Pool-Outside	0	-	N/A
Water Slide	0	-	N/A
Sledding Hill	0	-	N/A
Horseshoes	0	-	N/A
Disc Golf Holes	0	-	N/A
Nature Center	0	-	N/A

Family Center	0	-	N/A
Restroom Facility	1	2	Restroom building - both doors locked with "out of order" signs. 2 portables by soccer fields.
Picnic Shelter	2.5	1	Shelter paint is peeling. Roof is deteriorating picnic tables are peeling paint, access to grill.
Picnic Clusters	1	1	Some picnic tables scattered around parking lot.
Programed Park Amenities General Notes: Tennis courts and football field are unusable because of missing nets and goals. Newer playground is in great condition and was being heavily used during site visit.

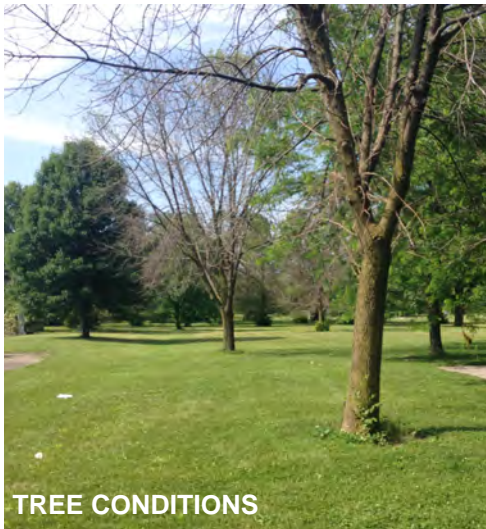
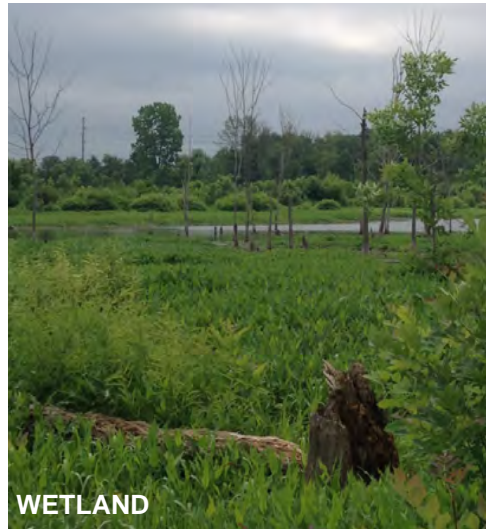
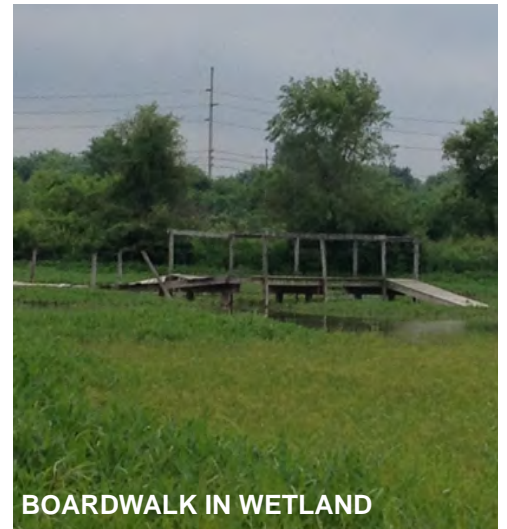
Park Open Space

Description	Scale of Conditions	Notes
Mowing	3	Recently mowed, Some edges/trim work missed
General Tree Conditions	2.5	Several dead trees, or trees with large dead limbs.
Planting Areas	0	N/A
Water Feature	1	Odd stream - modified stream along a possible levee. Dam structure at north end of main park.

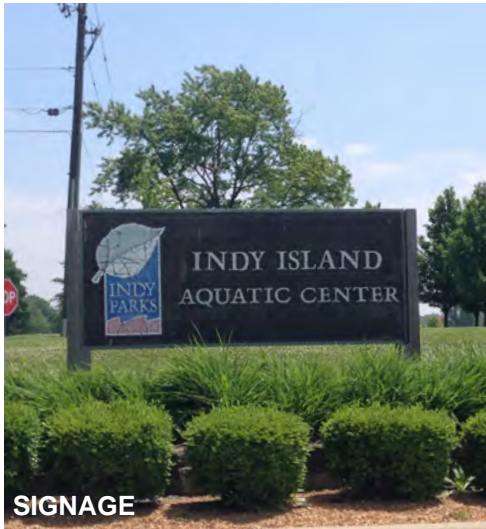
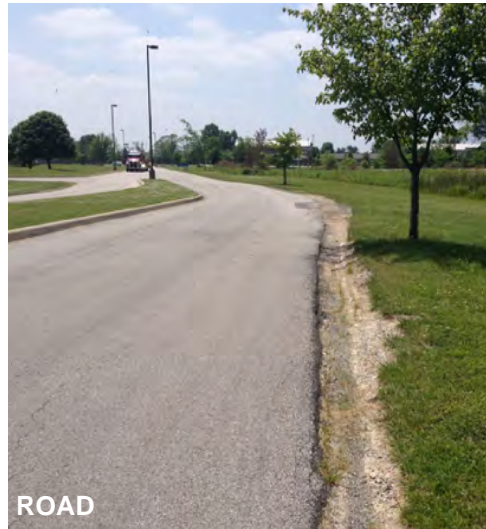
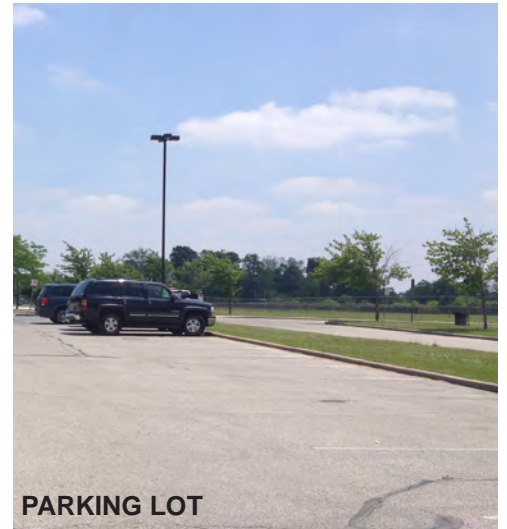
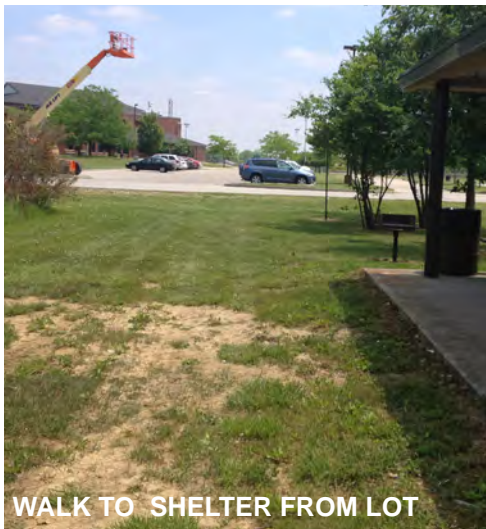
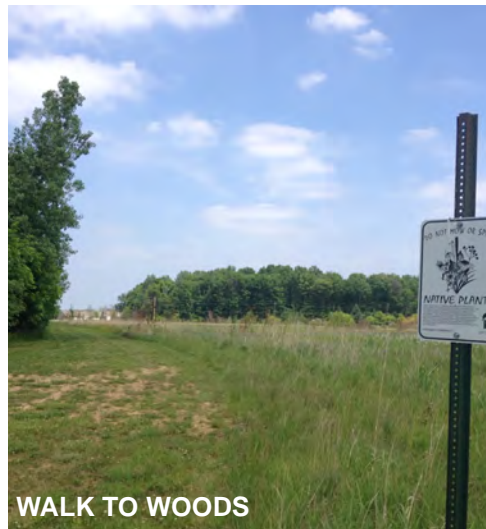
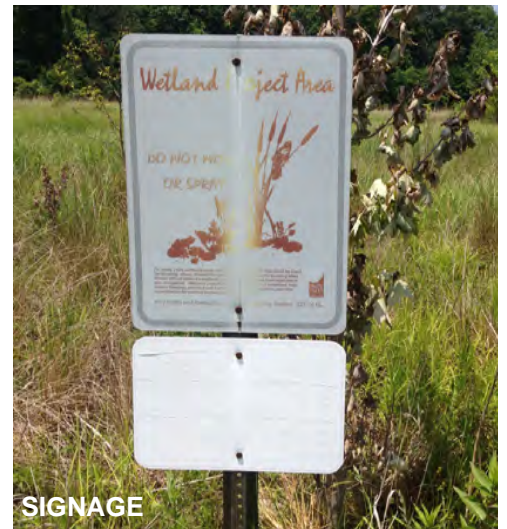
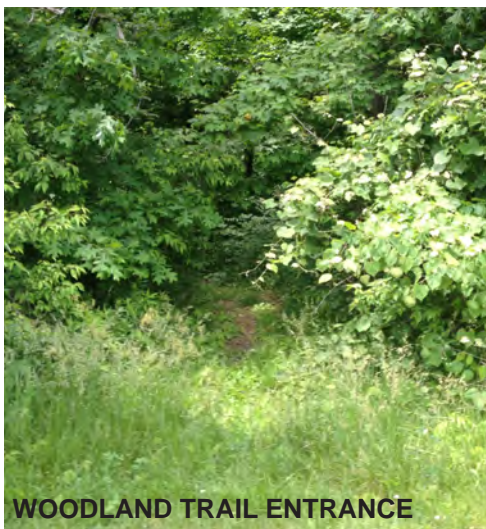
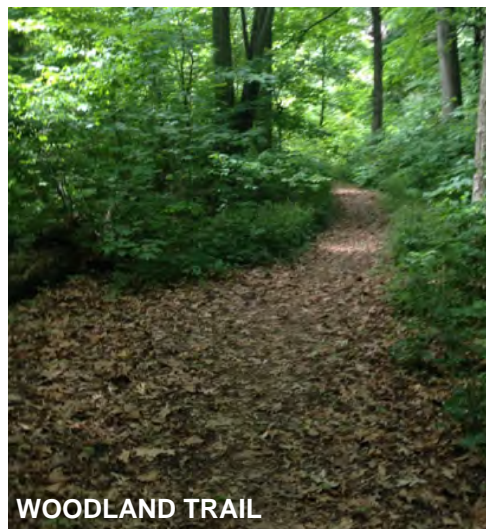
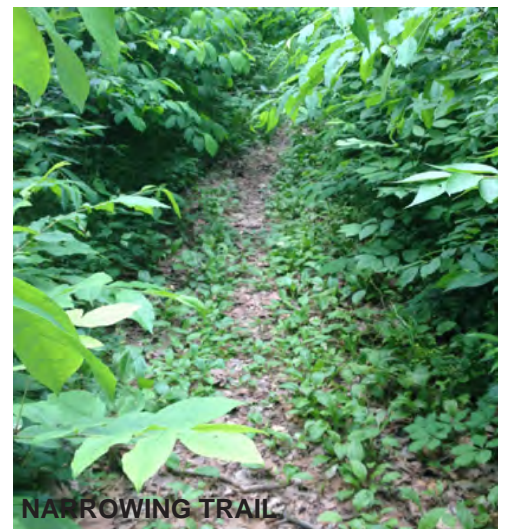
Park Infrastructure

Description	Scale of Conditions	Notes
Roads	3	Road leading in to park is in good condition, but no curb or markings. Road is primarily for school access.
Walks	0	N/A
Trails	1	Mowed paths that have bare dirt, can be muddy. Wood trails need vegetation cleared/cut back.
Parking	3	Lot is across road from park, shared with school and aquatic center. No walks/trails for connection.
Benches	3	Metal base with wood planks. Paint is peeling/wearing.
Trash Receptacles	3	Heavy duty metal drums, painted brown, no lids.
Site Lighting	1	Lighting present in parking lot, no where else.
Bike Racks	0	N/A
Park Signage	1	Indy Island sign, no Raymond Park sign. General park and educational signs are fading.
Bridges	0	N/A

Facilities Recommendation (Based on Park Assessments & Survey Results)
Trails are needed in this park to connect to the adjacent road, parking lot, schools and neighborhood. Trails through the park need better circulation and maintenance to preserve connection to the natural planting areas. Park signage and wayfinding should be improved.

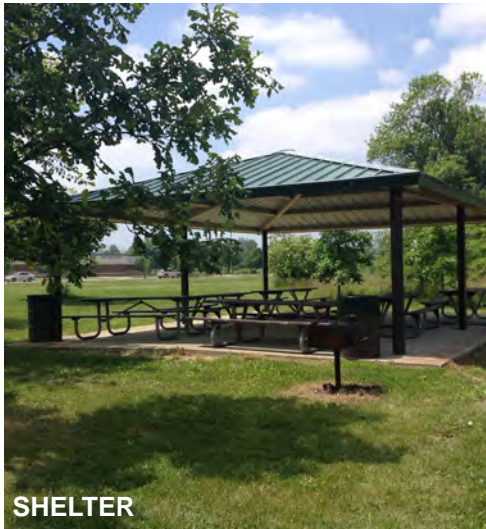
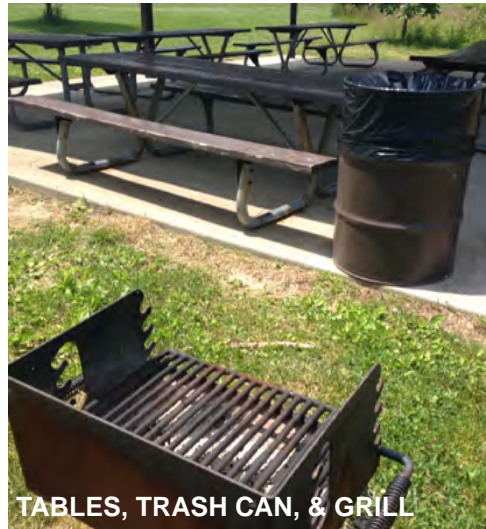
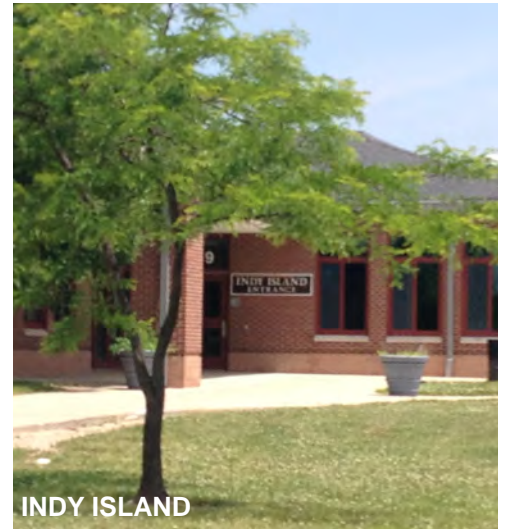
Programmed Park Amenities

Description	Scale of Conditions	QTY	Notes
Playground	0	-	N/A
Basketball Court	0	-	N/A
Tennis Court	0	-	N/A
Volleyball Court	0	-	N/A
Softball Field	0	-	N/A
Soccer Field	0	-	N/A
Football Field	0	-	N/A
Baseball Field	0	-	N/A
Canine Zone	0	-	N/A
Spray Area	0	-	N/A
Pool-Outside	0	-	N/A
Water Slide	0	-	N/A
Sledding Hill	0	-	N/A
Horseshoes	0	-	N/A
Disc Golf Holes	0	-	N/A
Nature Center	0	-	N/A

Family Center	0	-	N/A
Restroom Facility	0	-	N/A
Picnic Shelter	3	1	Good condition, with tables and grill. Next to road, but no walk connecting road and shelter.
Picnic Clusters	0	-	N/A
Programed Park Amenities General Notes: No programmed activities on site except for picnic shelter. Indy Island is across street, attached to school.

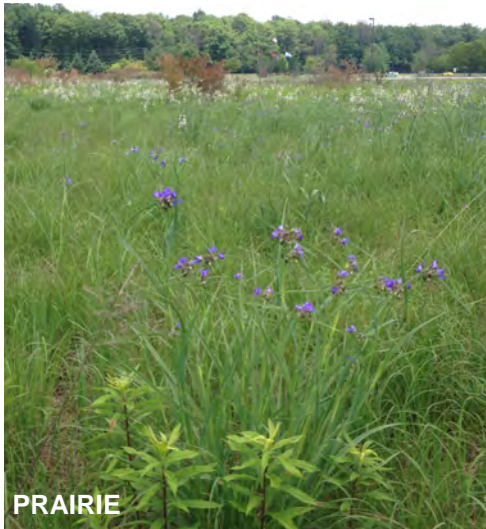
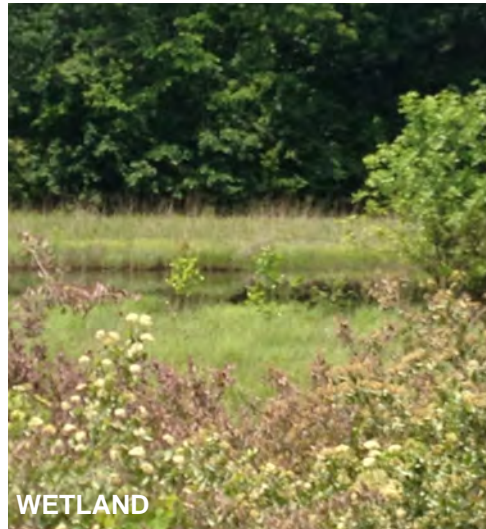
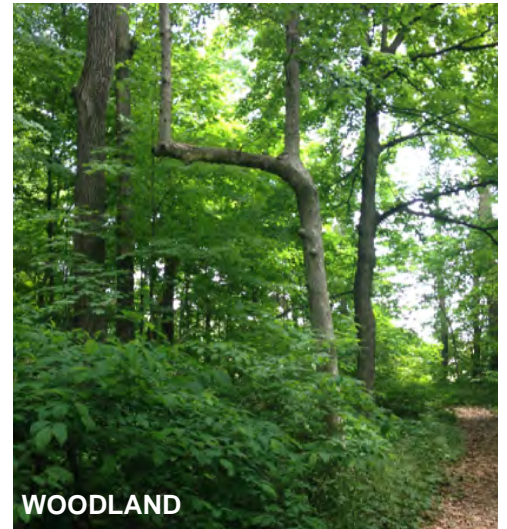
Park Open Space - Assessment		
Description	Scale of Conditions	Notes
Mowing	3	Bare turf areas, a lot of clover and other weeds in lawn. Muddy in primary path from parking lot.
General Tree Conditions	2	Good around shelter. Trees and woody growth along woodland trail need cut back for trail access.
Planting Areas	3	Variety of prairie plants, some educational signage - fading and unreadable.
Water Feature	~1	Wetland in middle of prairie area, non-accessible.
Park Open Space General Notes: Woodland area needs maintenance along trail - trees and understory are blocking the path.

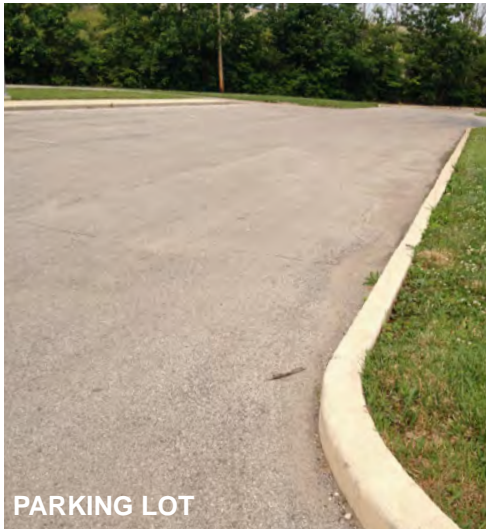
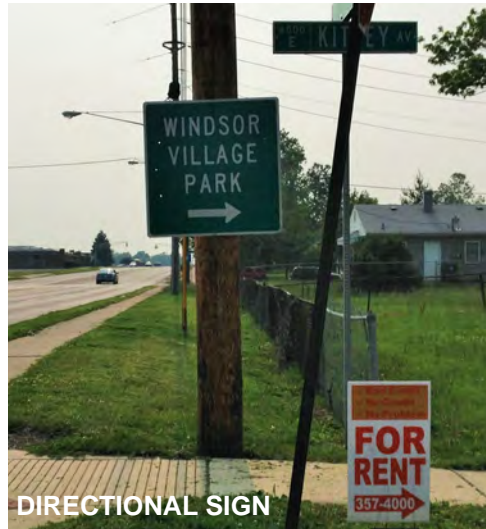
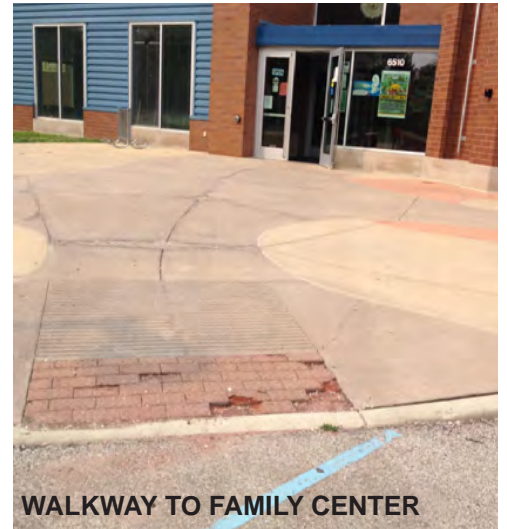
Park Infrastructure

Description	Scale of Conditions	Notes
Roads	0	No roads run through the site.
Walks	2	Walks are limited - located at perimeter and the family center only. Cracking and joints have weeds.
Trails	0	N/A
Parking	3	Located at family center. Asphalt is cracking and fading. Striping is also fading.
Benches	3	Wood planks on metal frame. All were recently painted. Bleachers have some broken seating planks.
Trash Receptacles	2	Mix of blue plastic and metal drums.
Site Lighting	3	Located only at basketball courts, seem to be in working order.
Bike Racks	0	N/A
Park Signage	2	Standard Indy Parks sign. Logo is fading, weeds surrounding fence posts.
Bridges	0	N/A

Facilities Recommendation (Based on Park Assessments & Survey Results)
Additional trails and sidewalks would increase park connectivity internally and to the surrounding neighborhoods.

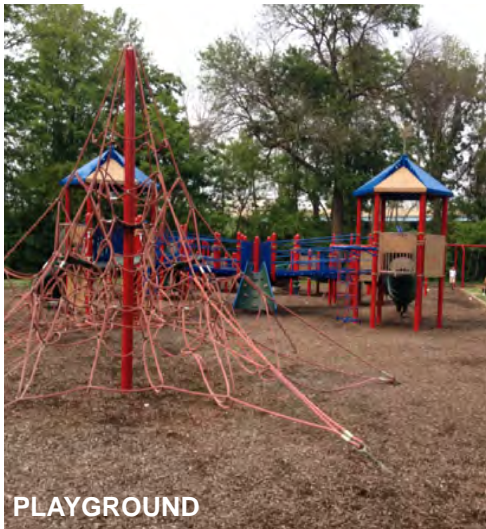
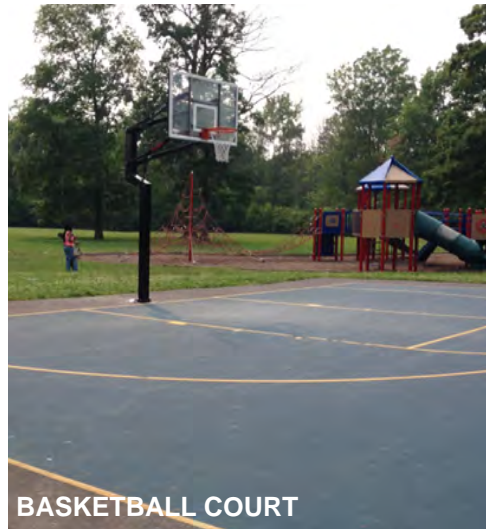
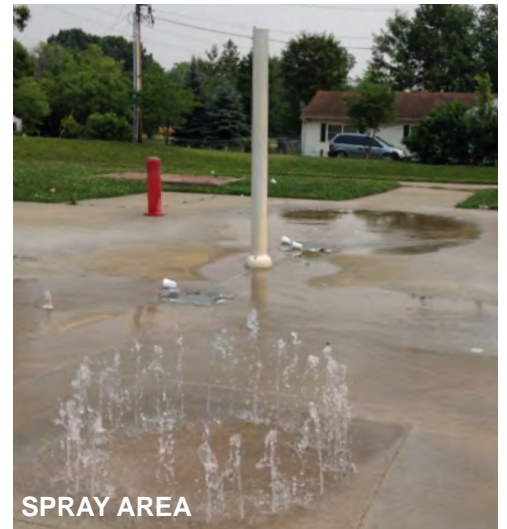
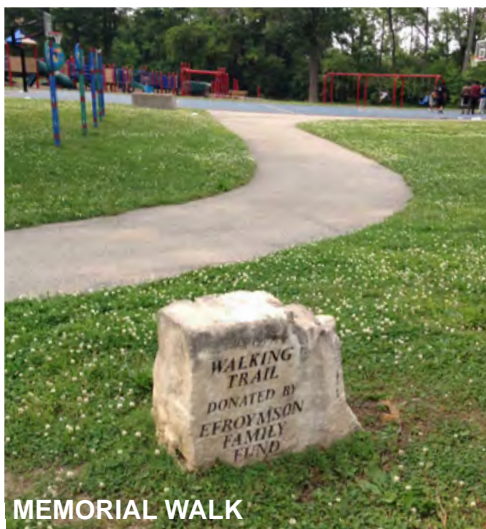
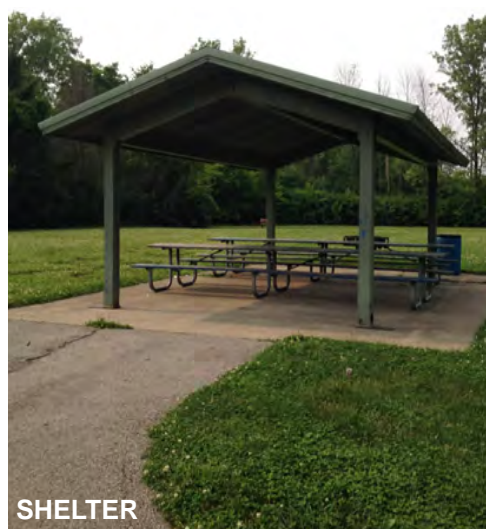
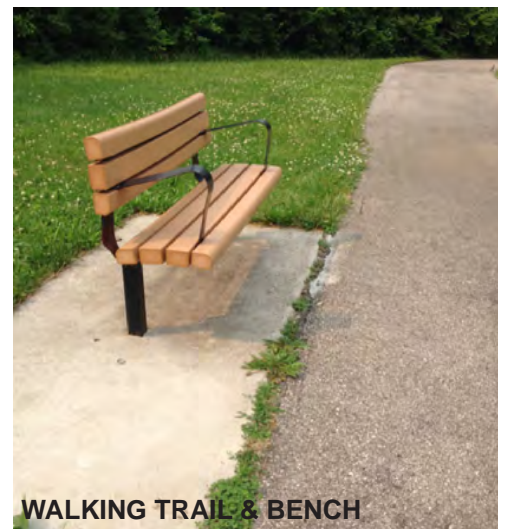
Programmed Park Amenities

Description	Scale of Conditions	QTY	Notes
Playground	2	1	Older structure - flat surface flexed when walking across. Some newer structures surrounding.
Basketball Court	2	2	Surface is fading and some minor cracking present.
Tennis Court	2	2	Surface is fading and some minor cracking present.
Volleyball Court	0	-	N/A
Softball Field	2	2	Infield is full of weeds and grass. Backstop is falling apart. Bleachers have broken planks.
Soccer Field	0	-	N/A
Football Field	2	1	Older goal post. No scoreboard or painted lines.
Baseball Field	0	-	N/A
Canine Zone	0	-	N/A
Spray Area	0	-	N/A
Pool-Outside	0	-	N/A
Water Slide	0	-	N/A
Sledding Hill	0	-	N/A
Horseshoes	2	2	Freshly painted, some missing boards on backstop. Needs sand.
Disc Golf Holes	0	-	N/A
Nature Center	0	-	N/A

Family Center	3	1	Outside appears in good condition.
Restroom Facility	2	1	Located in family center and a portable restroom onsite.
Picnic Shelter	3	2	Older shelter near playground, newer within open lawn area. Freshly painted.
Picnic Clusters	0	-	N/A
Programed Park Amenities General Notes: Several of the amenities appear older and could use maintenance or replacement.

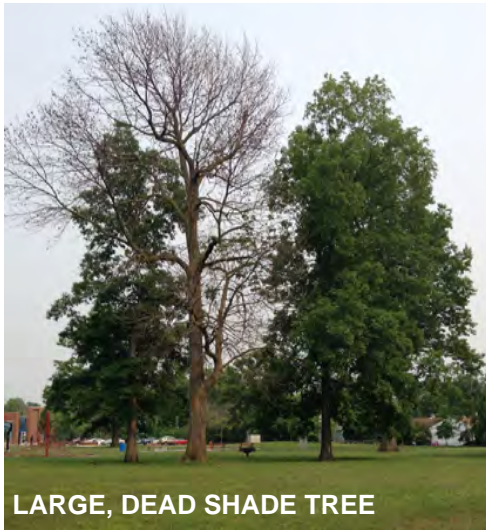
Park Open Space - Assessment		
Description	Scale of Conditions	Notes
Mowing	3	Large open lawn space. Recently mowed, but not underneath bleachers.
General Tree Conditions	3	Large, mature stand of trees near playground - need dead limbs removed.
Planting Areas	3	Recently planted and mulched. Plant material is minimal.
Water Feature	0	N/A
Park Open Space General Notes: Primarily large open lawn with a handful of mature shade trees.

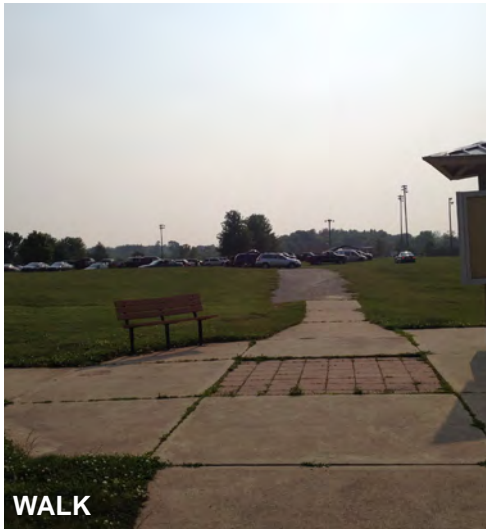
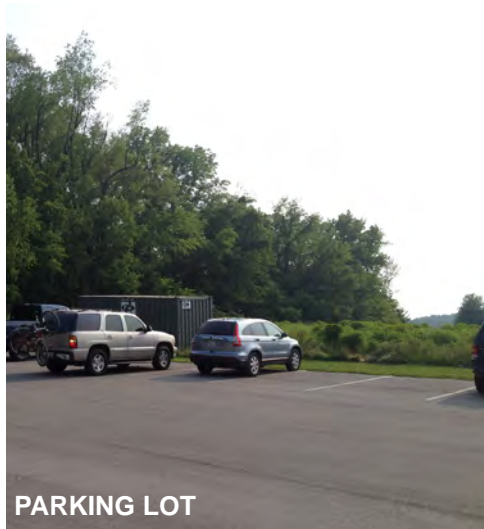
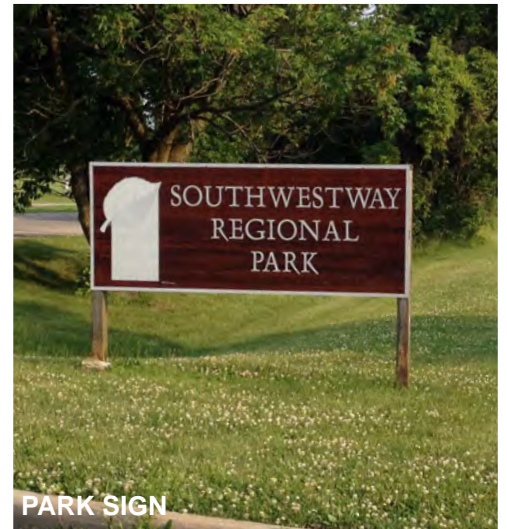
Park Infrastructure

Description	Scale of Conditions	Notes
Roads	4	Asphalt has minimal cracking and fresh pavement markings.
Walks	2	Very minimal walks present. Mix of concrete and crushed stone paths.
Trails	3	Dirt trails appear heavily used. Accommodate bikers, walkers, and horseback riding.
Parking	3	Asphalt is in good condition. Limited amount.
Benches	3	Minimal amount. Bleachers at ball fields - heavily used.
Trash Receptacles	2	A few plastic drums.
Site Lighting	3	Located at baseball/softball fields only. Appear to be in working order.
Bike Racks	0	N/A
Park Signage	3	Standard Indy Parks signage and good wayfinding signage. Some wood signs are peeling paint and rotting.
Bridges	4	Foot path bridges on trails in good shape - donated to aid mountain biking.

A lot of this park is underutilized. Additional parking should be added to accommodate games at the ballfields. There is a need for trail hierarchy; almost all trails are narrow dirt paths used for mountain biking, which is unsafe for those walking the trails.

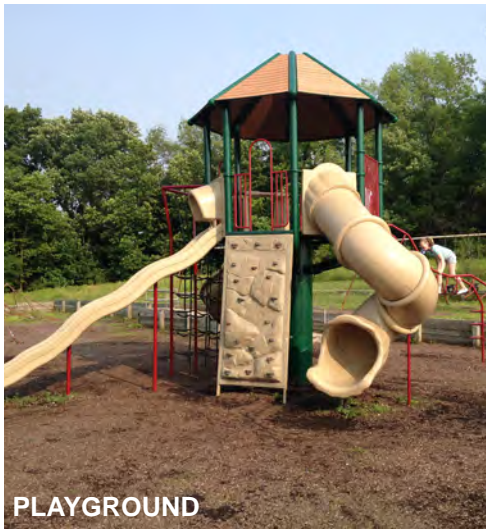
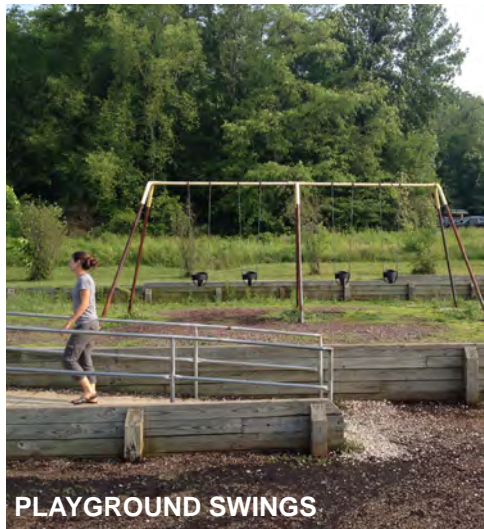
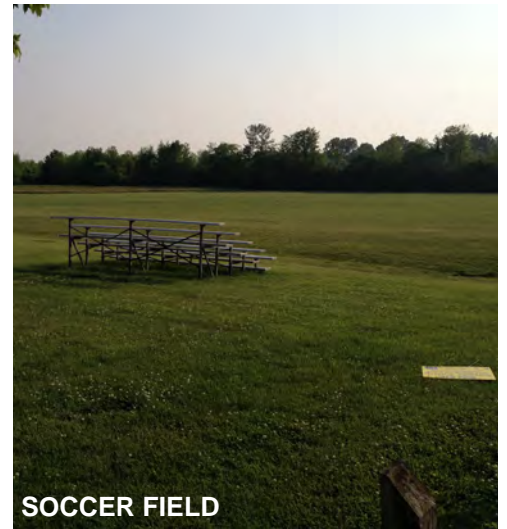
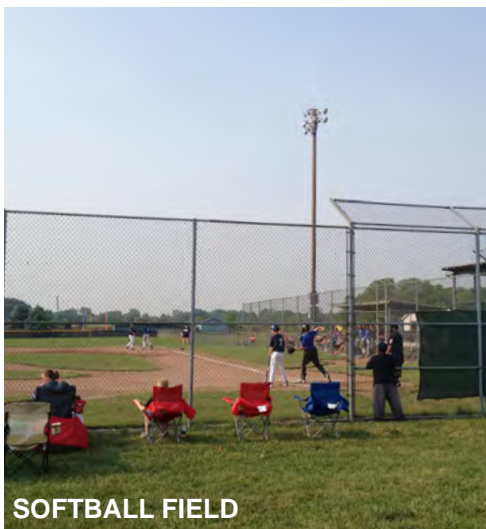
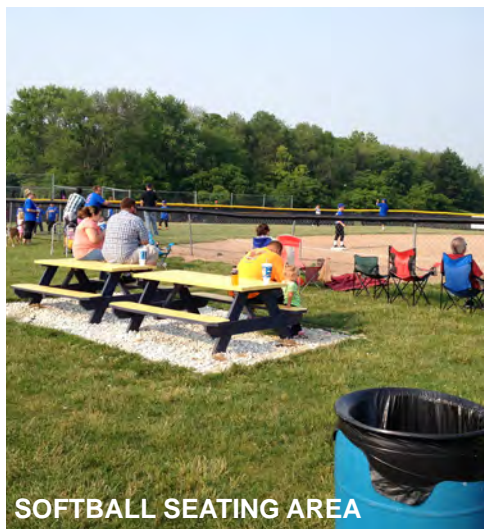
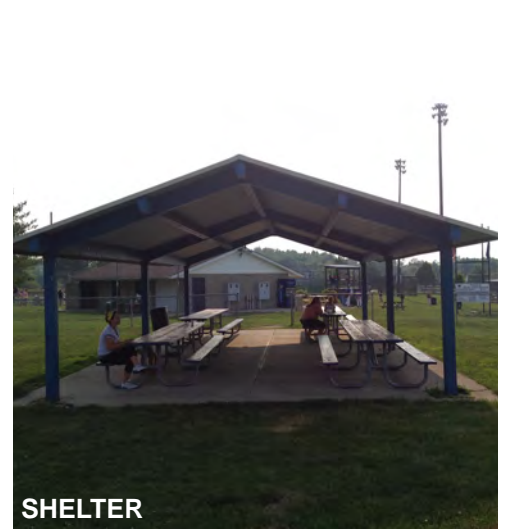
Programmed Park Amenities

Description	Scale of Conditions	QTY	Notes
Playground	2	1	Newer playground, mulch is full of weeds and needs mulch replenished.
Basketball Court	0	-	N/A
Tennis Court	0	-	N/A
Volleyball Court	0	-	N/A
Softball Field	0	-	N/A
Soccer Field	3	1	No goals present. Has bleachers on sidelines.
Football Field	0	-	N/A
Baseball Field	3	6	3 full size fields and 3 little league fields. Concession stand. In use during visit.
Canine Zone	0	-	N/A
Spray Area	0	-	N/A
Pool-Outside	0	-	N/A
Water Slide	0	-	N/A
Sledding Hill	0	-	N/A
Horseshoes	0	-	N/A
Disc Golf Holes	0	-	N/A
Nature Center	0	-	N/A

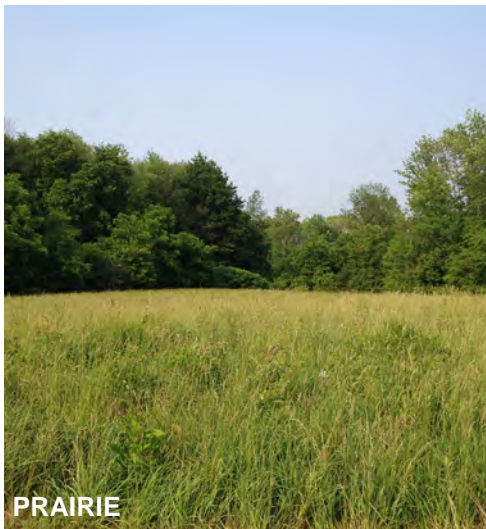
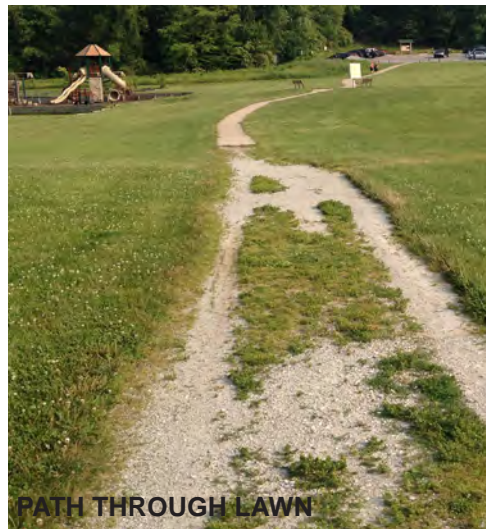
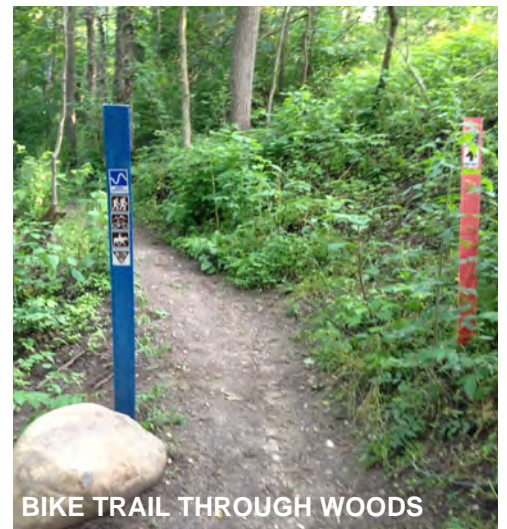
Park Open Space

Description	Scale of Conditions	Notes
Mowing	3	Recently mowed and trimmed. Some areas of tall weeds around building structures.
General Tree Conditions	3	Very minimal trees around playground and ball fields. Large wooded area with trail access.
Planting Areas	0	N/A
Water Feature	1	White River runs alongside park, however there are no trails leading to the river.

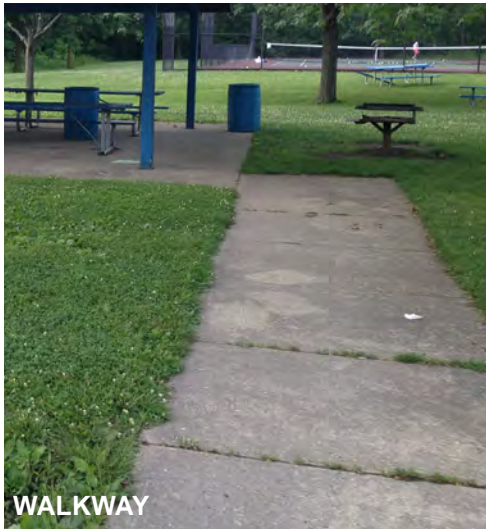
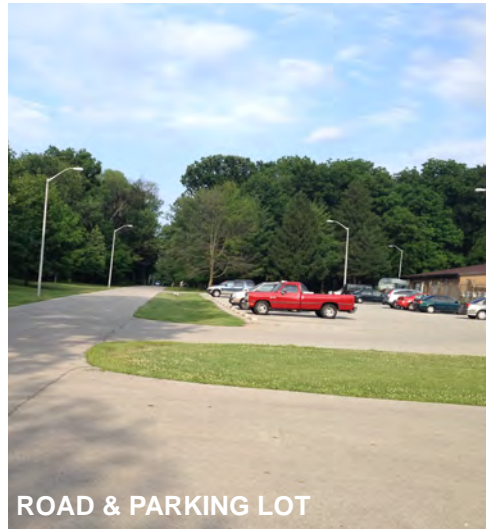
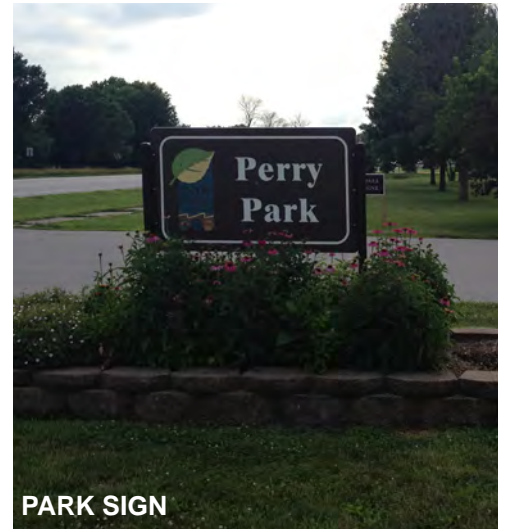
Park Infrastructure

Description	Scale of Conditions	Notes
Roads	3	No curbs, asphalt has minimal cracking.
Walks	3	Concrete walks appear to be in good condition.
Trails	2	Dirt trail. Entrance to trail is not well marked behind shelter.
Parking	3	Asphalt has minimal cracking and fresh pavement markings.
Benches	2	Mix of metal benches and wood slat benches. Metal benches appear worn and in need of new paint.
Trash Receptacles	3	Mix of metal receptacles and plastic barrels.
Site Lighting	3	Located a parking lots and pool.
Bike Racks	0	N/A
Park Signage	3	Standard Indy Park Sign. Could use wayfinding signage.
Bridges	0	N/A

Facilities Recommendations (Based on Park Assessments & Survey Results)
Perry Park needs additional trails to connect to the surrounding neighborhood, including the adjacent schools. A trail around the perimeter of the park would create a walking loop.

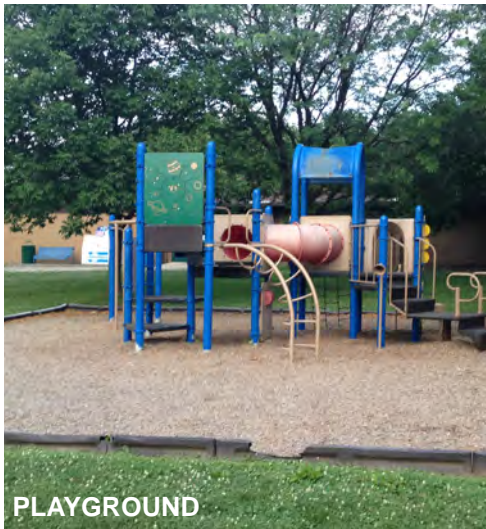
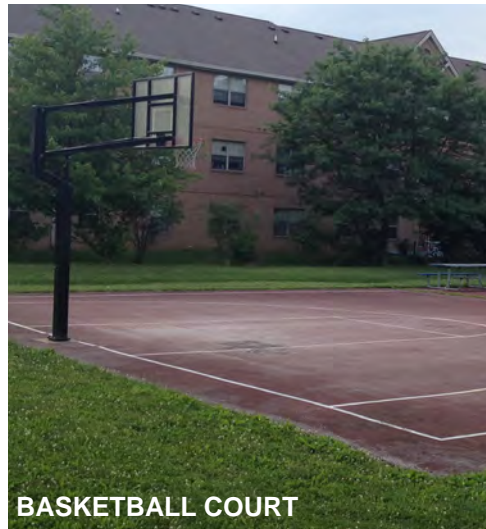
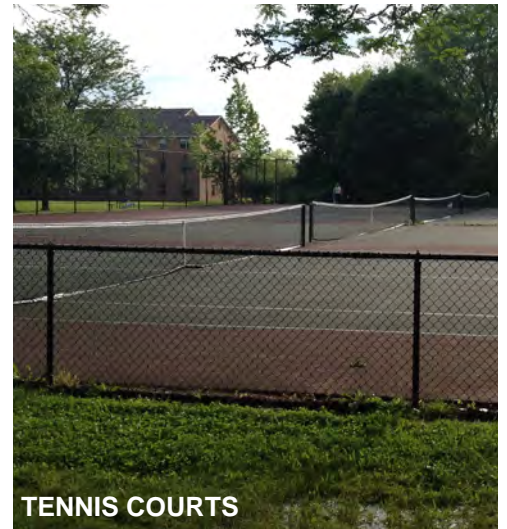
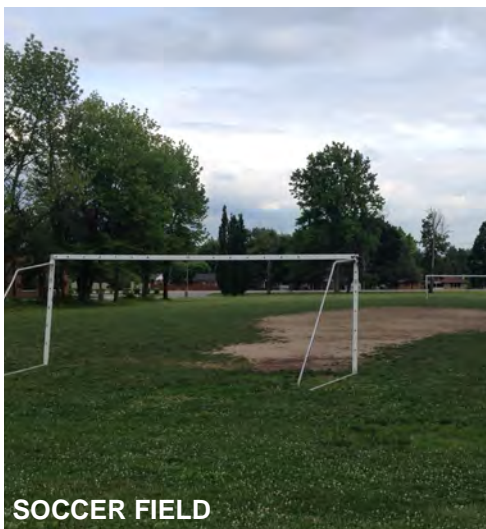
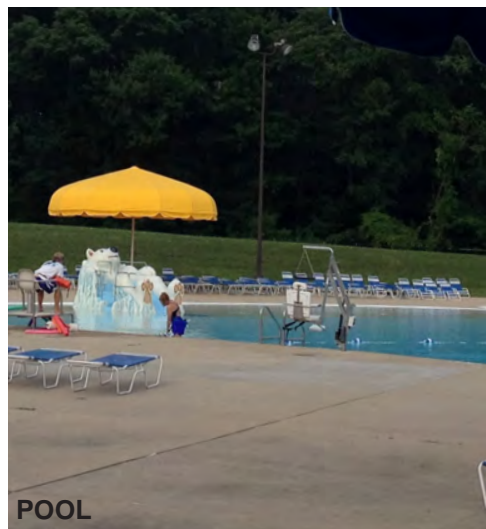
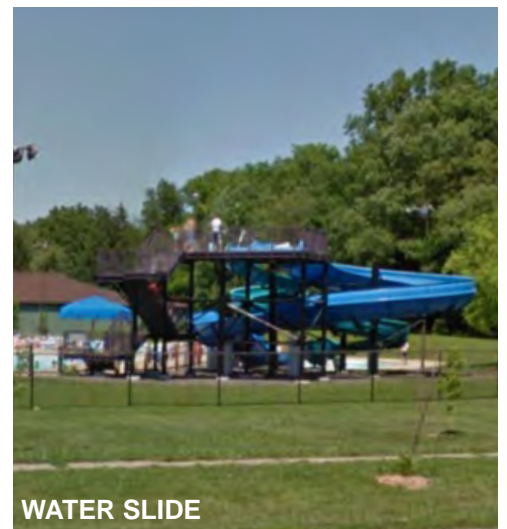
Programmed Park Amenities

Description	Scale of Conditions	QTY	Notes
Playground	2	1	Playground structure and swings are older. Playground edge restraint is broken.
Basketball Court	3	1	Some cracking present, fading surface.
Tennis Court	3	4	Some cracking present but in over-all good shape.
Volleyball Court	0	-	N/A
Softball Field	0	-	N/A
Soccer Field	2	1	Center of field needs reseeded because of heavy use.
Football Field	0	-	N/A
Baseball Field	0	-	N/A
Canine Zone	0	-	N/A
Spray Area	3	1	Located in pool.
Pool-Outside	3	1	Pool appears to be well maintained with newer furniture.
Water Slide	4	1	Large slide. Well maintained and in use.
Sledding Hill	0	-	N/A
Horseshoes	0	-	N/A
Disc Golf Holes	0	-	N/A
Nature Center	0	-	N/A

Family Center	0	-	N/A
Restroom Facility	3	2	Located in pool and ice rink
Picnic Shelter	2	2	Peeling paint. One is large in size and older/historic. Large branch has fallen on structure.
Picnic Clusters	0	-	N/A
Ice Rink	3	1	Looks to be in good condition.
Programed Park Amenities General Notes: Many of the park's amenities, including the outdoor aquatics center are older, but appear to be well maintained Picnic Shelters need attention from general maintenance and cleaning.

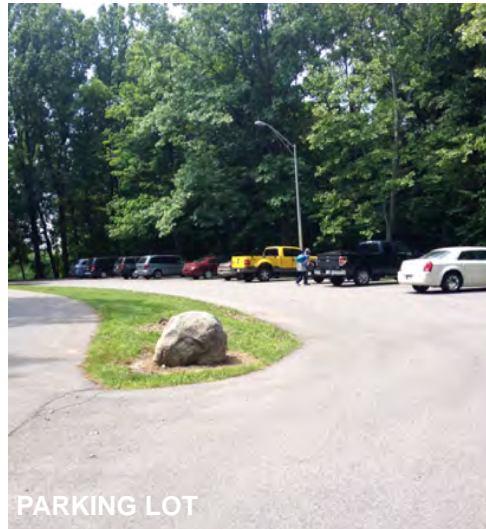
PARKING LOT

Description	Scale of Conditions	Notes
Roads	4	Good condition - no pot holes and minor cracking, clear markings and signage for crosswalks.
Walks	3.5	Most are clean and stable except for a walk sinking between a shelter and the playground.
Trails	4	Asphalt paths through main park - wide and level. Dirt paths through woods, clear - stairs and footbridges.
Parking	3.5	Pavement in good shape, some cracking and fading parking lines.
Benches	3.5	Metal base with wood plank tops, painted brown. Some wear - peeling paint.
Trash Receptacles	3	Heavy metal drums, no lids next to woods - animals?
Site Lighting	3	Good condition, seem to work. Only along roads and very widely spaced.
Bike Racks	0	N/A
Park Signage	4	Several road directing signs, picnic shelter signs, and signs with park maps attached.
Bridges	3	Minimal footbridges on wood trails, no railing.

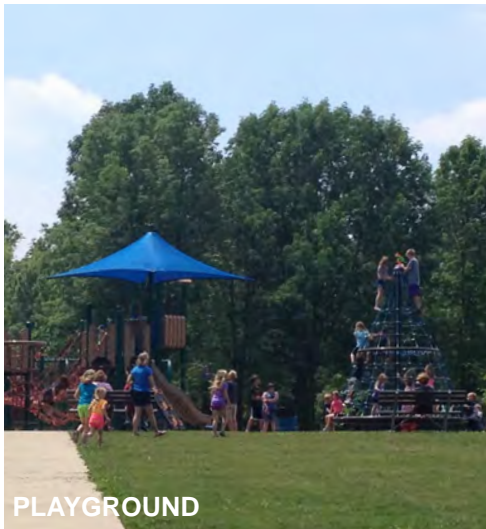
PLAYGROUND

Description	Scale of Conditions	QTY	Notes
Playground	4	2	looks new, large, variety of playing options. Several children were playing at time of visit.
Basketball Court	0	-	N/A
Tennis Court	0	-	N/A
Volleyball Court	0	-	N/A
Softball Field	0	-	N/A
Soccer Field	0	-	N/A
Football Field	0	-	N/A
Baseball Field	0	-	N/A
Canine Zone	0	-	N/A
Spray Area	0	-	N/A
Pool-Outside	0	-	N/A
Water Slide	0	-	N/A
Sledding Hill	3	1	No clear path to hill, no shelter or benches for observers.
Horseshoes	0	-	N/A
Disc Golf Holes	0	-	N/A
Nature Center	3.5	1	Nature Center/Activity Center/Park office. Large, open room with office in a loft. Dated building

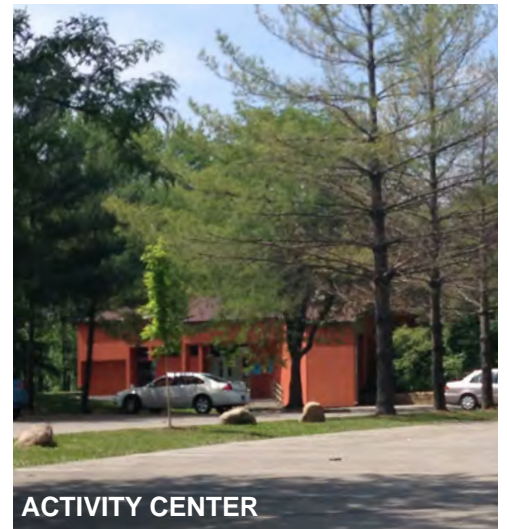
ACTIVITY CENTER

Park Weaknesses
This park has a rural location that is only accessible by vehicle. There is old, deteriorating infrastructure around the Activity Center. The Infrastructure does not support the large amount of visitors.

Park Strategic Recommendations
The park would benefit from the addition of a nature center in conjunction with renovating the existing activity center. Adding activities such as a rock climbing feature or ropes course would activate the community's engagement with the existing natural habitats while generating park revenue. Overlooks and fishing piers could be added along Buck Creek to improve connections to the water.
Signage should be added on I-74 to create awareness of the park's location. In this rural location, more land could be added to support the large volume of visitors.
